## **US 301 Bridge**

Petrographic Examination of Concrete Cores

Orangeburg County, South Carolina

### **FINAL REPORT**

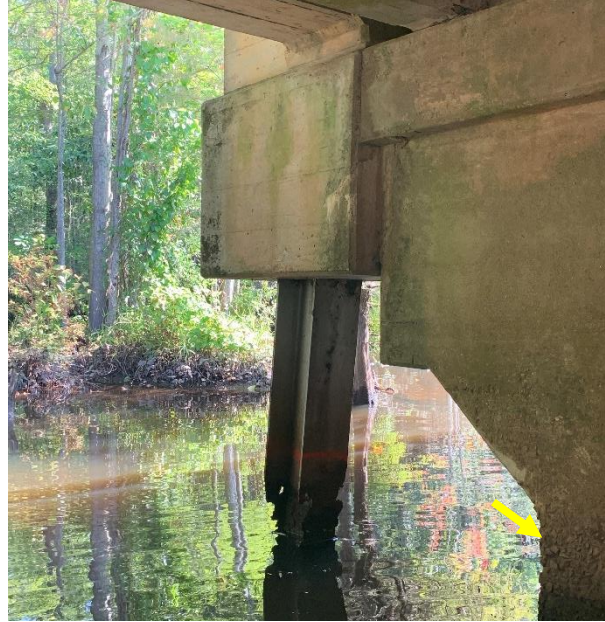
Figure 1. Bridge pier with corroded steel and deteriorated concrete near the waterline (arrow). Image provided by ESP.

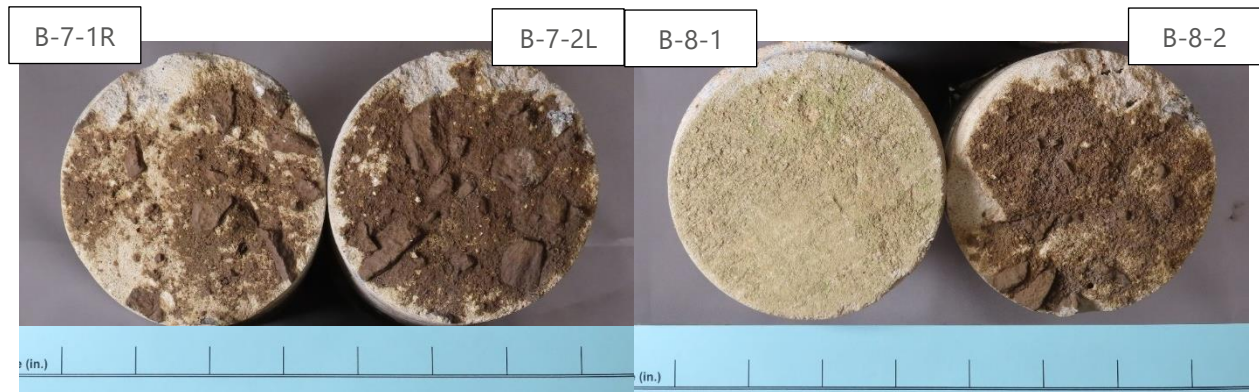
Figure 2. As-received appearance of exterior surfaces of the four core samples. Cores B-7-1R, B-7-2L, and B-8-2 were extracted in the waterline fluctuation zone, whereas Core B-8-1 was extracted at a higher elevation on the bridge pier.

The exterior surface of Cores B-7-1R, B-7-2L, and B-8-2, all extracted within the waterline fluctuation zone, is irregular in profile due to loss of surface paste resulting in the partial exposure of coarse aggregates (Figure 2, Figure 3, and Figure 4). The relief of the irregular surface profile, indicating the minimum depth of paste erosion from the original formed surface at the time of coring, is 1/4 inch in Core B-7-1R, 1/8 inch in Core B-7-2L, and 1/4 inch in Core B-8-2.

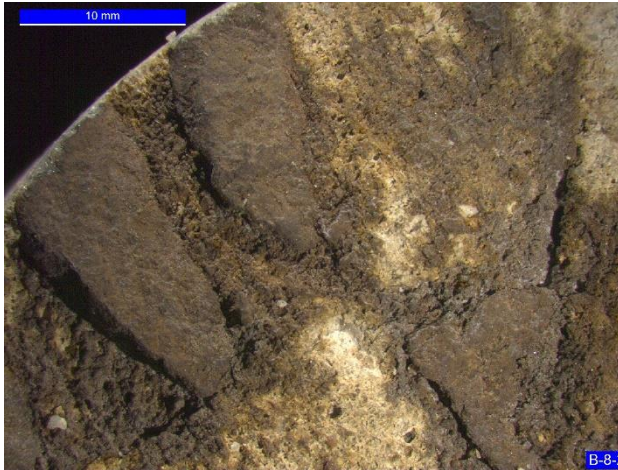
Figure 3. Brown discoloration on the exposed surface of coarse aggregates and paste.

The exterior surfaces contain brown discoloration on the exposed coarse aggregates and paste (Figure 2 and Figure 3). Beneath the brown-colored material on the exterior paste, the paste is tan to yellow in color, granular in texture, friable, and extremely absorptive.

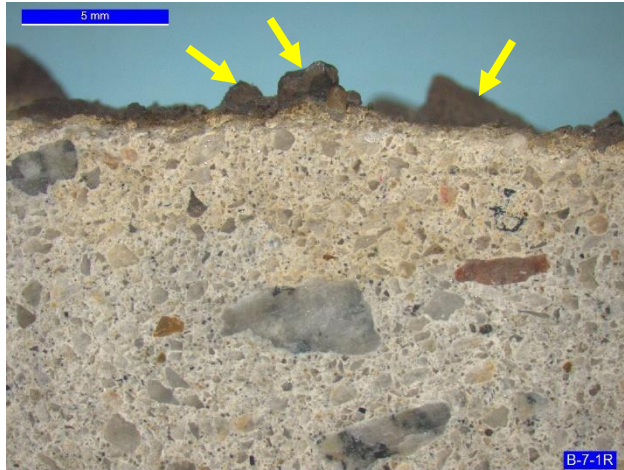
Figure 4. Aggregates (arrows) protruding from the exterior surface.

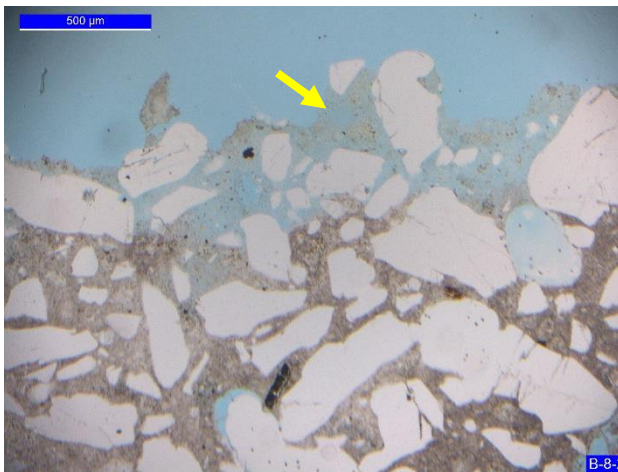
In thin section, a portion of the surface contains a thin layer of isotropic paste (measured to a maximum depth of approximately 0.5 mm) that suggests leaching of calcium-containing components from the surface (Figure 5 and Figure 6). Siliceous fine aggregates are embedded within the isotropic paste. The paste immediately below this surface region is dense and carbonated.

Figure 5. Porous paste (arrow) outboard of carbonated paste along the exterior surface; plane-polarized light.

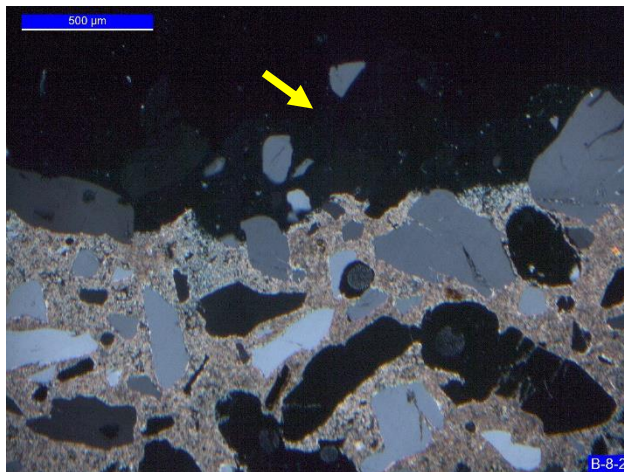
Figure 6. Isotropic paste (arrow) outboard of carbonated paste along the exterior surface; cross-polarized light.

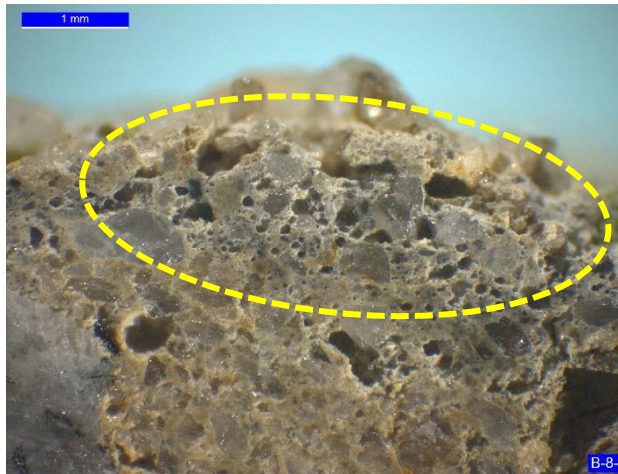
The exterior surface of Core B-8-1, extracted above the waterline fluctuation zone, was not discolored brown and did not contain isotropic paste. Rather, a gray colored, air-entrained mortar was observed on portions of the exterior surface to a depth of approximately 1/16 inch (Figure 7). Microcracks within the surface mortar were present (Figure A7). The gray paste along the exterior surface has a slight green hue due to plant growth. The surface has a microtexture of linear striations possibly due to a trowel application. Fine aggregates (and no coarse aggregates) are partially exposed on the surface. The surface mortar paste is friable, extremely soft, and extremely absorptive. Entrained air voids are visible in the exterior paste, and no secondary deposits were observed within the voids. A white haze was not present on the surface of Core B-8-1 as was observed in the other three cores. In thin section, remnants of this surface mortar contained some portland cement particles that were visually dissimilar to that in the body of the cores (Figure A8) but still coarsely graded.

Figure 7. Gray, air-entrained mortar on the surface of Core B-8-1.

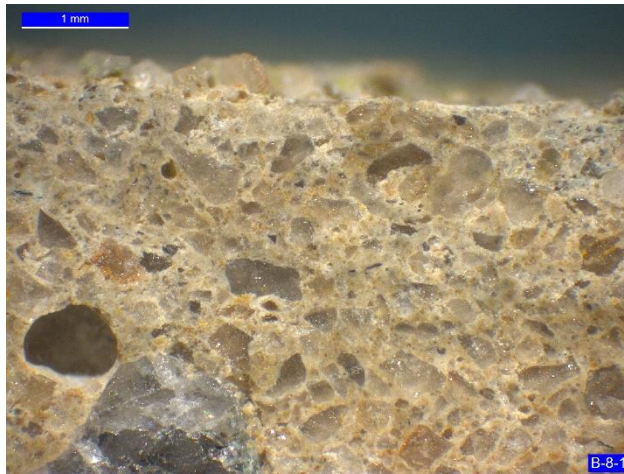
No distress was observed in the concrete beneath the surface mortar (Figure 8).

Figure 8. No distress in the concrete beneath the surface mortar on the surface of Core B-8-1.

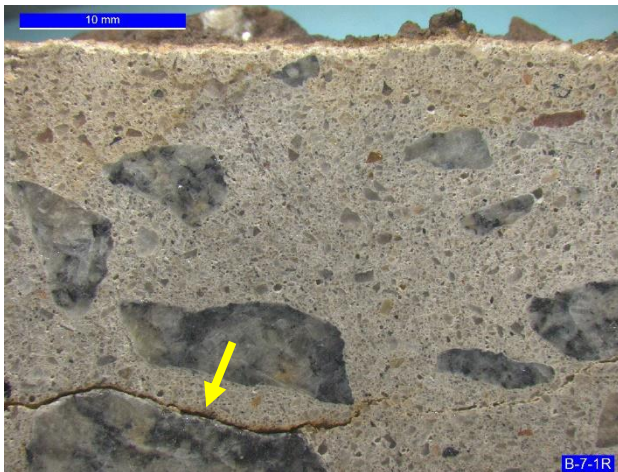
For Core B-7-1R, a separation is present within Core B-7-1R that is angled from the exterior surface up to a depths of 3 inches (Figure 9 and Figure A9). The separation may represent a crack or a settlement/movement feature within the concrete. The presence of mortar stringers spanning the width suggests that the feature formed while the concrete was still plastic (unset). The surfaces along the separation are lined with secondary deposits, indicating moisture has been able to migrate through it over time (Figure 10). The core remained intact during core extraction, shipment, and sample preparation despite this feature.

Figure 9. A separation (arrow) near the exterior surface of Core B-7-1R.

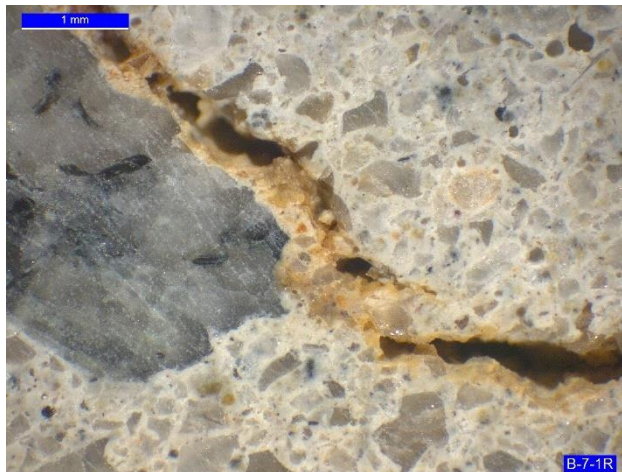
Figure 10. Mortar stringers and secondary deposits lining the separation in Core B-7-1R.

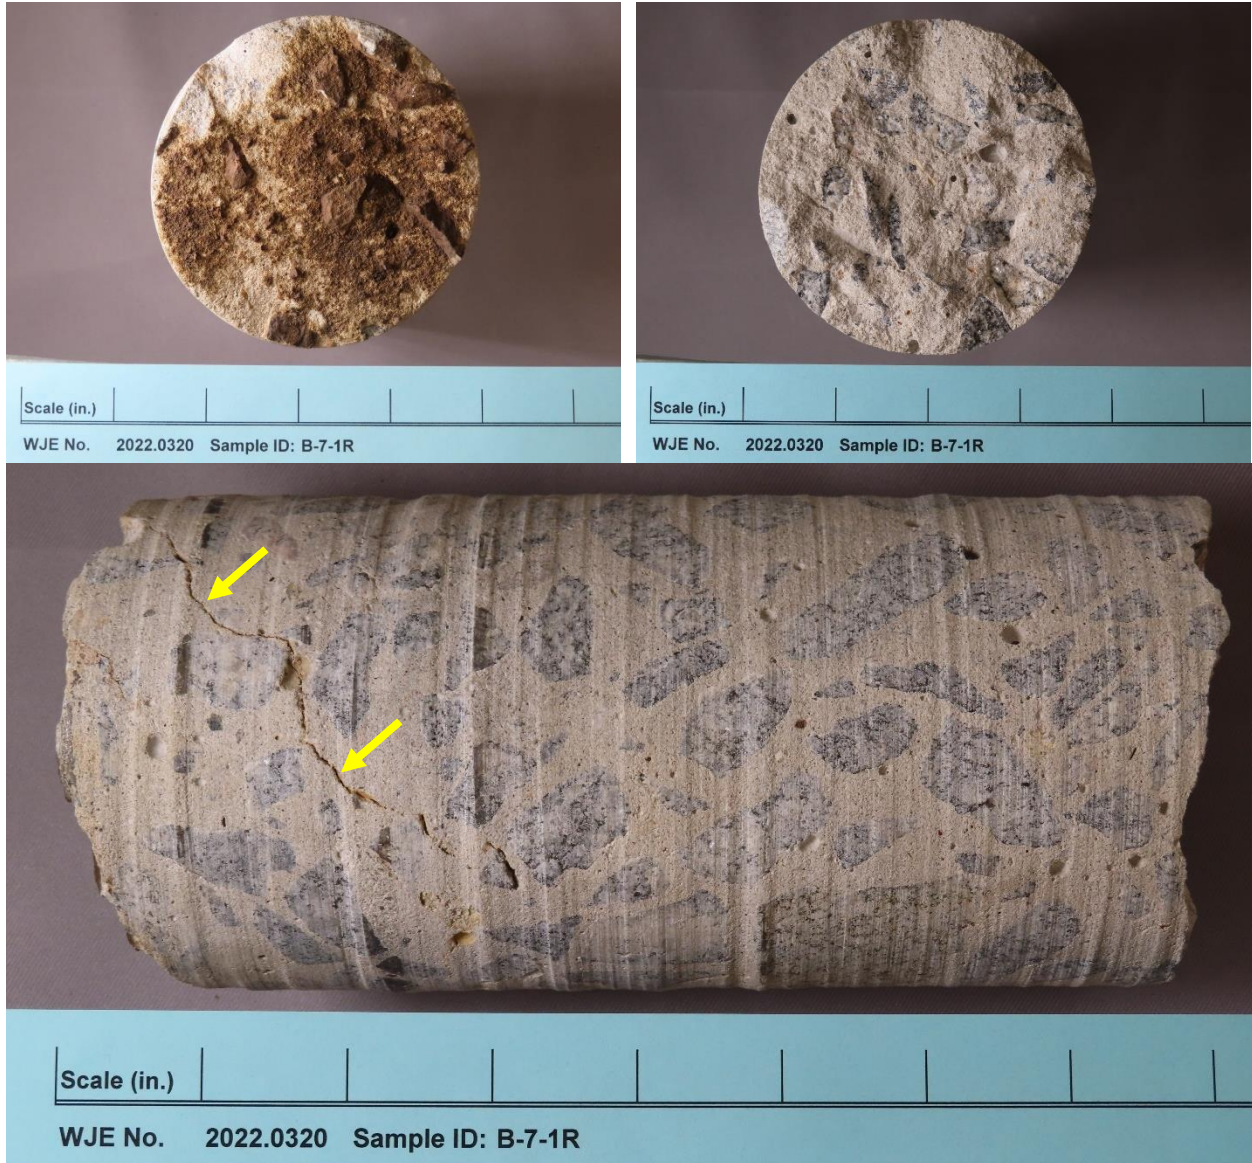
Figure A1. As-received appearance of exterior (upper left), interior (upper right), and side (lower) of Core B-7-1R. Separations within the exterior of the core are identified with arrows.

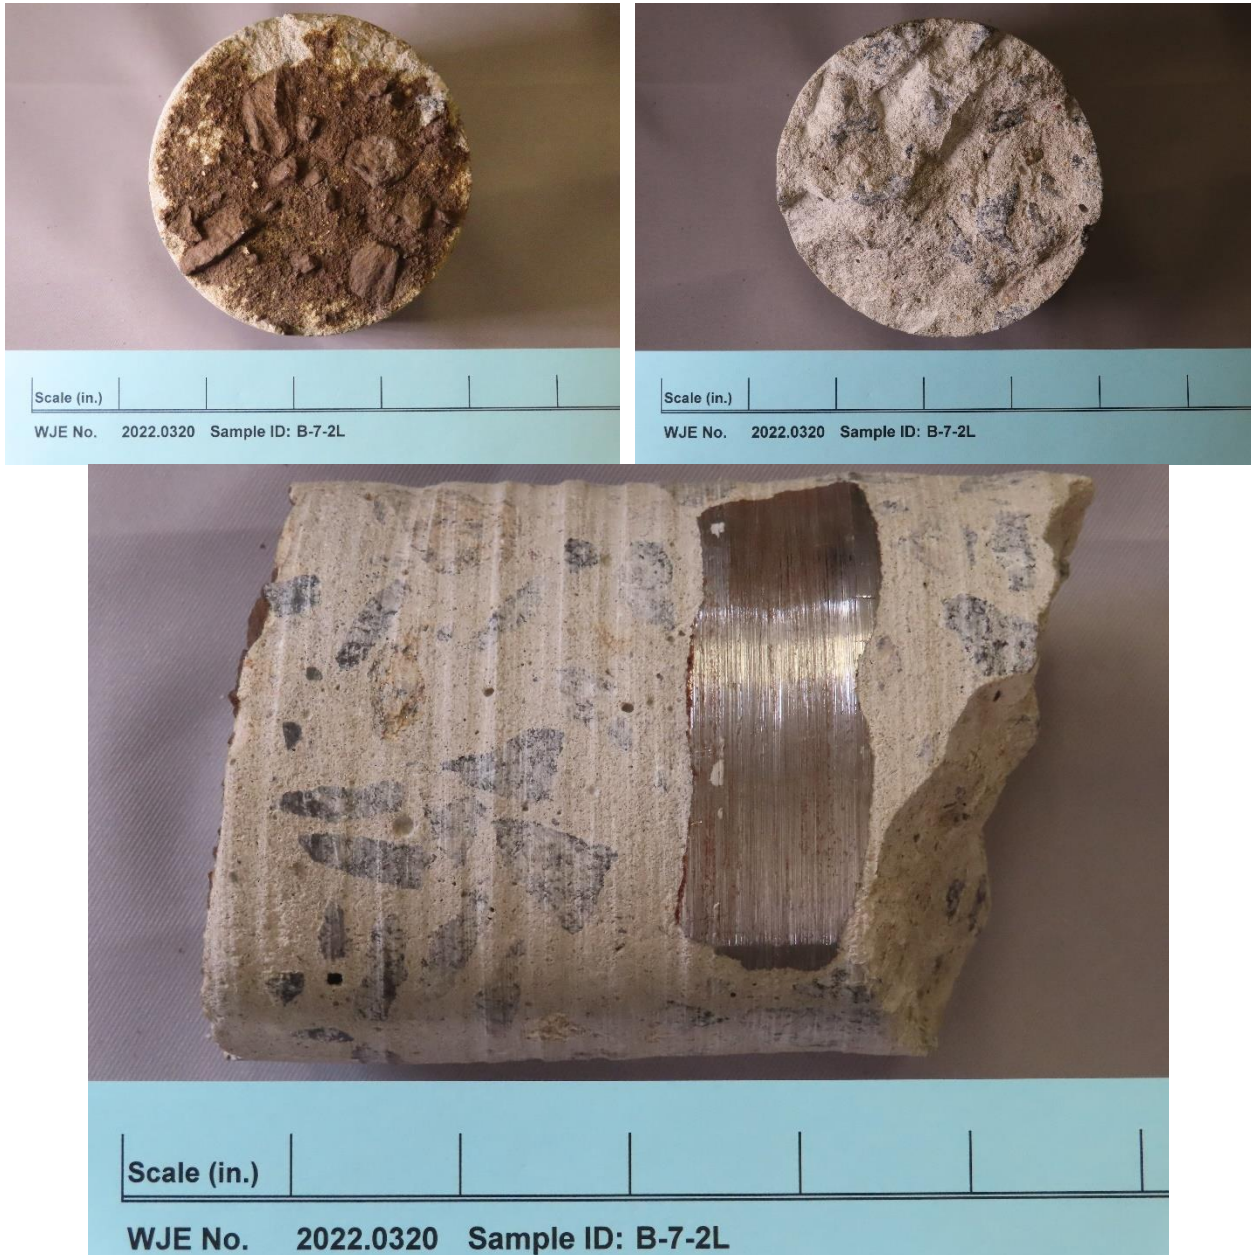
Figure A2. As-received appearance of exterior (upper left), interior (upper right), and side (lower) of Core B-7-2L. The intersected reinforcement is square in profile with 1 inch dimension.

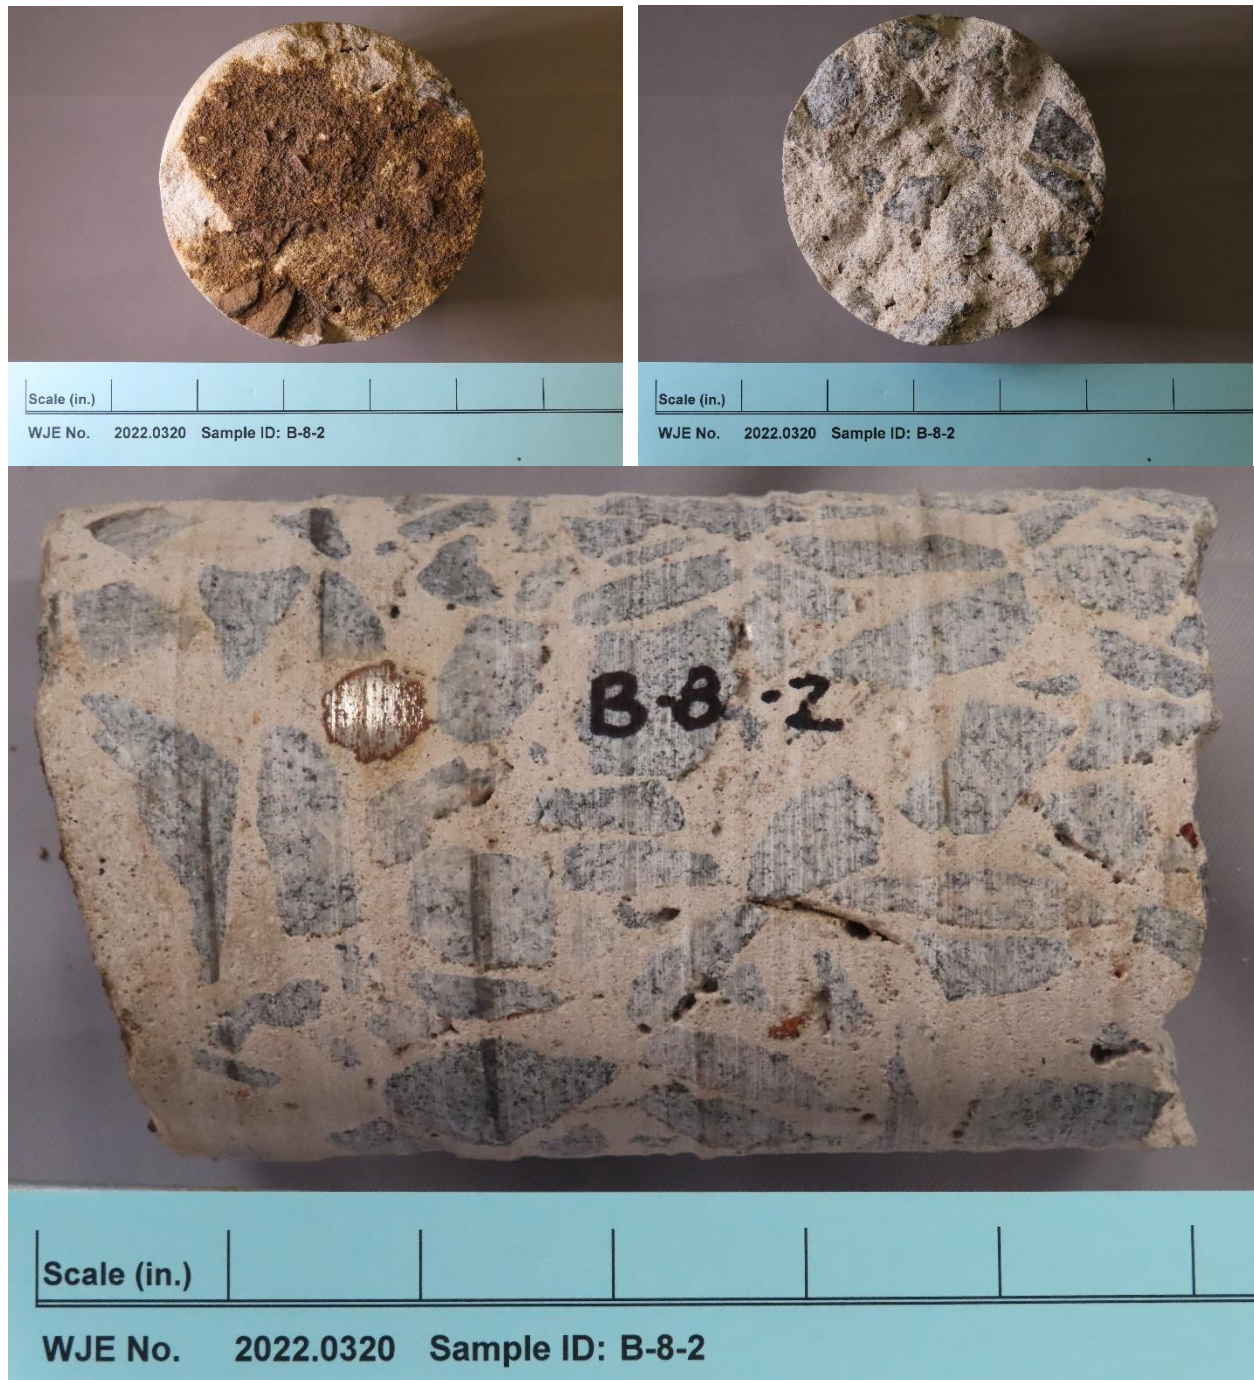
Figure A4. As-received appearance of exterior (upper left), interior (upper right), and side (lower) of Core B-8-2. The intersected reinforcement is round in profile with ribs and 1/2" diameter.

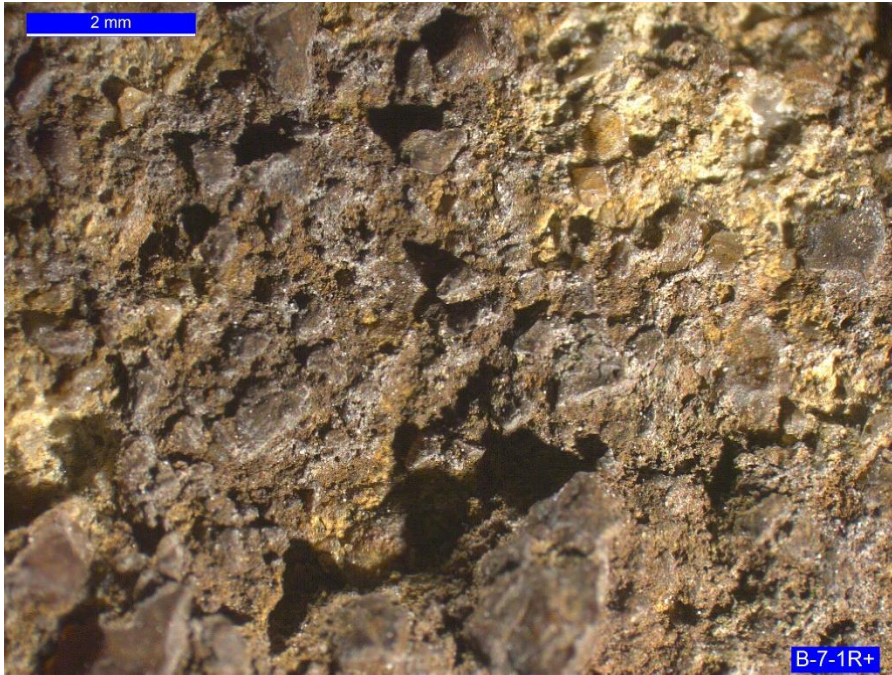
A white film or haze was observed on portions of the brown discolored surface that may represent efflorescence (salts precipitated on the surface) (Figure A5). Minor amounts of white secondary deposits of ettringite, carbonate, and isotropic material were observed lining some voids on the surface of Core B-7-1R; trace to no secondary deposits were observed for Cores B-7-2R and B-8-2. The surface of Core B-8-2 contains green plant growth.

Figure A5. A white film outboard of the brown discolored surface, pictured for Core B-7-1R.

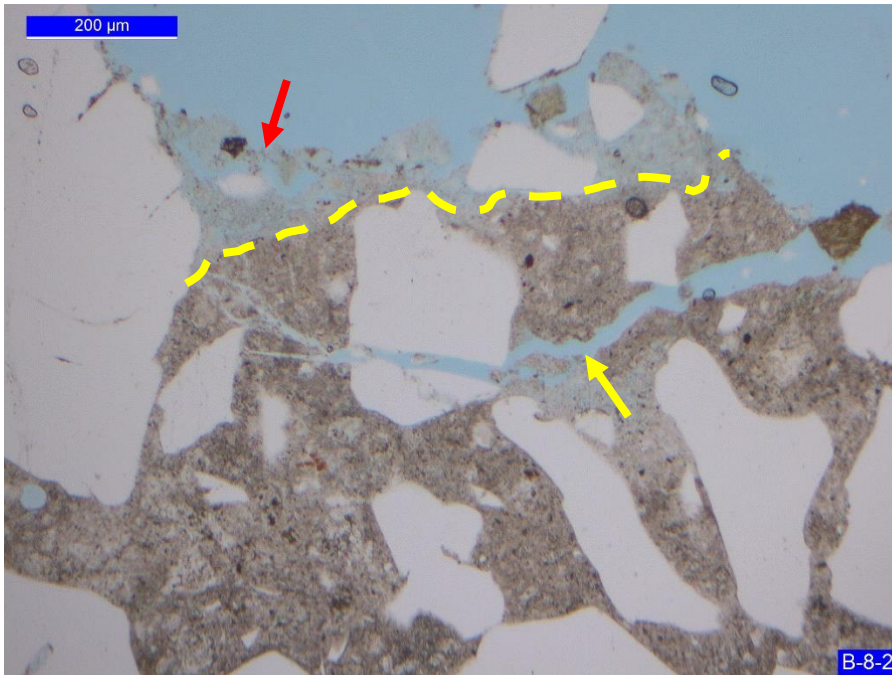
Trace microfractures within the paste and fine aggregates was observed in thin section for Cores B-7-2L and B-8-2 (Figure A6).

Figure A6. A fracture (yellow arrow) near the surface and isotropic paste (red arrow) along the exterior surface of Core B-8-2. The interface between the isotropic paste and the underlying carbonated concrete is marked with a dashed line.

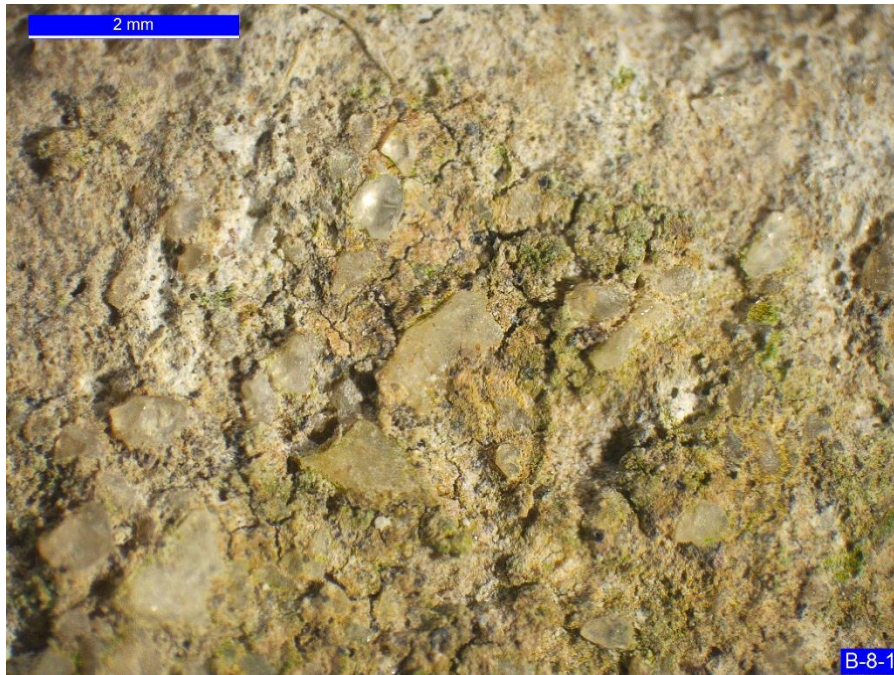
Figure A7. Green plant growth and microcracks on the surface of Core B-8-1.

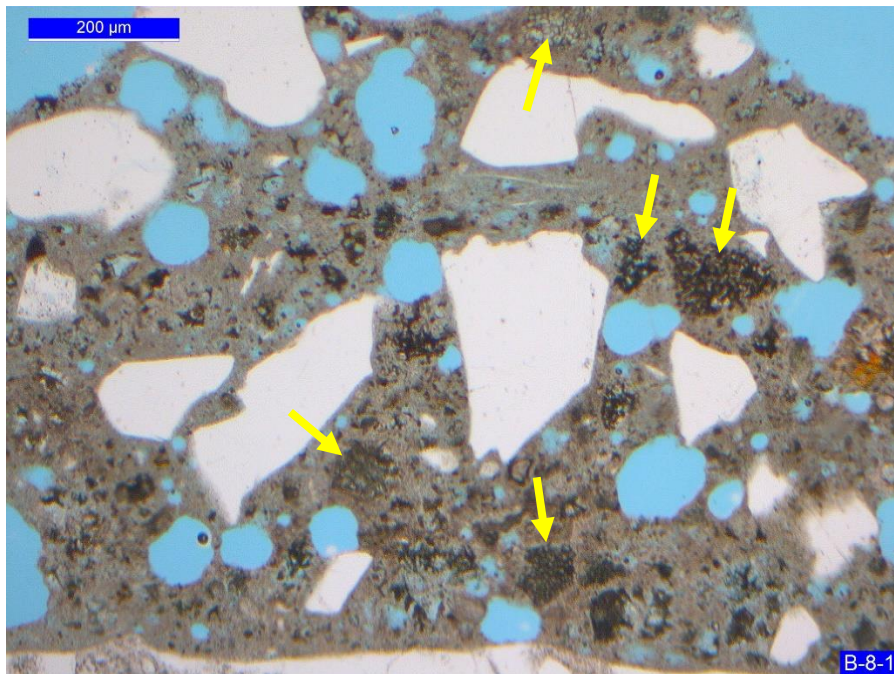
Figure A8. Residual cement particles (arrows) within the surface mortar in Core B-8-1.

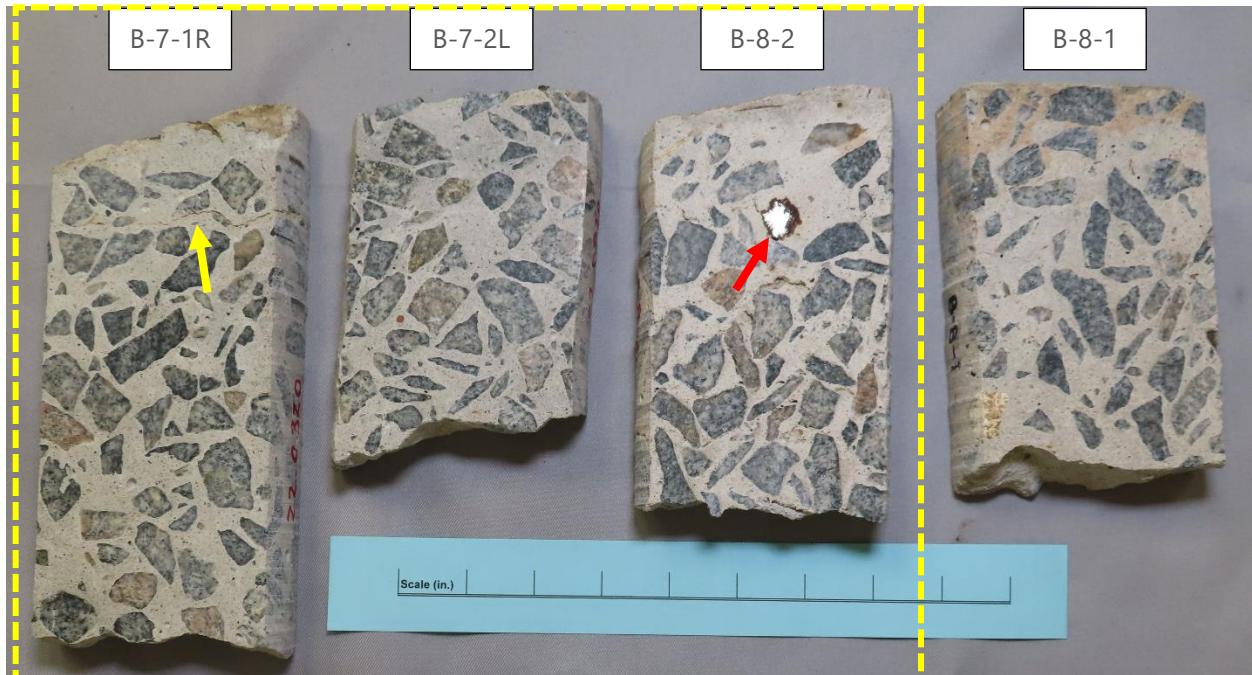
Figure A9. Lapped surfaces of the four examined core samples with compositionally similar concrete constituents. Variability in the volume and distribution of aggregates is apparent. The cores in the boxed region were extracted from within the waterline fluctuation zone, and Core B-8-1 was extracted at a higher elevation. A separation is identified with a yellow arrow in Core B-7-1R. A reinforcing bar intersected by Core B-8-2 is identified with a yellow arrow. The pink paste discoloration along the exterior surface (to top of the image) of Core B-8-1 is due to carbonation.

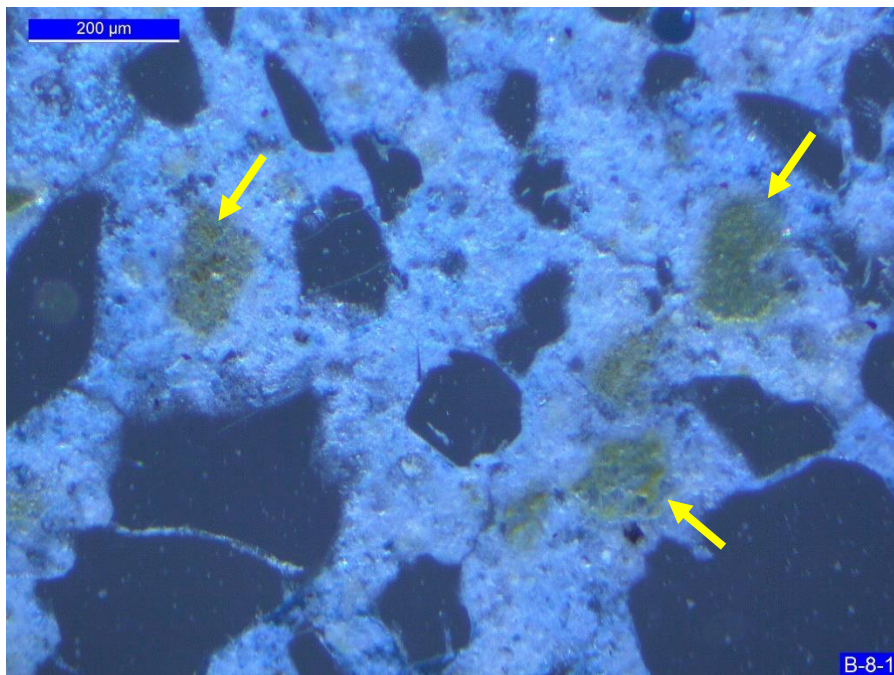
Figure A10. Coarse residual cement particles (arrows) in the concrete body.

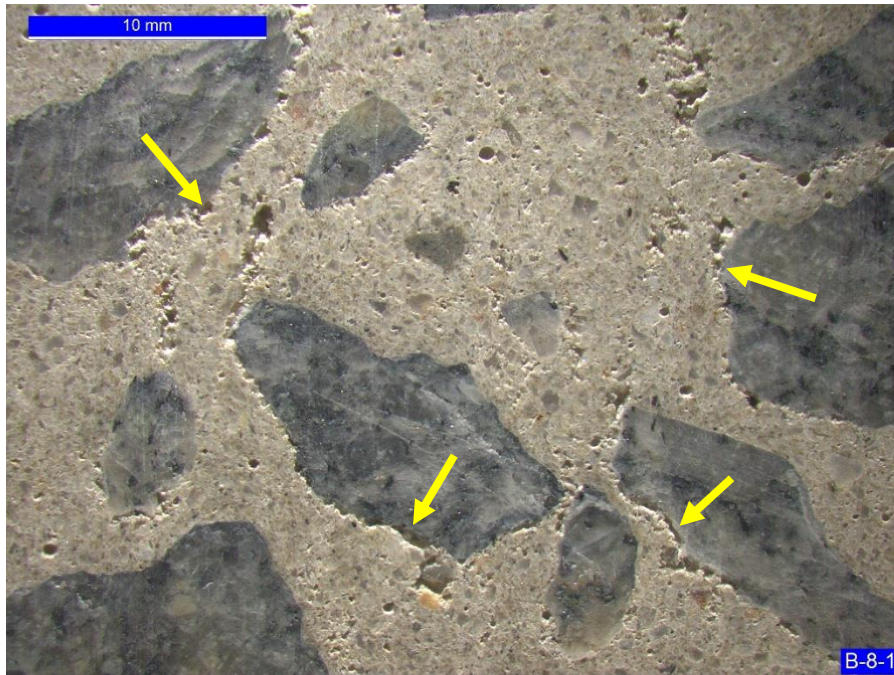
The paste is not air-entrained, and small, spherical voids characteristic of the use of an air-entraining admixture were not frequently observed. Voids are irregularly shaped voids and commonly located adjacent to coarse aggregates representing bleed water channels and water gain voids (Figure A11). In thin section, large concentrations of calcium hydroxide crystals were present in these voids for Core B-8-1. Secondary deposits were not frequently observed in the examined cores.

Figure A11. Irregularly shaped voids (arrows) adjacent coarse aggregates, pictured for Core B-8-1.
