# ASBESTOS CONTAINING MATERIAL INVESTIGATION REPORT

**I-26 BRIDGE OVER THE CSX RAILWAY  
RICHLAND COUNTY, SOUTH CAROLINA**

**February 27, 2019**

F&ME Project No.: G5662.010

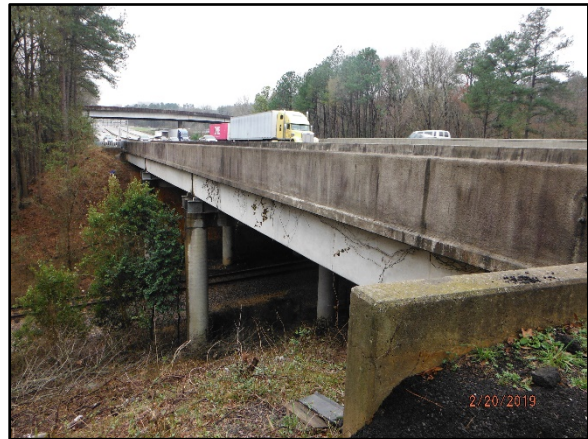
*Photo 1 – I-26 Bridge over the CSX Railway in Richland County, SC.*

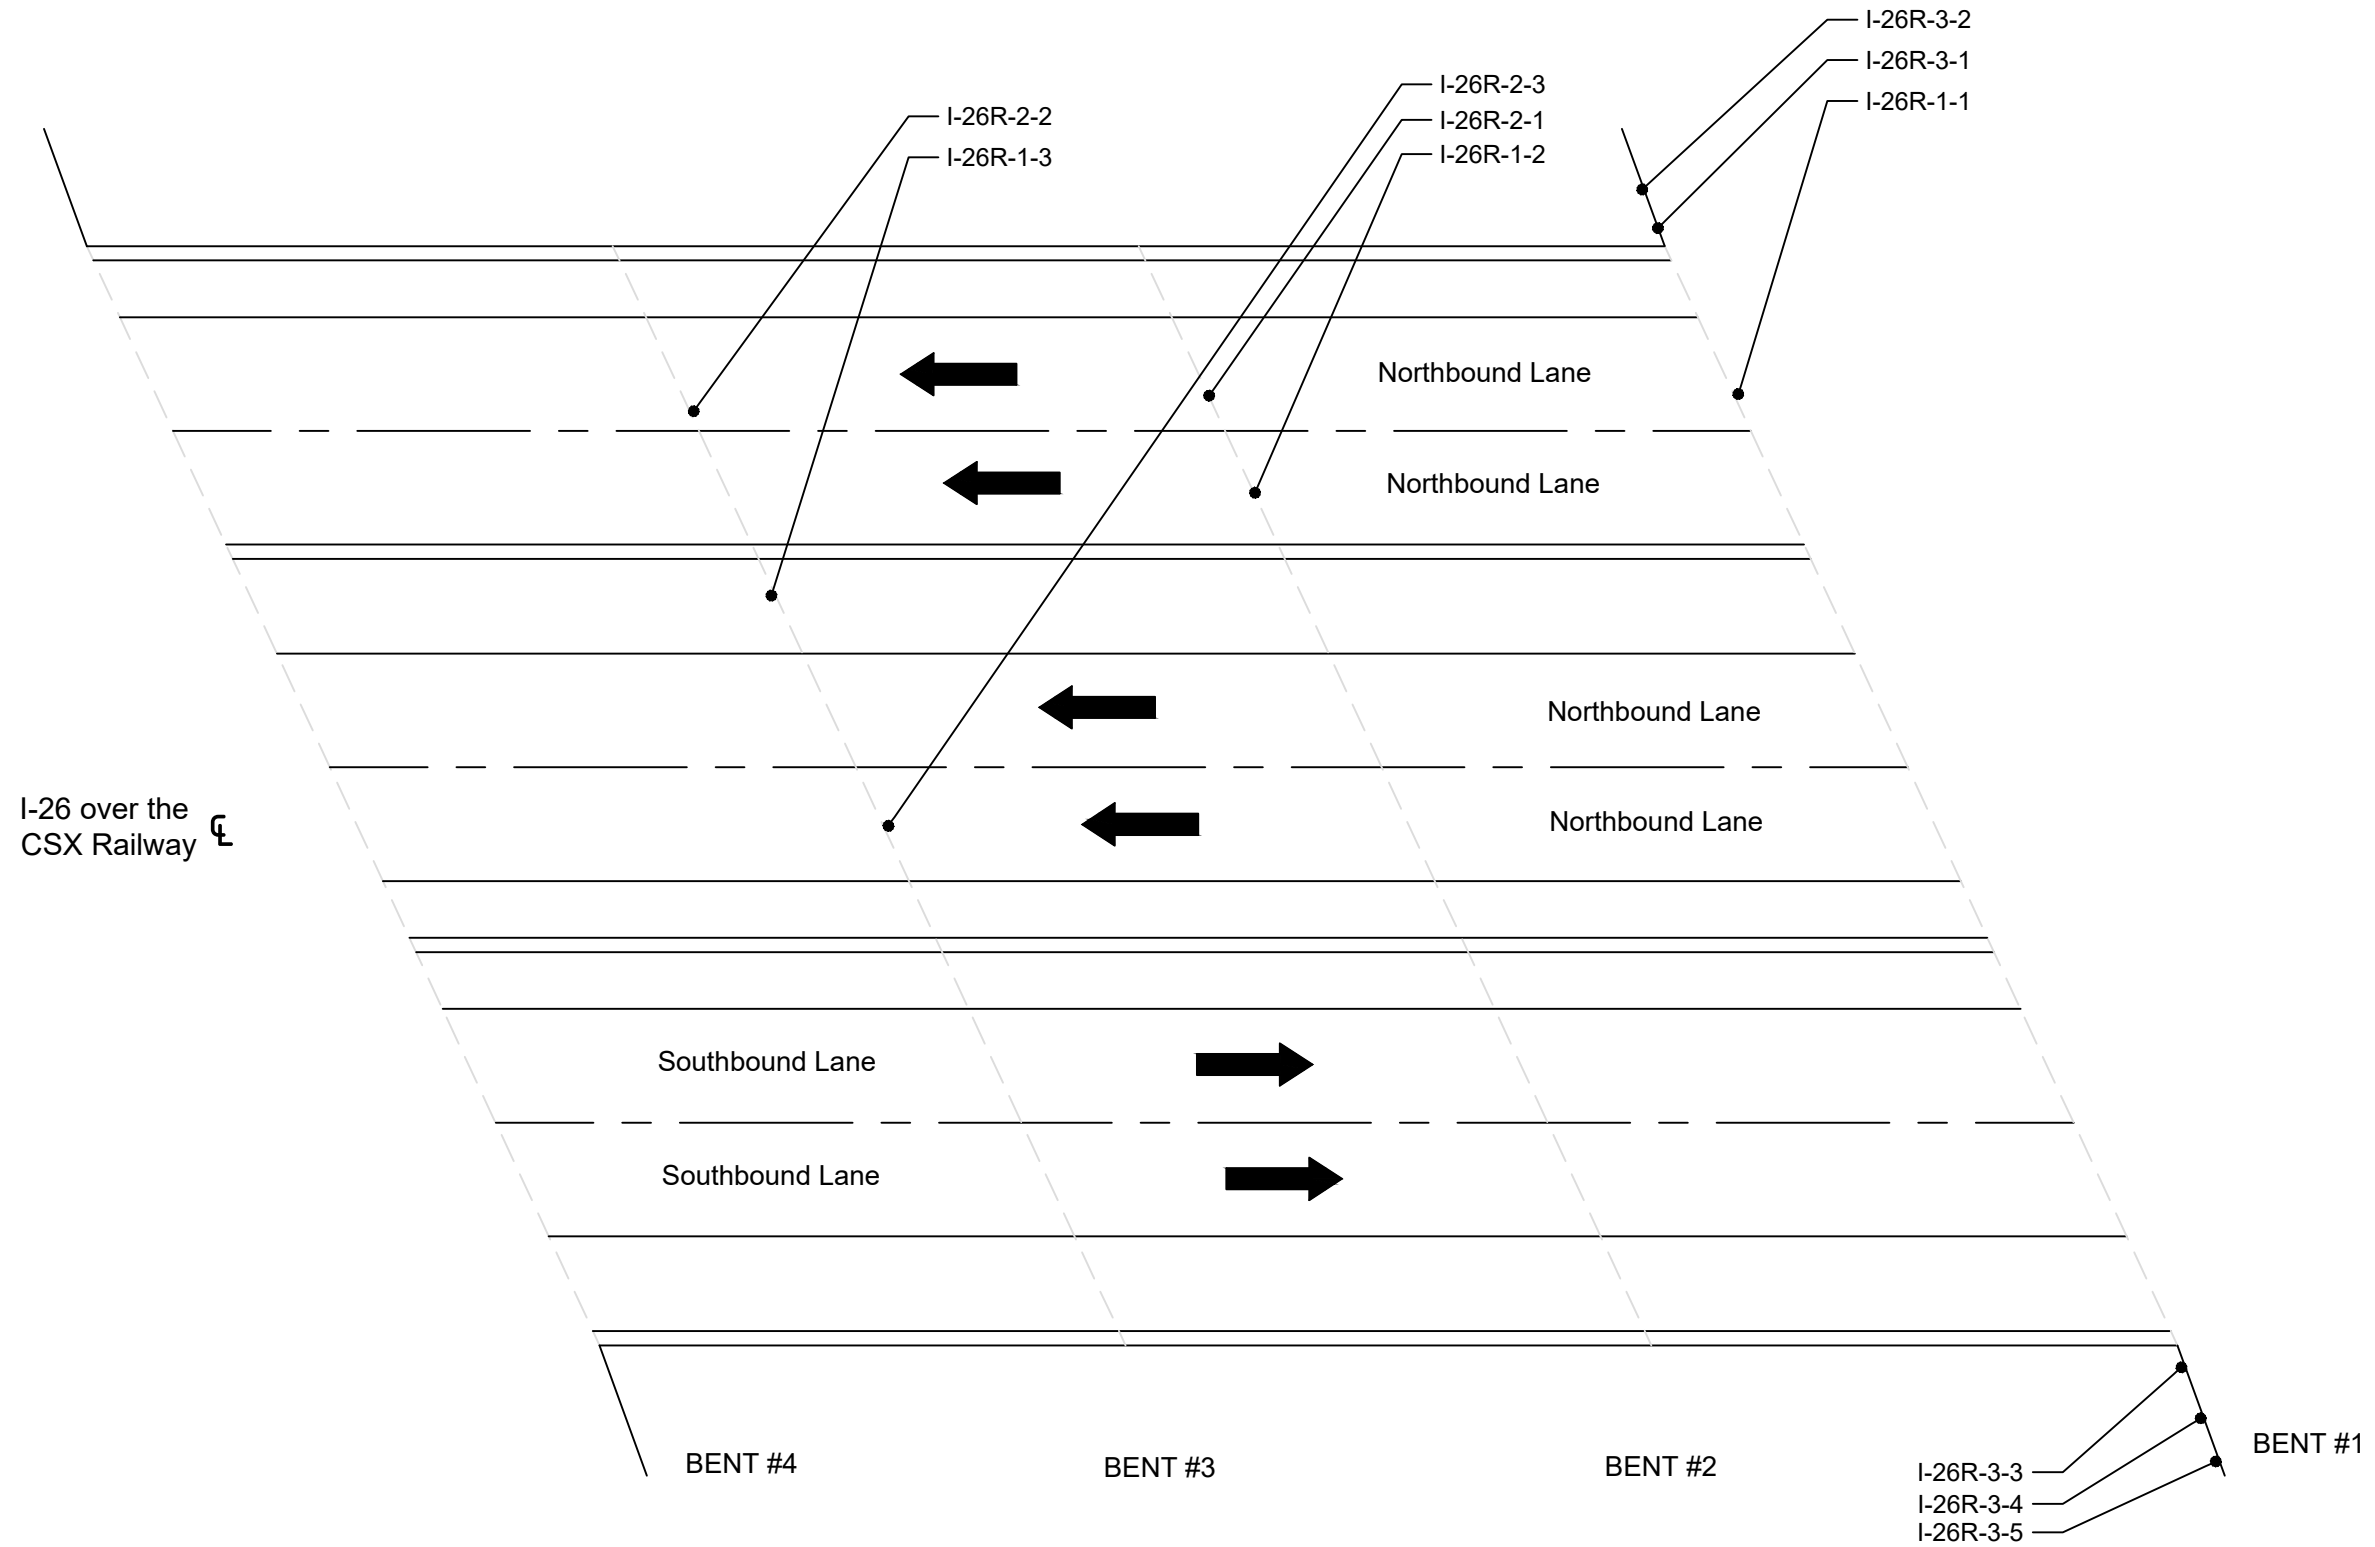
FIGURE NUMBER:  
**2**

**ASBESTOS CONTAINING MATERIALS INVESTIGATION**  
**I-26 over the CSX Railway**  
Richland County, SC  
**Sample Location Map**  
Prepared for: HDR, Inc.  
3955 Faber Place Drive, Suite 300  
North Charleston, SC 29405

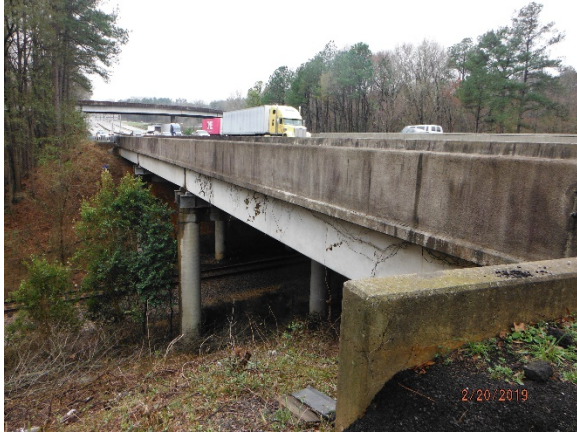
**Photo 1.** East Side View of Bridge.

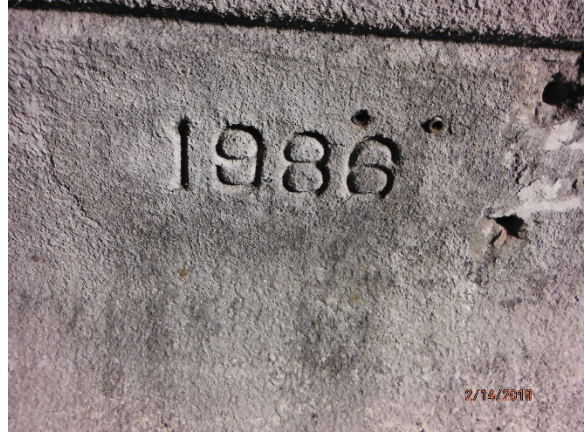
**Photo 2.** Date Stamp on Bridge

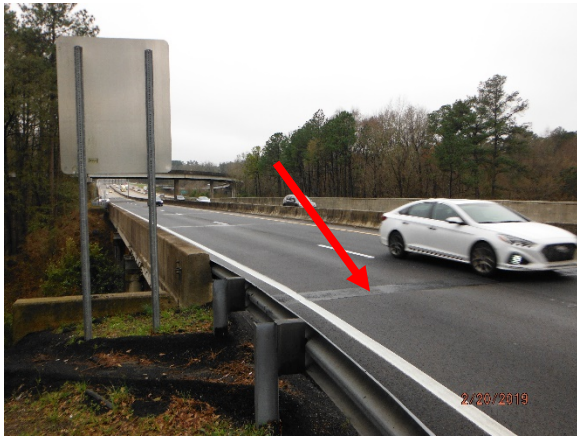
**Photo 3.** Black Mastic on Asphalt Overlay at Expansion Joints

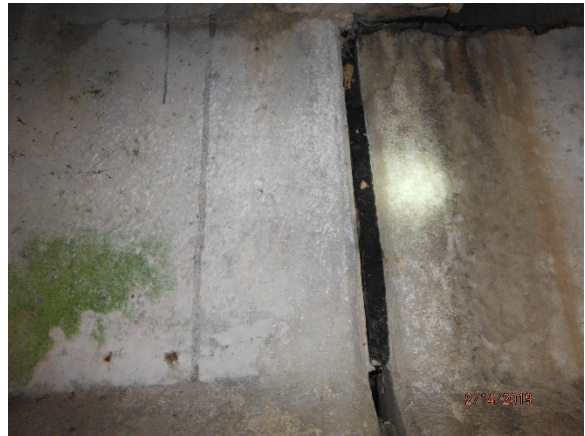
**Photo 4.** Black Expansion Joint Material

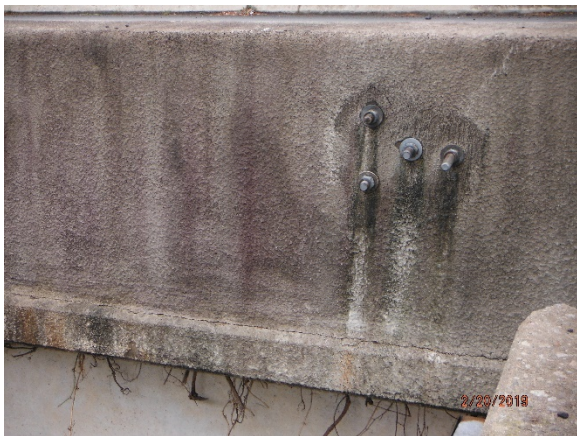
**Photo 5.** Texture Material on Wall (Spray-Applied)

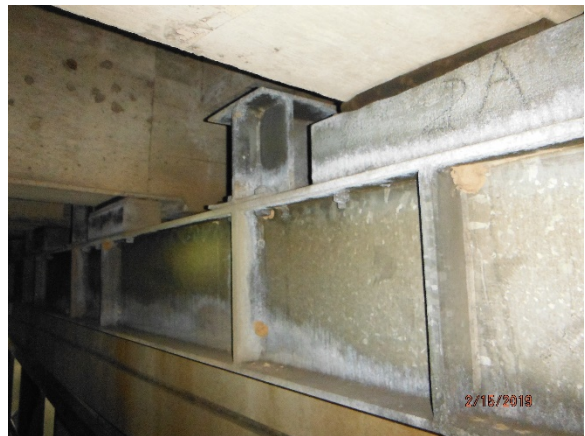
**Photo 6.** I-Beams to Increase Track Clearance
