ASBESTOS CONTAINING MATERIAL INVESTIGATION REPORT

**S-40-757 - HARBISON BLVD. BRIDGE
OVER I-26 (EAST & WEST BOUND LANES)
SCDOT BRIDGE #407075700100
RICHLAND COUNTY, SOUTH CAROLINA**

March 13, 2018

F&ME Project No.: G5662.010

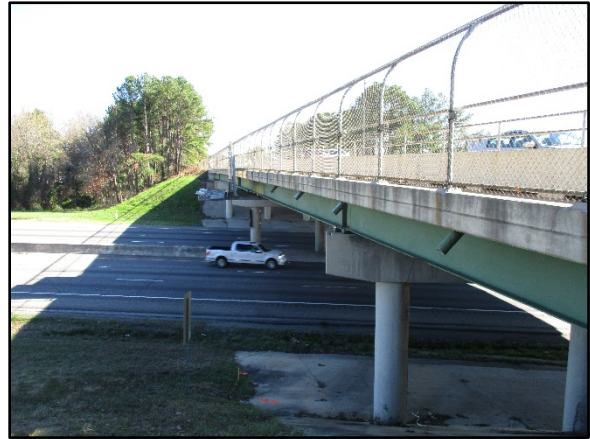
Photo 1 – S-40-757 (Harbison Blvd) Bridge over I-26 in Richland County, SC.

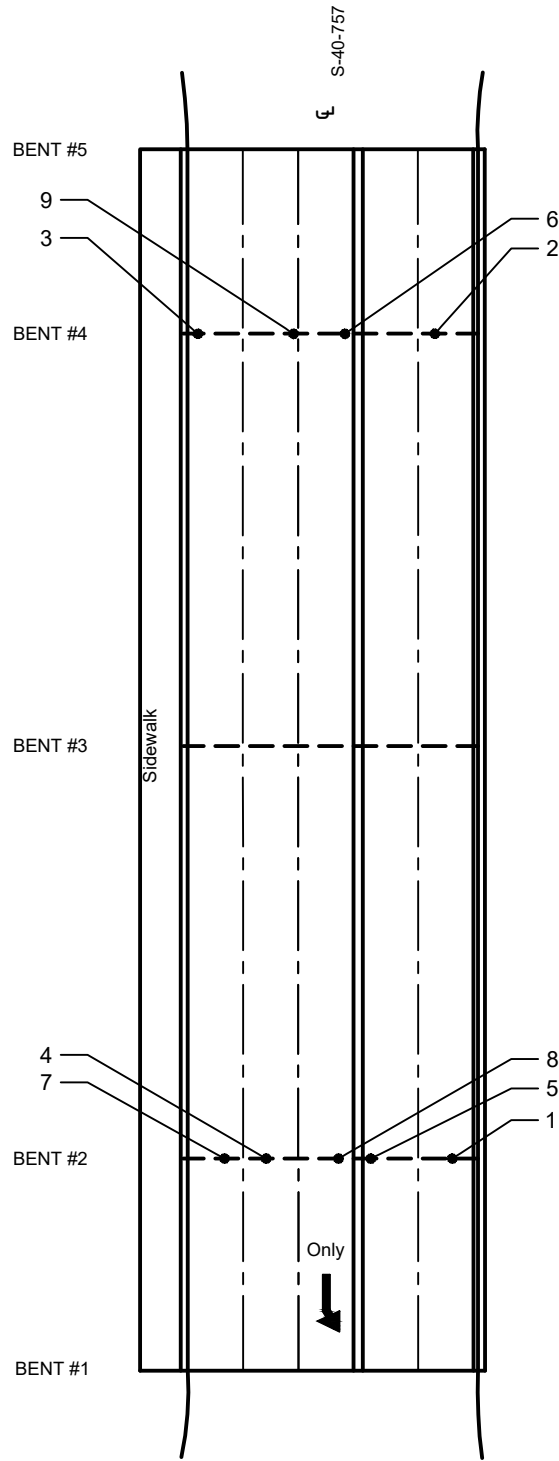
2

See Appendix B – Sample Location Plan, for detailed sample locations. Also, see Appendix G – Site Photographs, for more details.

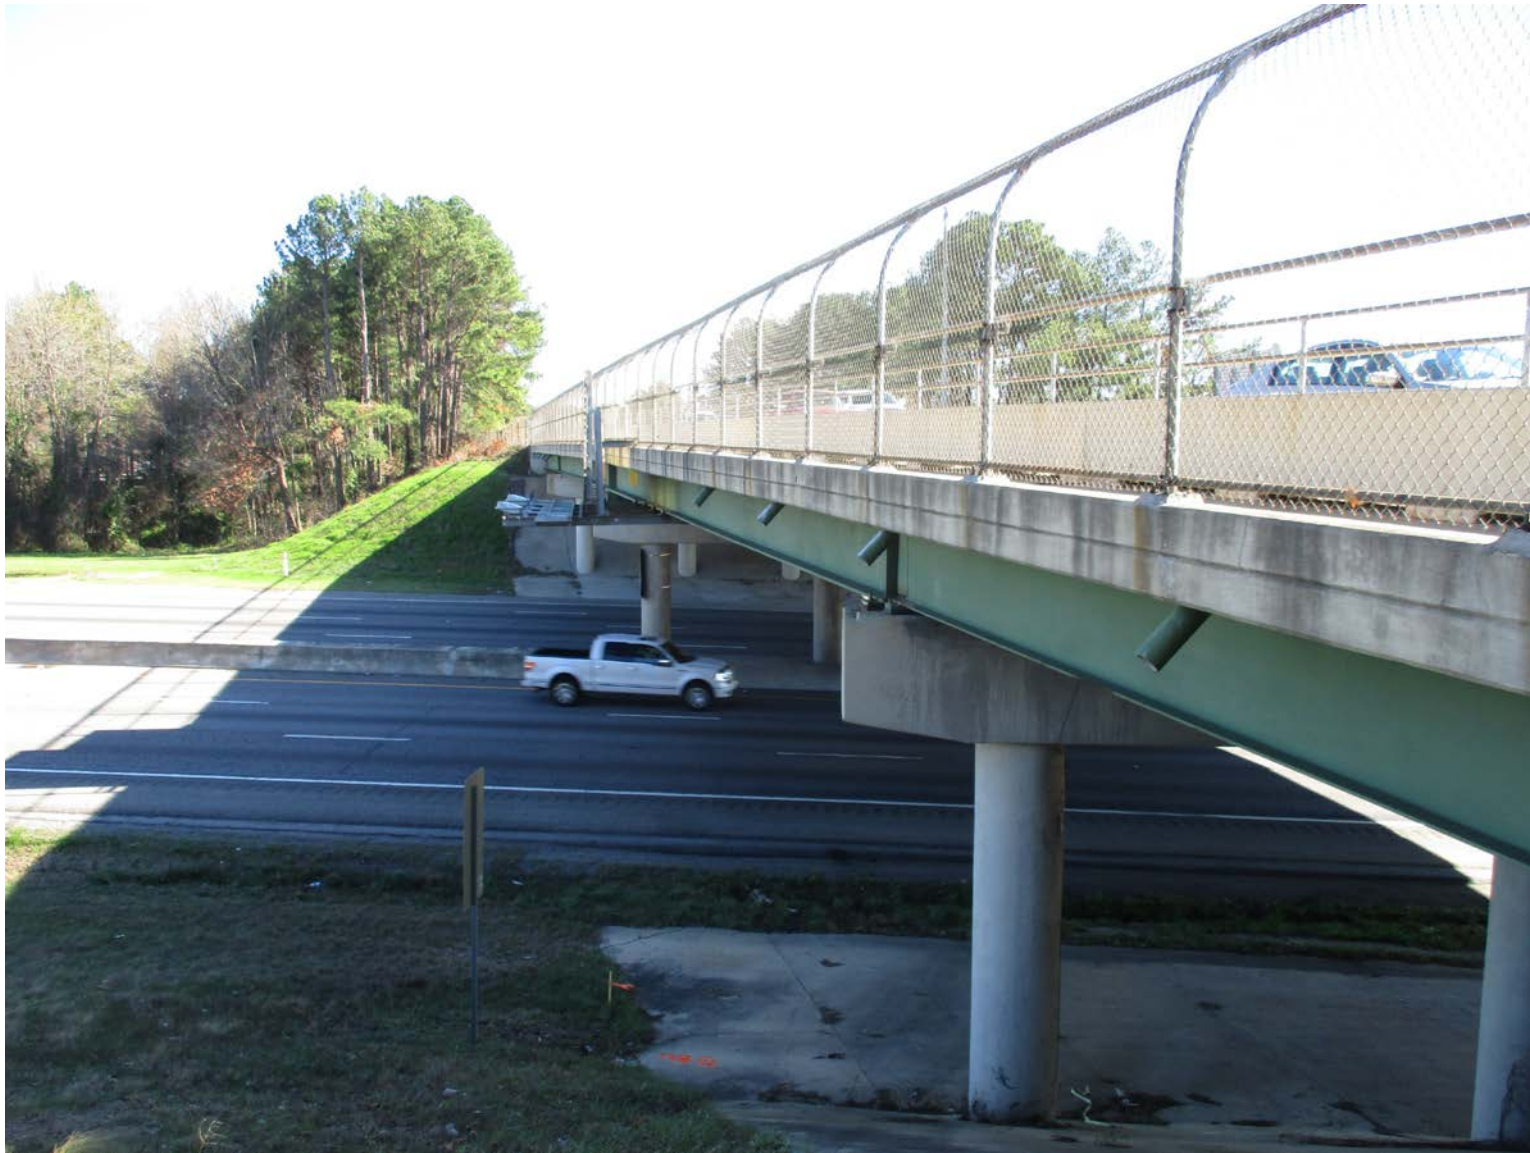
Photograph 1

- West Side View of Bridge

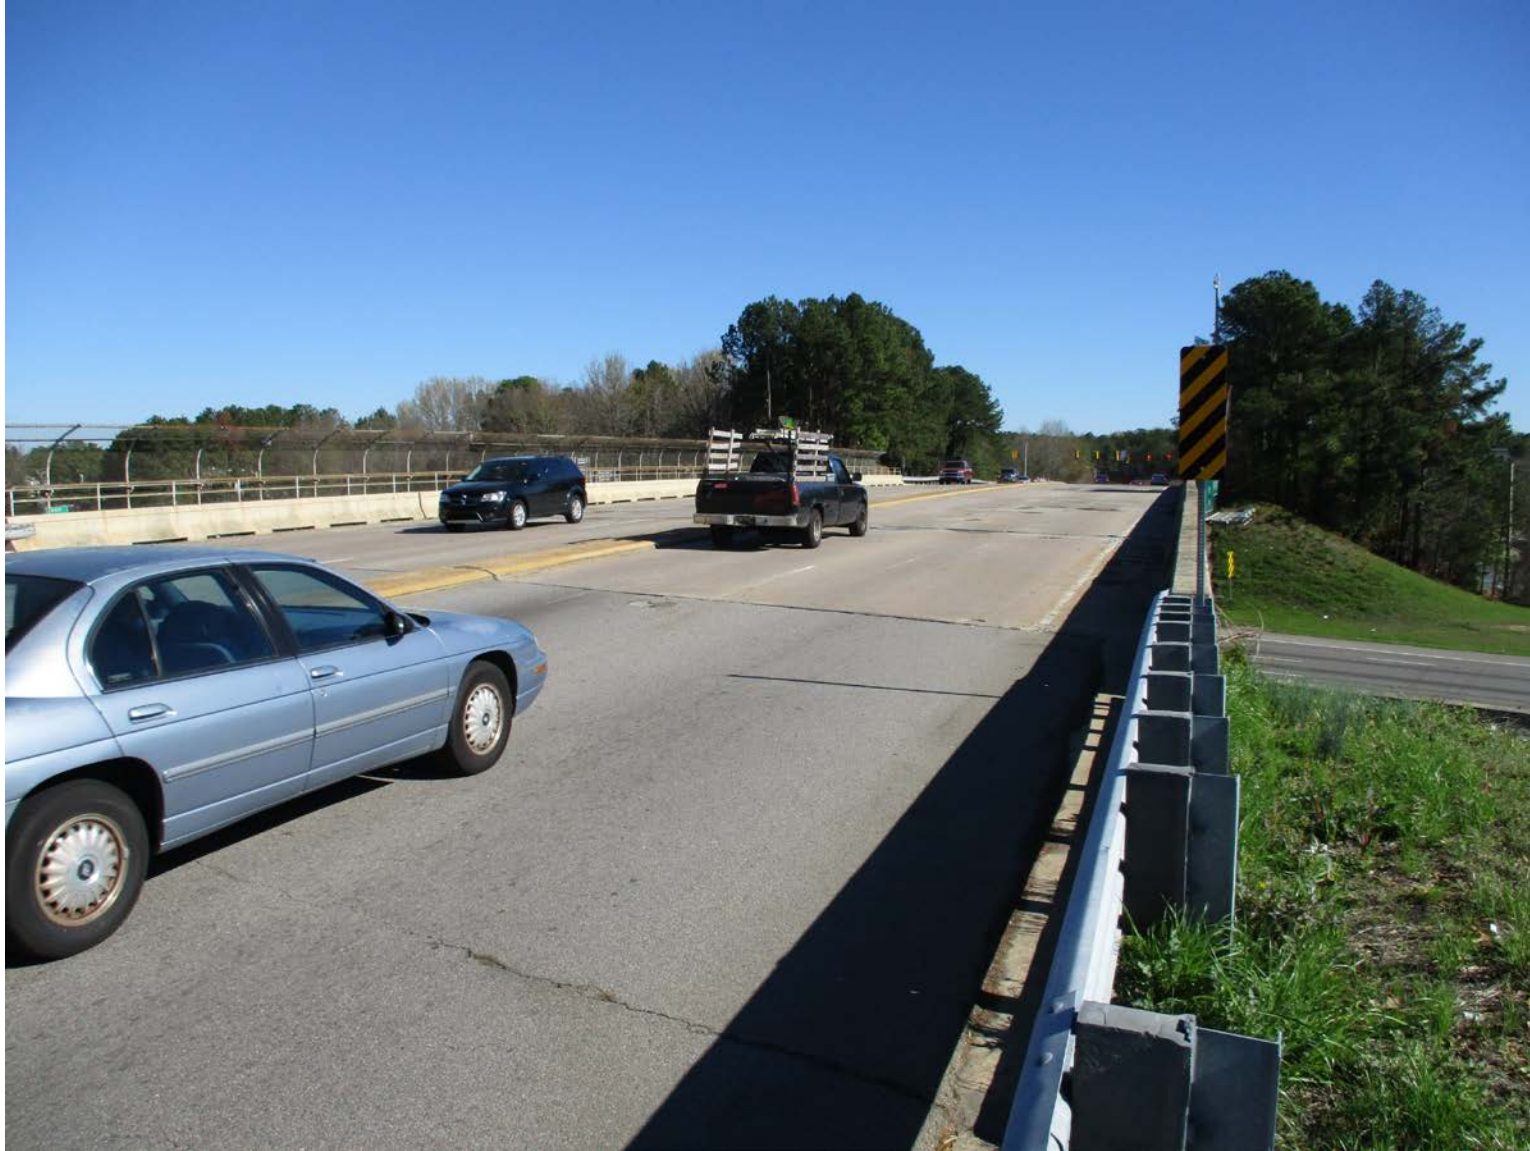
Photograph 2

- Top of Bridge Deck
View

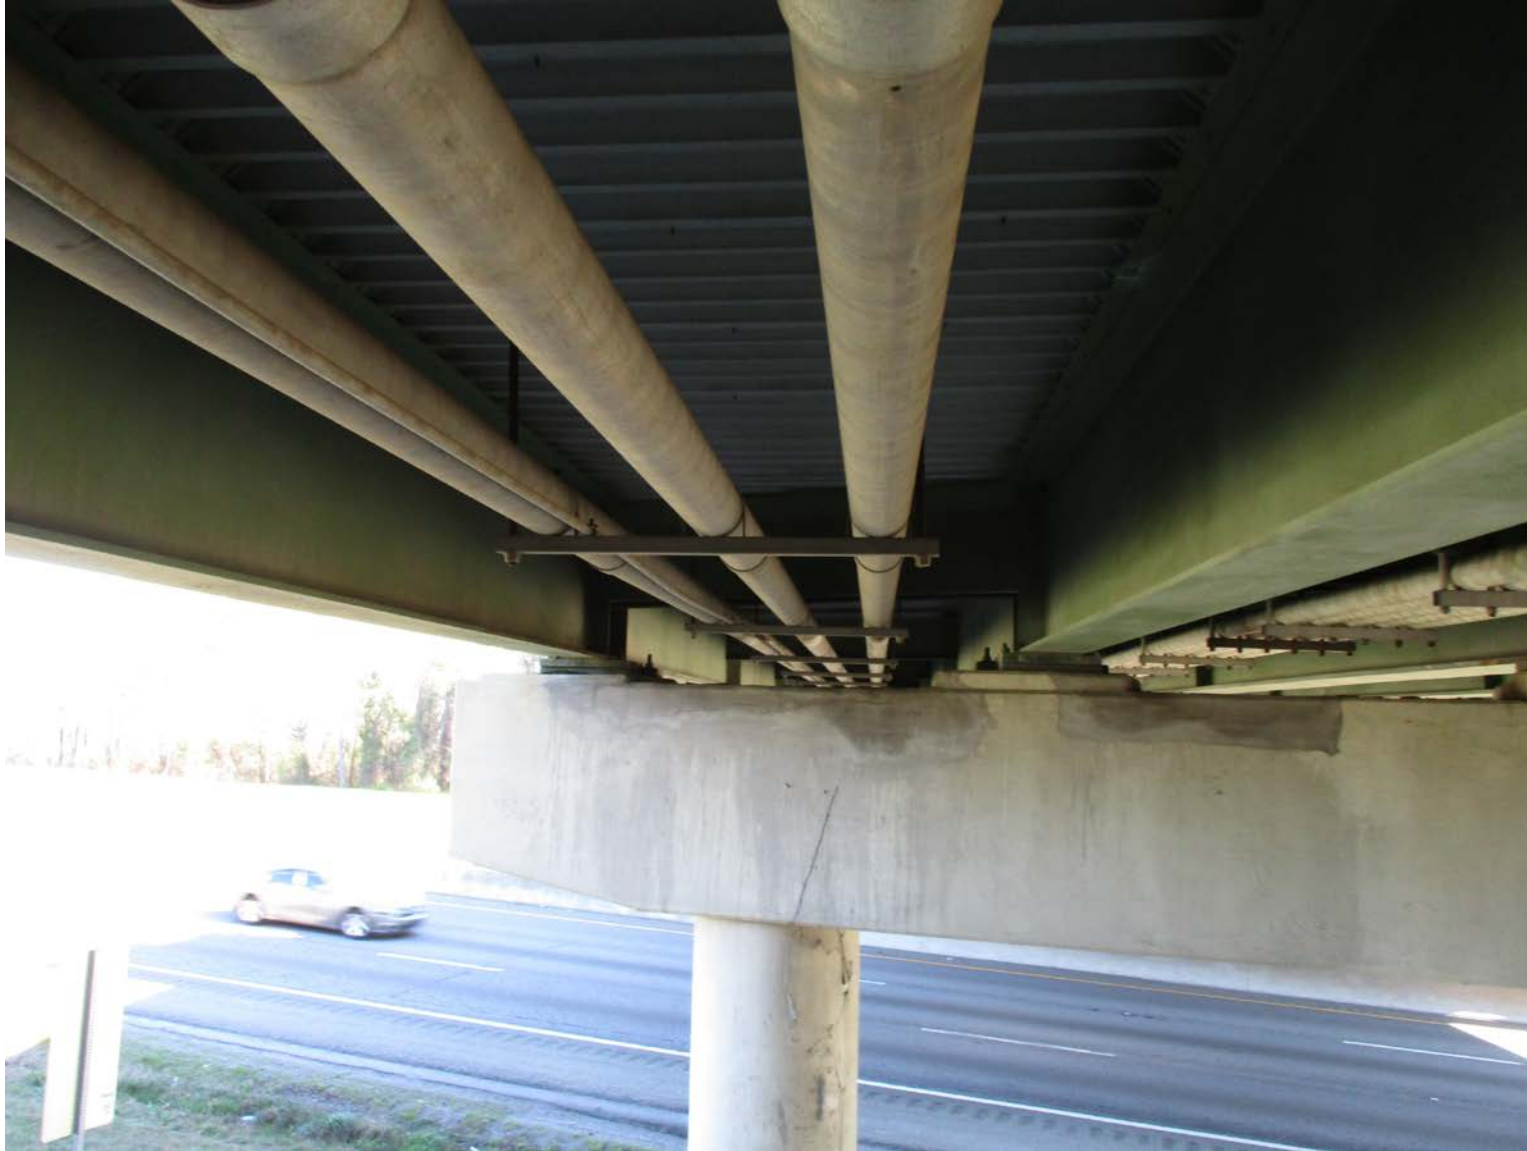
Photograph 3

- Underside of Bridge View.

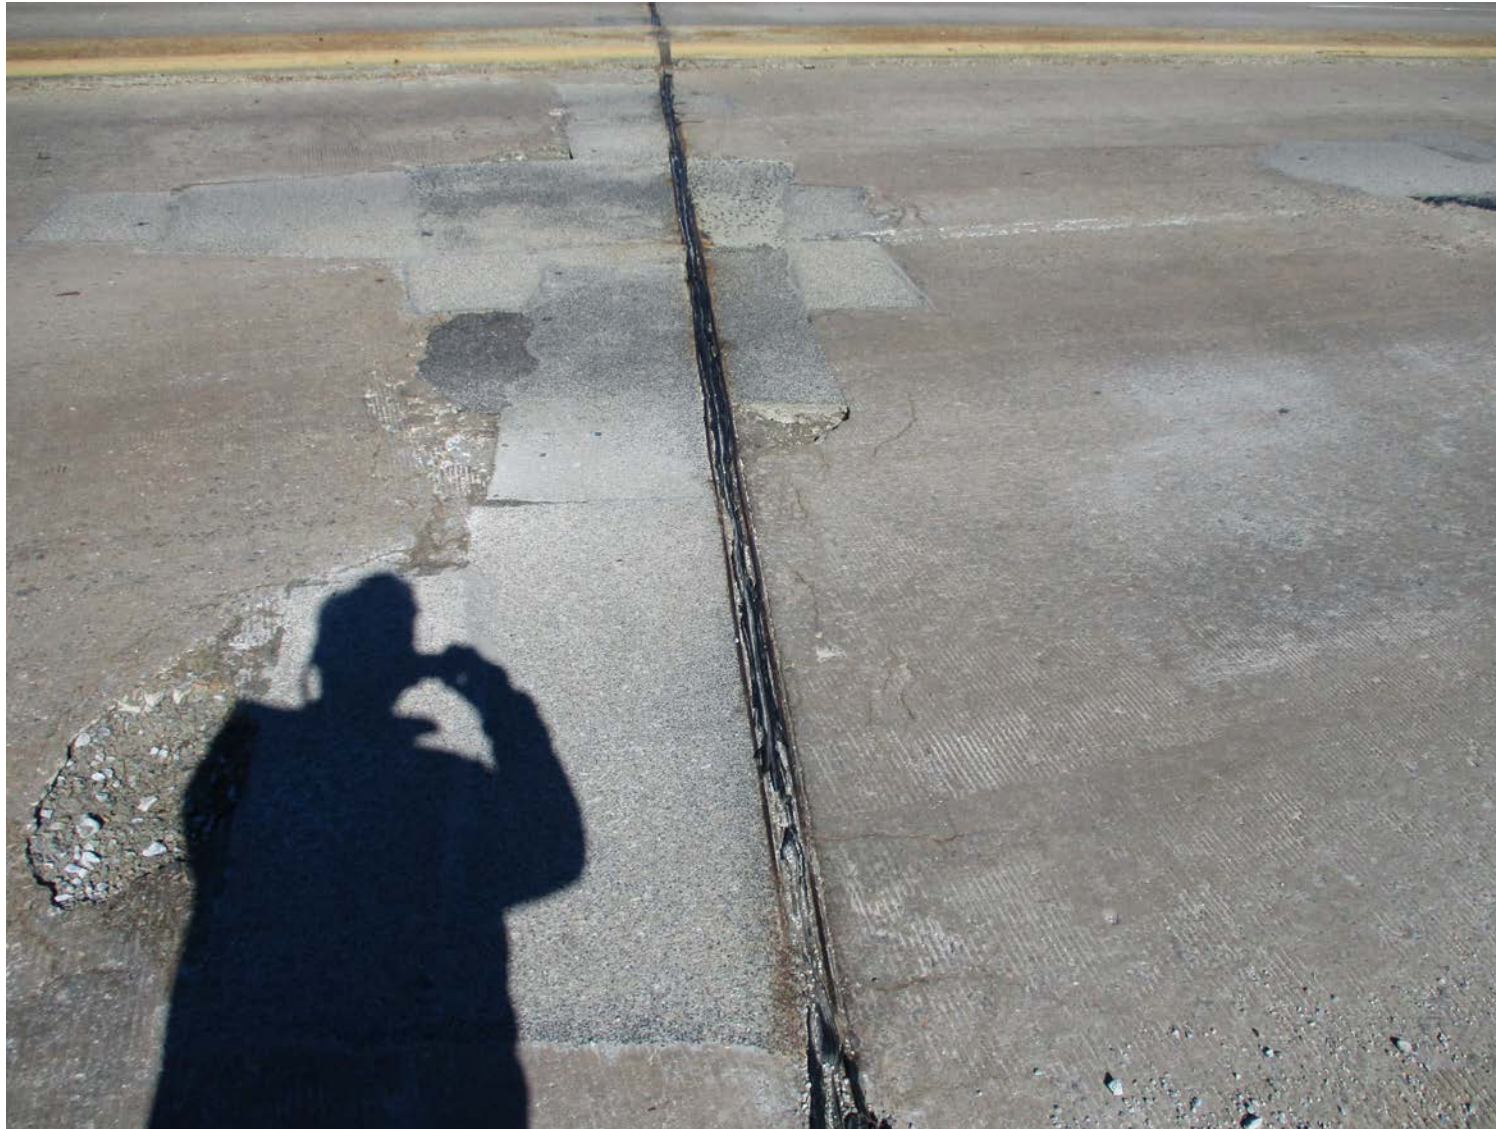
Photograph 4

It is our understanding that the subject structure is to be demolished as part of this project. All accessible suspect materials have been sampled and analyzed by an accredited laboratory and found to contain no ACM. Therefore, there are no foreseen special handling or disposal requirements, regarding asbestos, that will be required for the demolition of this bridge.

- Expansion Joint Material on Top of Bridge Deck.
