LEAD-BASED PAINT INVESTIGATION REPORT

**I-20 BRIDGE OVER SALUDA RIVER
LEXINGTON COUNTY, SOUTH CAROLINA**

March 1, 2019

F&ME Project No.: G5662.010

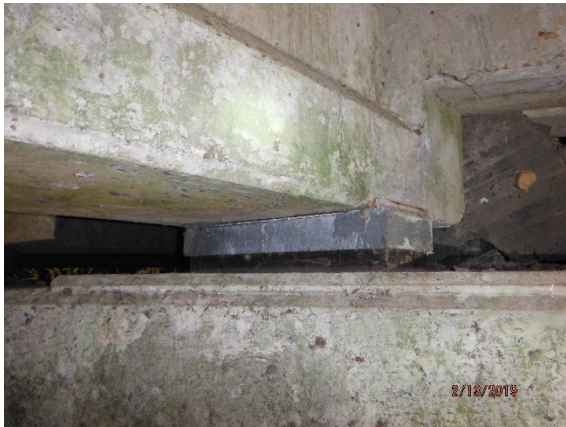
Photo 3. LBP Positive Thick Beam Plate

Components found to contain lead should be handled appropriately. It is recommended that work tasks which require grinding, sanding, cutting torch, or other disturbance of the LBP surfaces identified herein be performed in accordance with federal regulations pertaining to worker protection from exposure to LBP. When lead containing items are disturbed or begin to decay they become a concern regarding human health and the environment. The typical routes of exposure to lead are through the inhalation or ingestion of lead-contaminated materials. Minimal risk of exposure exists where the lead-containing paint and coating are intact (e.g., has not been aerosolized, free of chipping or flaking, etc.).

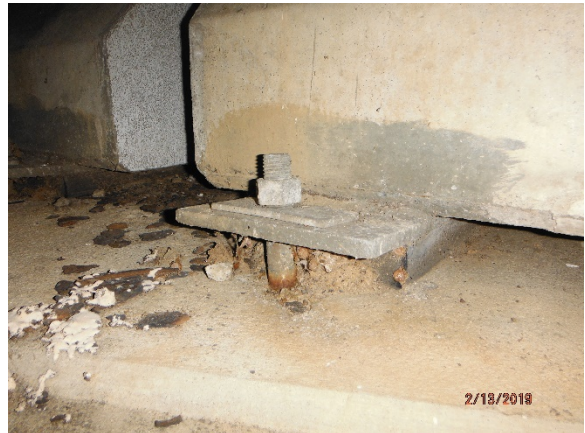
Photo 4. LBP Positive Thin Beam Plate

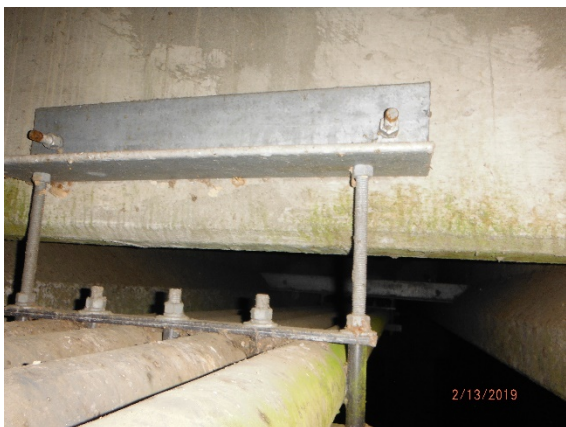
Photo 5. LBP Positive Pipe Support Channels
