ASBESTOS CONTAINING MATERIAL INVESTIGATION REPORT

**S-32-671 – PINEY GROVE RD. BRIDGE
OVER I-26 (EAST & WEST BOUND LANES)
LEXINGTON COUNTY, SOUTH CAROLINA**

March 15, 2018

F&ME Project No.: G5662.010

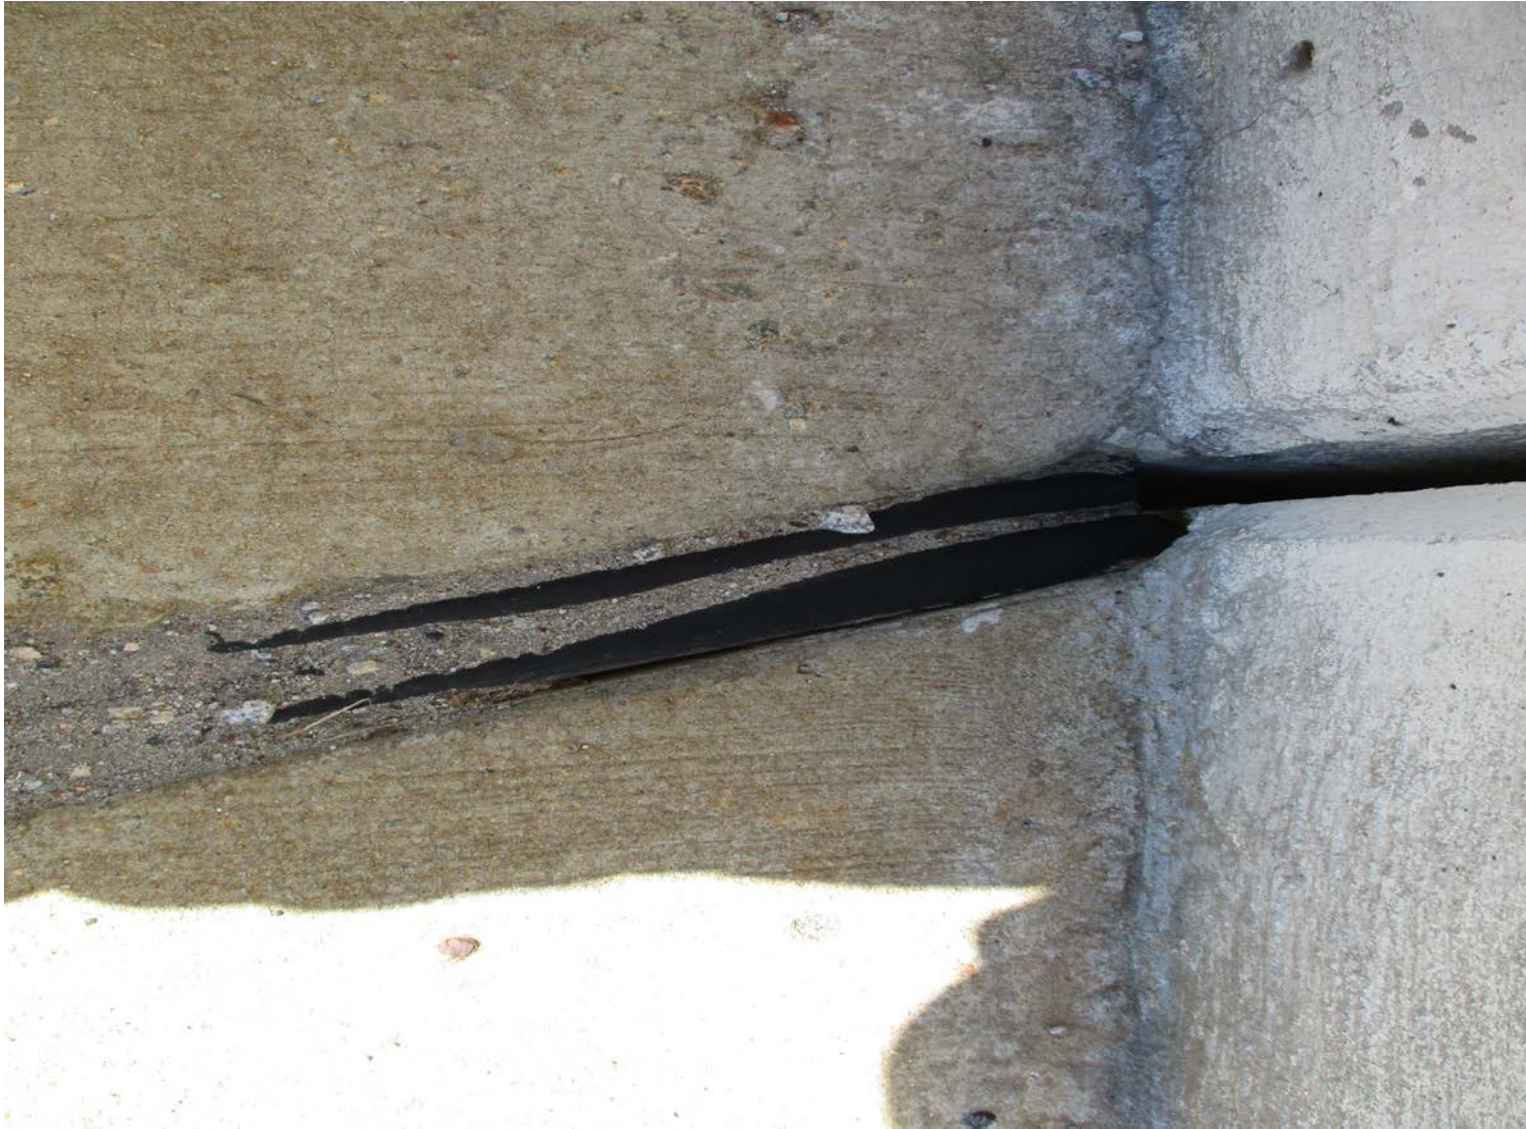
Photograph 4

During the investigation, the deck expansion joint material, column expansion joint material and white caulk were the only suspect materials observed on the subject bridge. Three (3) random samples of each suspect material were collected for laboratory analysis, and their physical characteristics were recorded. The remaining structural materials (i.e. concrete, steel, etc.) were not considered suspect and were not sampled.

- Expansion Joint Material on Top of Bridge Deck.

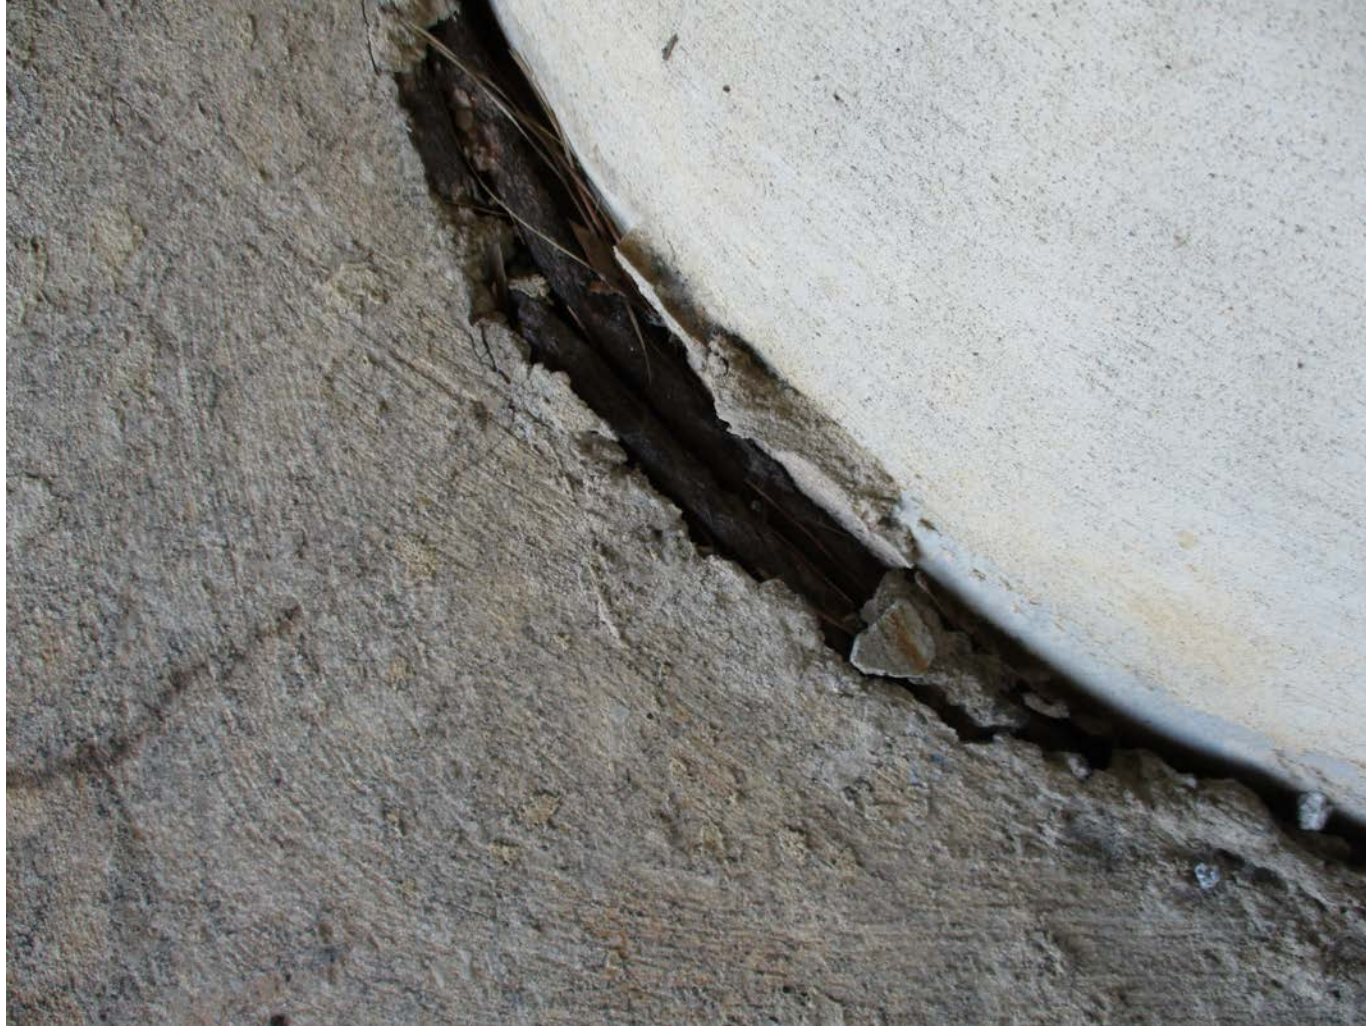
Photograph 5

- Column Expansion Joint Material Located at the Interface of Concrete at Grade and Concrete Column
