LEAD-BASED PAINT INVESTIGATION REPORT

**I-26 BRIDGE OVER CSX RAILWAY
RICHLAND COUNTY, SOUTH CAROLINA**

March 1, 2019

F&ME Project No.: G5662.010

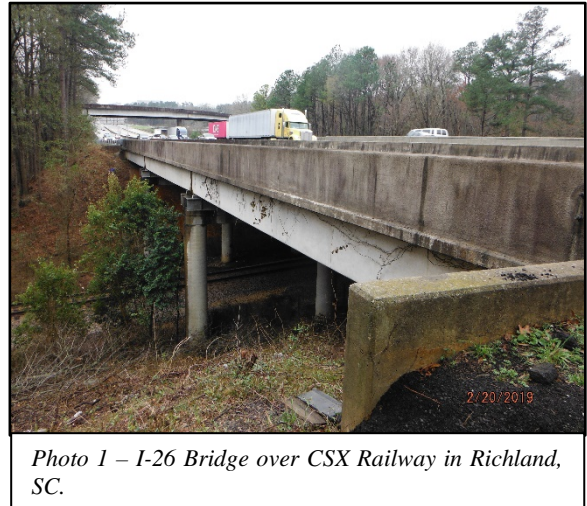
Photo 1 – I-26 Bridge over CSX Railway in Richland, SC.

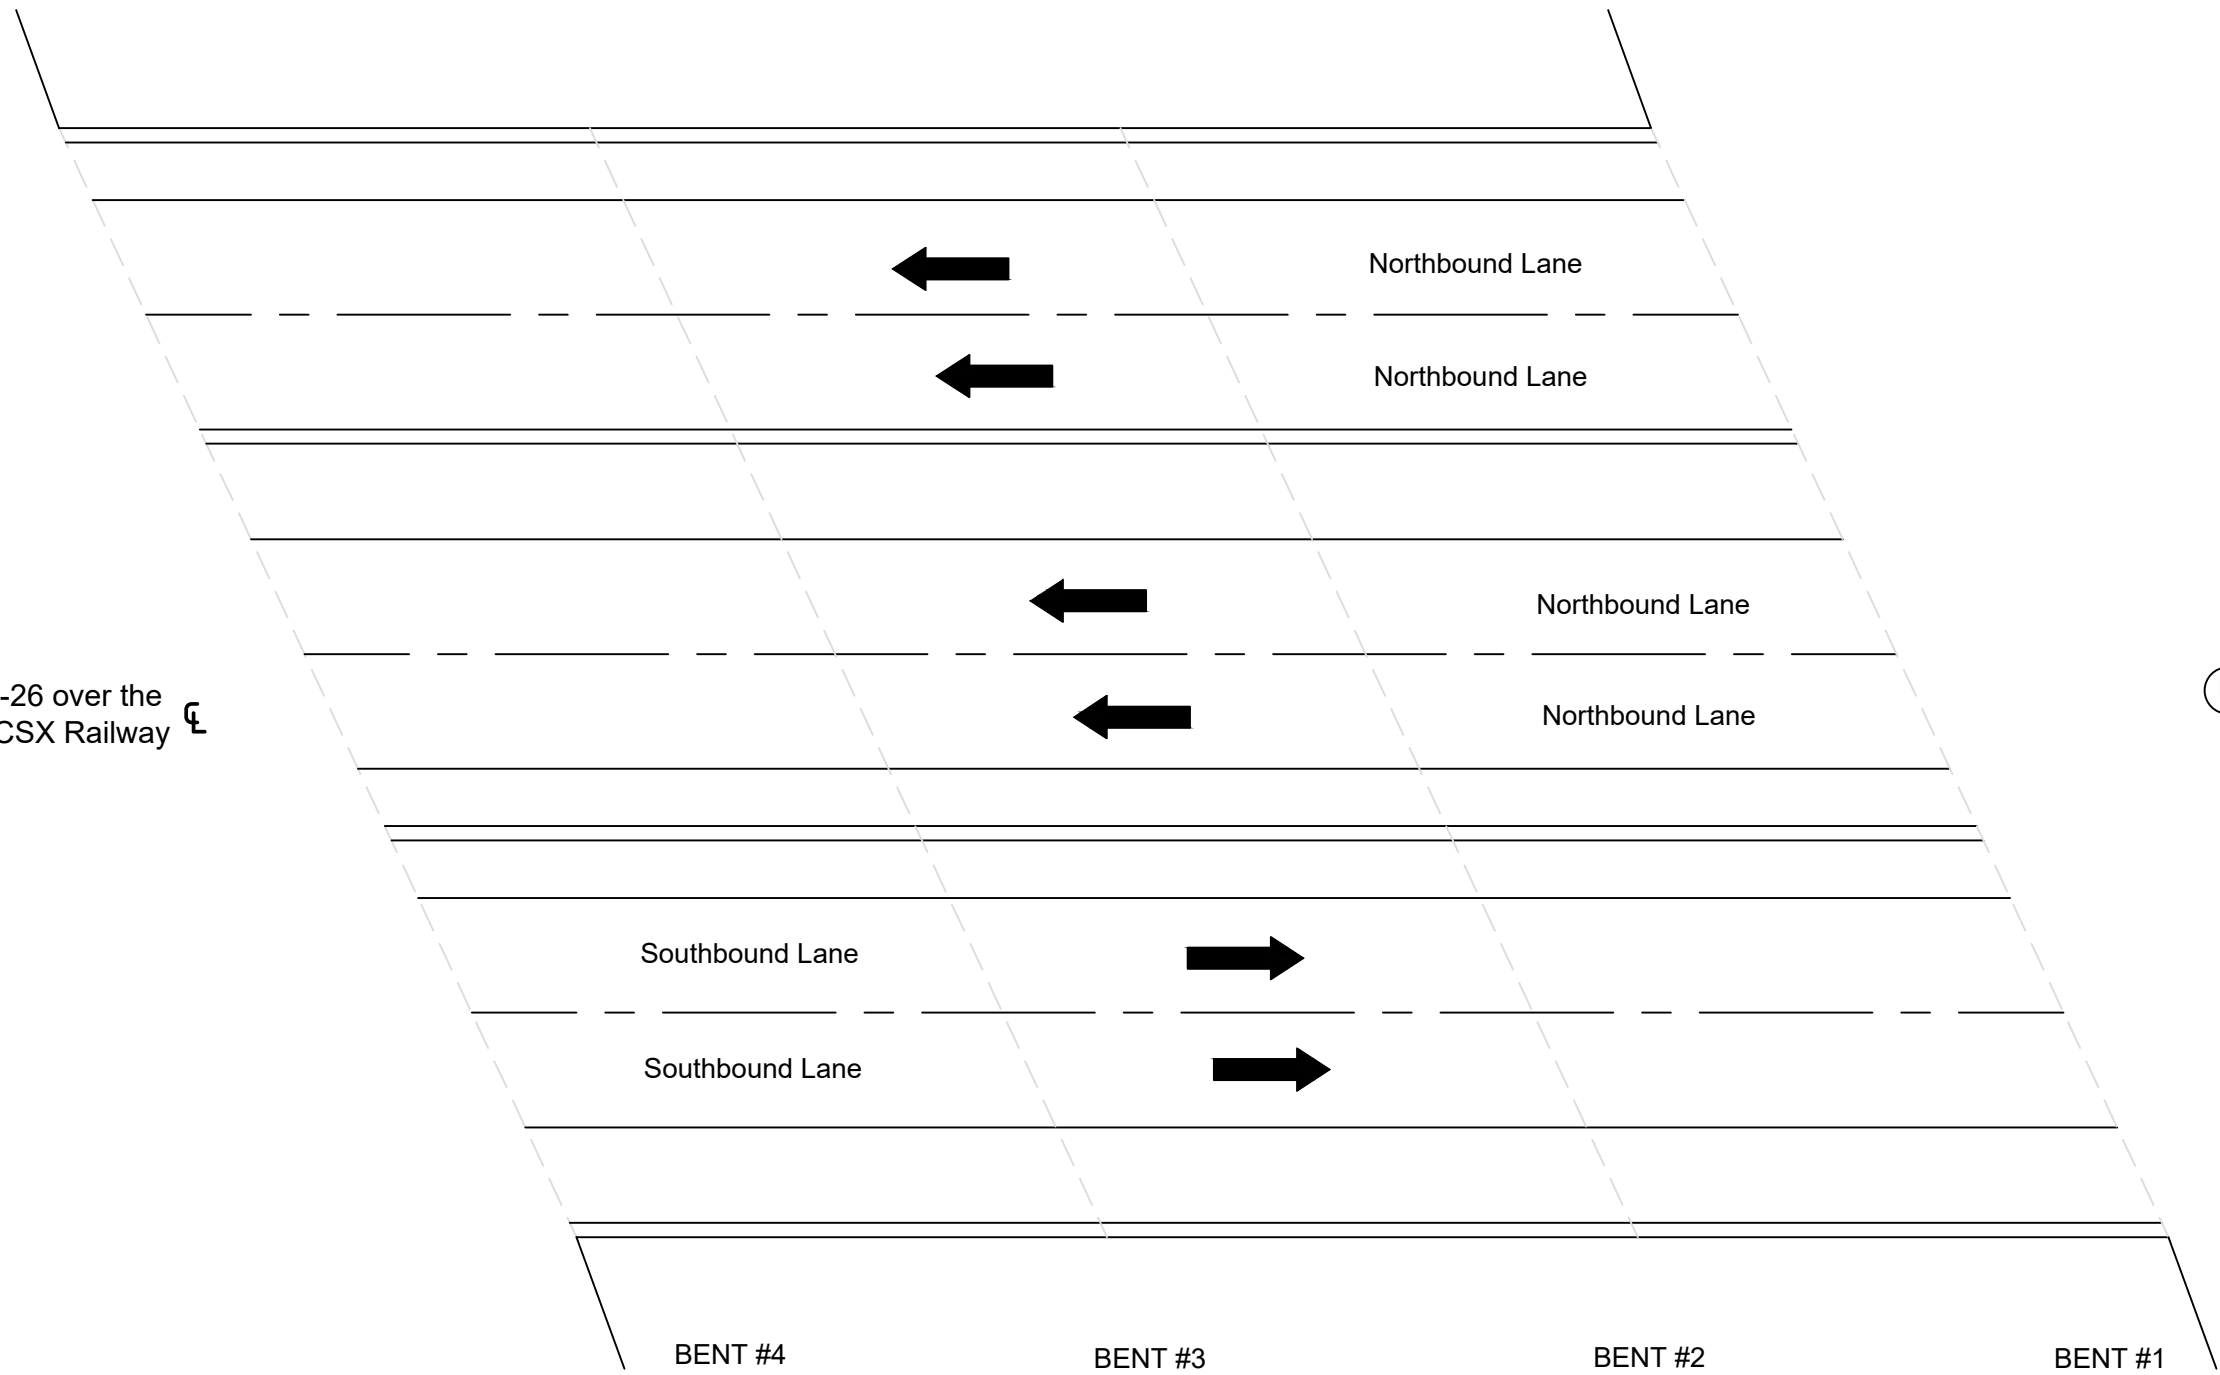
FIGURE NUMBER:
2

F&ME Consultants has completed a Lead-Based Paint (LBP) Investigation on the I-26 Bridge Over CSX Railway in Richland County, South Carolina, for HDR, Inc (David Kinard, P.E. - Project Manager), on February 14, 2019, into February 15, 2019. Appendix A – Site Vicinity Map is provided to show the location of the bridge. Appendix B – General Bridge Plan, is provided to show the layout of the bridge and locations of XRF scans taken on the bridge.

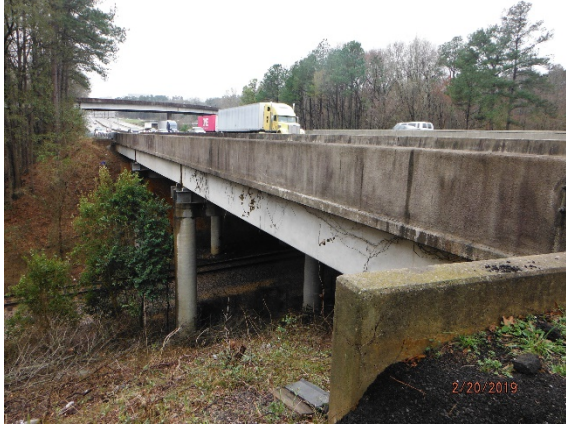
Photo 1. East Side View of Bridge

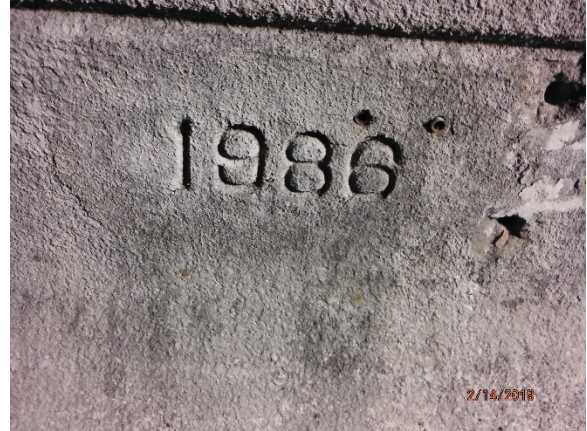
Photo 2. Date Stamp on Bridge

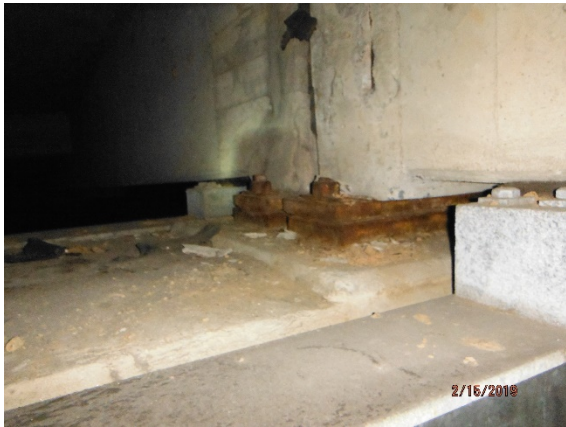
The results from this LBP Investigation indicate that lead is present in paint and/or coatings at levels that equal to or exceed the SCDHEC threshold limit for lead (0.7 mg/cm^2) on the older beam plates, and structural repair beams. Some components tested positive for lead at levels that would be a concern under OSHA regulations. Therefore, OSHA regulations and procedures should be followed when handling these components. Refer to the blue highlighted components listed on the XRF Data Summary Table found in Appendix C for a list of these items.

Photo 3. LBP Positive Old Beam Plate

It is important to ensure that the debris generated from the demolition activities is handled and disposed of appropriately. The proper handling and disposal procedures depend on the type of substrate (e.g., metal, wood, masonry block, etc.). To reduce and/or eliminate the generation of lead-containing dust, and residue, it is recommended that cutting, sanding and grinding be kept to a minimum, and to the extent practicable, the substrate materials should be removed intact. Metal components painted with and/or containing lead, such as the beam plates may be recycled, if they are taken to a recycling facility that accepts lead painted and/or lead-containing material.

Components found to contain lead should be handled appropriately. It is recommended that work tasks which require grinding, sanding, cutting torch, or other disturbance of the LBP surfaces identified herein be performed in accordance with federal regulations pertaining to worker protection from exposure to LBP. When lead containing items are disturbed or begin to decay they become a concern regarding human health and the environment. The typical routes of exposure to lead are through the inhalation or ingestion of lead-contaminated materials. Minimal risk of exposure exists where the lead-containing paint and coating are intact (e.g., has not been aerosolized, free of chipping or flaking, etc.).

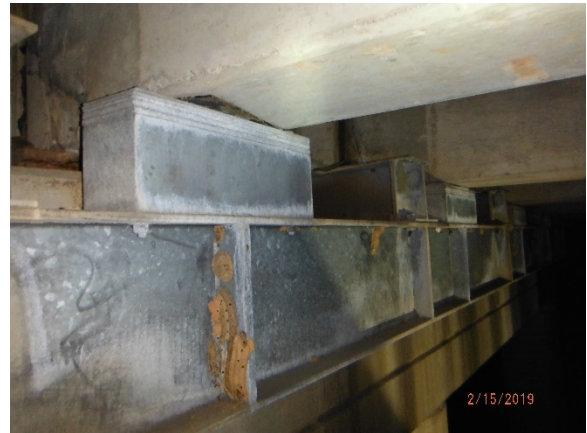
Photo 4. LBP Positive Small Repair Beam

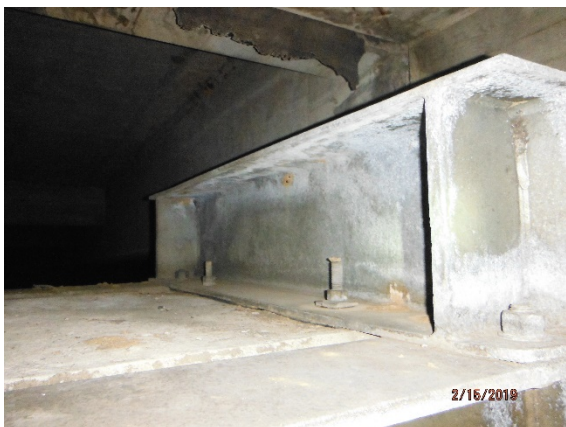
Photo 5. LBP Positive Large Repair Beam
