LEAD-BASED PAINT INVESTIGATION REPORT

**I-26 BRIDGE OVER SALUDA RIVER
RICHLAND/LEXINGTON COUNTY, SOUTH
CAROLINA**

March 1, 2019

F&ME Project No.: G5662.010

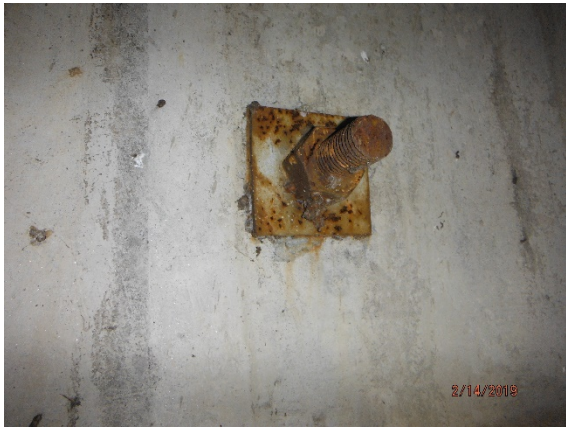
Scan No.	Component	Substrate	Side	Condition	Color	Pbc (mg/cm ²)
1	Calibrate					0.98
2	Calibrate					0.98
3	Calibrate					0.97
4	Tie Rod Plate	Metal	B	Deteriorated	Grey	10.94
5	Tie Rod Plate	Metal	B	Deteriorated	Grey	10.89
6	Decking Angle Iron	Metal	Center	Intact	Grey	LOD
7	Decking Angle Iron	Metal	Center	Intact	Grey	LOD
8	Tie Rod Plate	Metal	B	Deteriorated	Grey	7.89
9	Tie Rod Plate	Metal	B	Deteriorated	Grey	7.82
10	Decking Angle Iron	Metal	Center	Deteriorated	Grey	0.16
11	Decking Angle Iron	Metal	Center	Intact	Grey	LOD
12	Tie Rod Plate	Metal	B	Intact	Grey	3.95
13	Beam Plate	Metal	Center	Deteriorated	Grey	15.95
14	Beam Plate	Metal	Center	Deteriorated	Grey	6.85
15	Transite Pipe Angle Iron Support Bracket	Metal	Center	Deteriorated	Grey	LOD
16	Transite Pipe Angle Iron Support Bracket	Metal	Center	Deteriorated	Grey	LOD
17	Transite Pipe Angle Iron Support Bracket	Metal	Center	Deteriorated	Grey	LOD
18	Calibrate					0.97

Photo 3. LBP Positive Tie Rod Plate

Components found to contain lead should be handled appropriately. It is recommended that work tasks which require grinding, sanding, cutting torch, or other disturbance of the LBP surfaces identified herein be performed in accordance with federal regulations pertaining to worker protection from exposure to LBP. When lead containing items are disturbed or begin to decay they become a concern regarding human health and the environment. The typical routes of exposure to lead are through the inhalation or ingestion of lead-contaminated materials. Minimal risk of exposure exists where the lead-containing paint and coating are intact (e.g., has not been aerosolized, free of chipping or flaking, etc.).

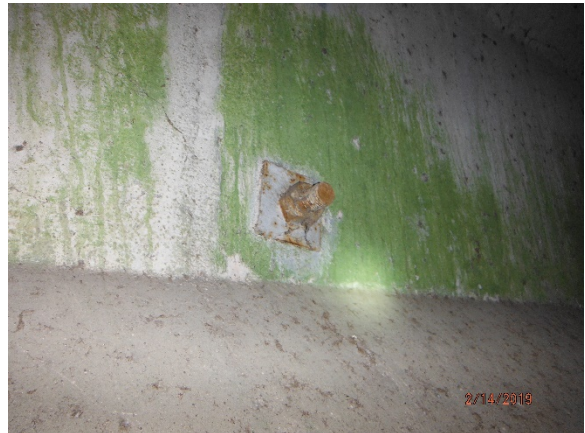
Photo 4. LBP Positive Tie Rod Plate

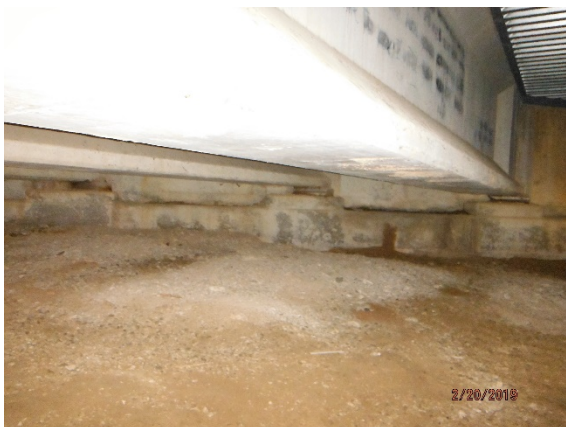
- Tie Rod Plates
- Beam Bearing Plates

Photo 5. LBP Positive Beam Plate
