LEAD-BASED PAINT INVESTIGATION REPORT

**S-40-757 - HARBISON BLVD. BRIDGE
OVER I-26 (EAST & WEST BOUND LANES)
SCDOT BRIDGE #407075700100
RICHLAND COUNTY, SOUTH CAROLINA**

March 13, 2018

F&ME Project No.: G5662.010

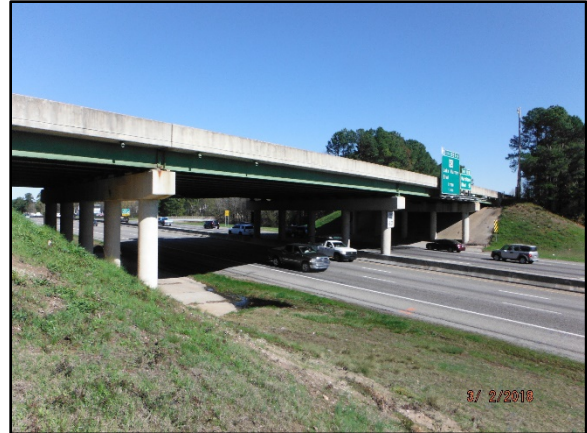
Photo 1 – View of the subject bridge, S-40-757 (Harbison Blvd) Bridge over I-26 looking up-station (Westward).

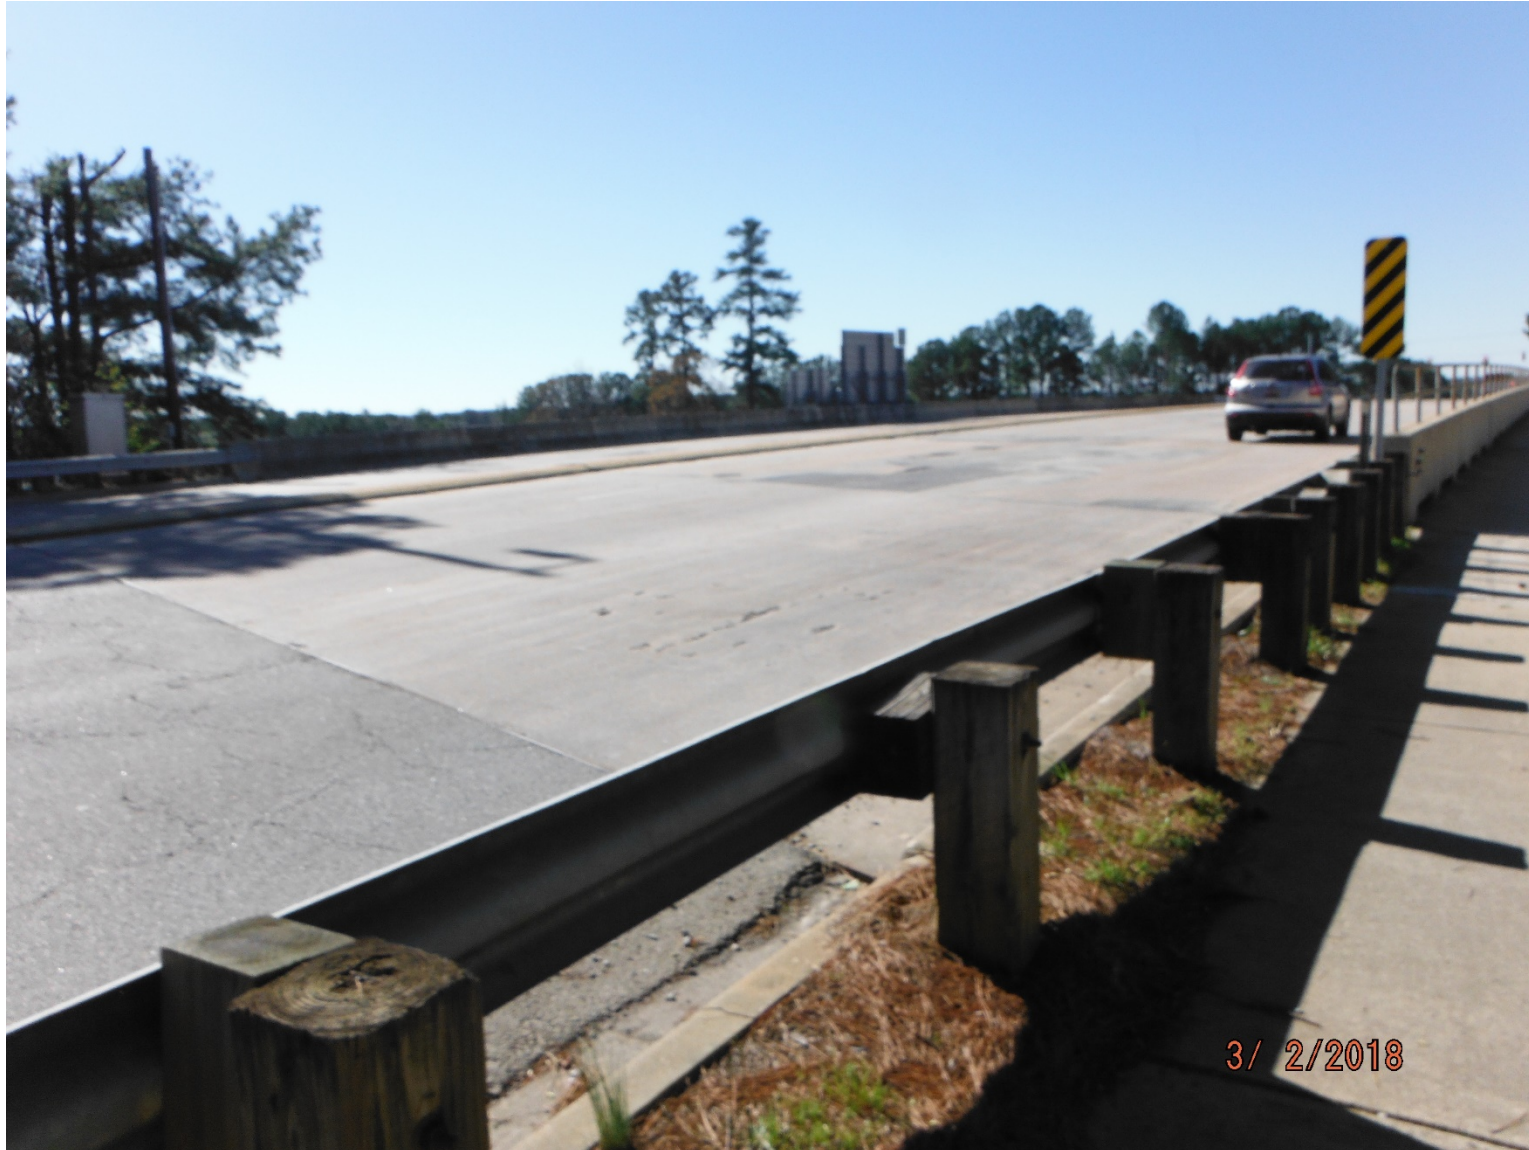
Photograph 1

Top view of the subject bridge looking down station with a view of the top deck of the bridge.

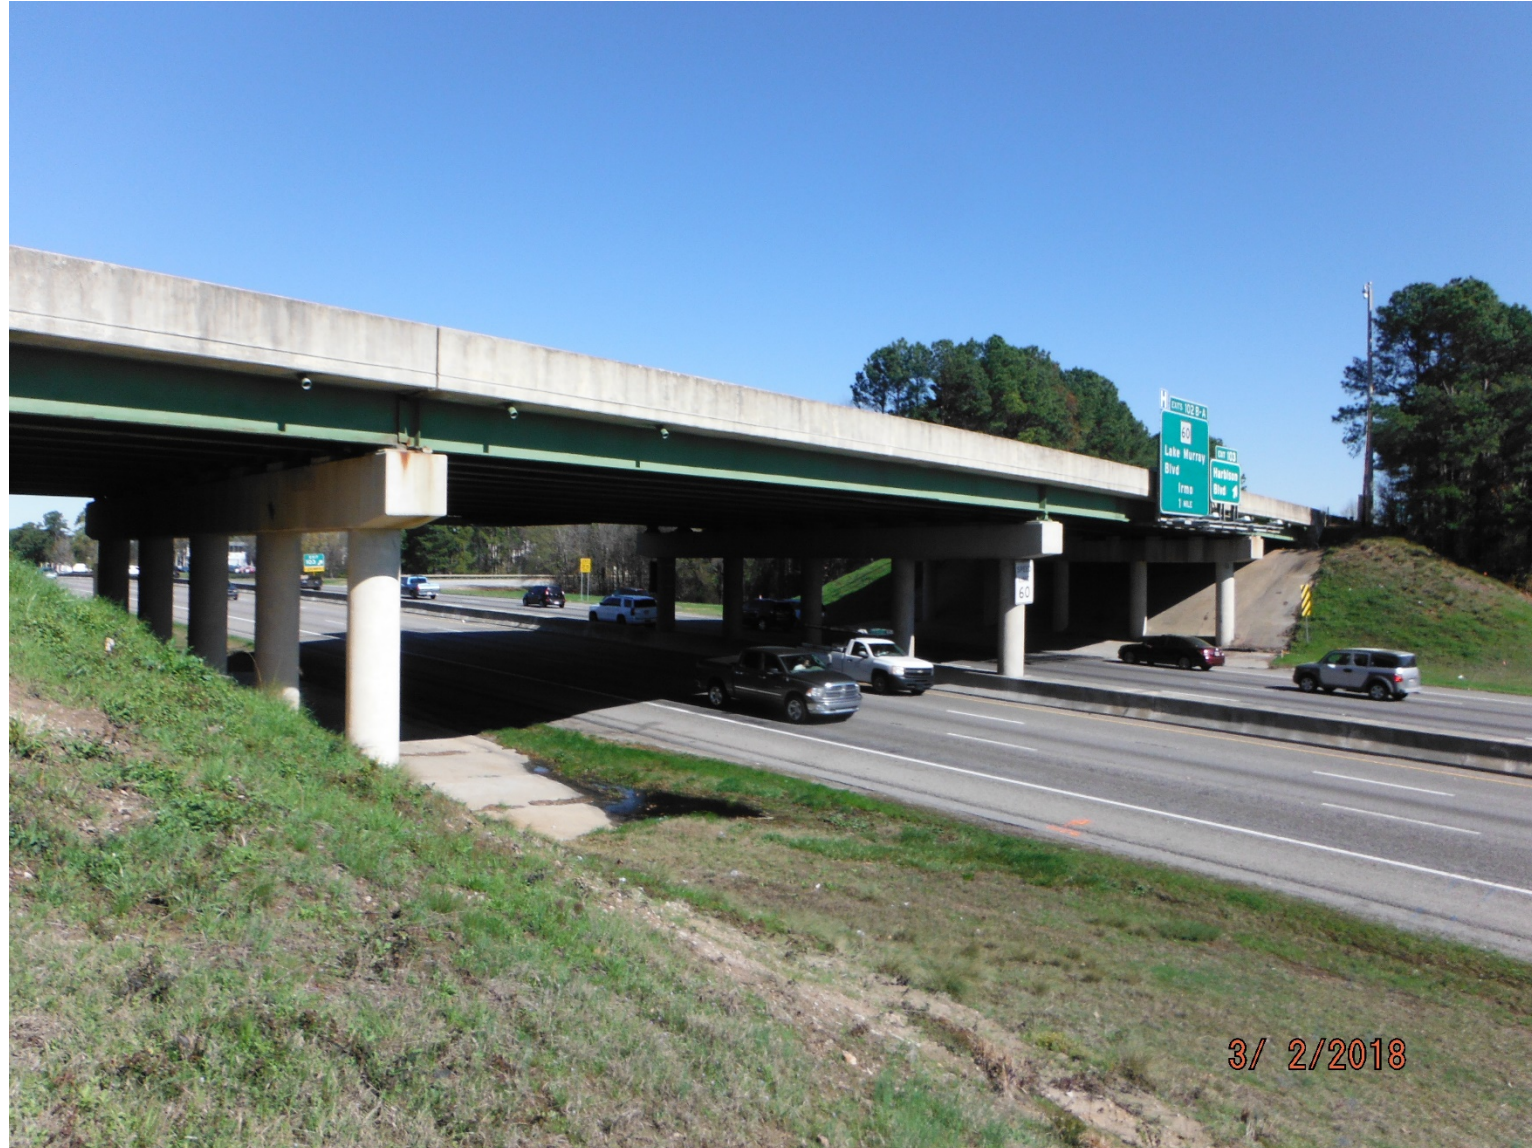
Photograph 2

East side of the bridge.

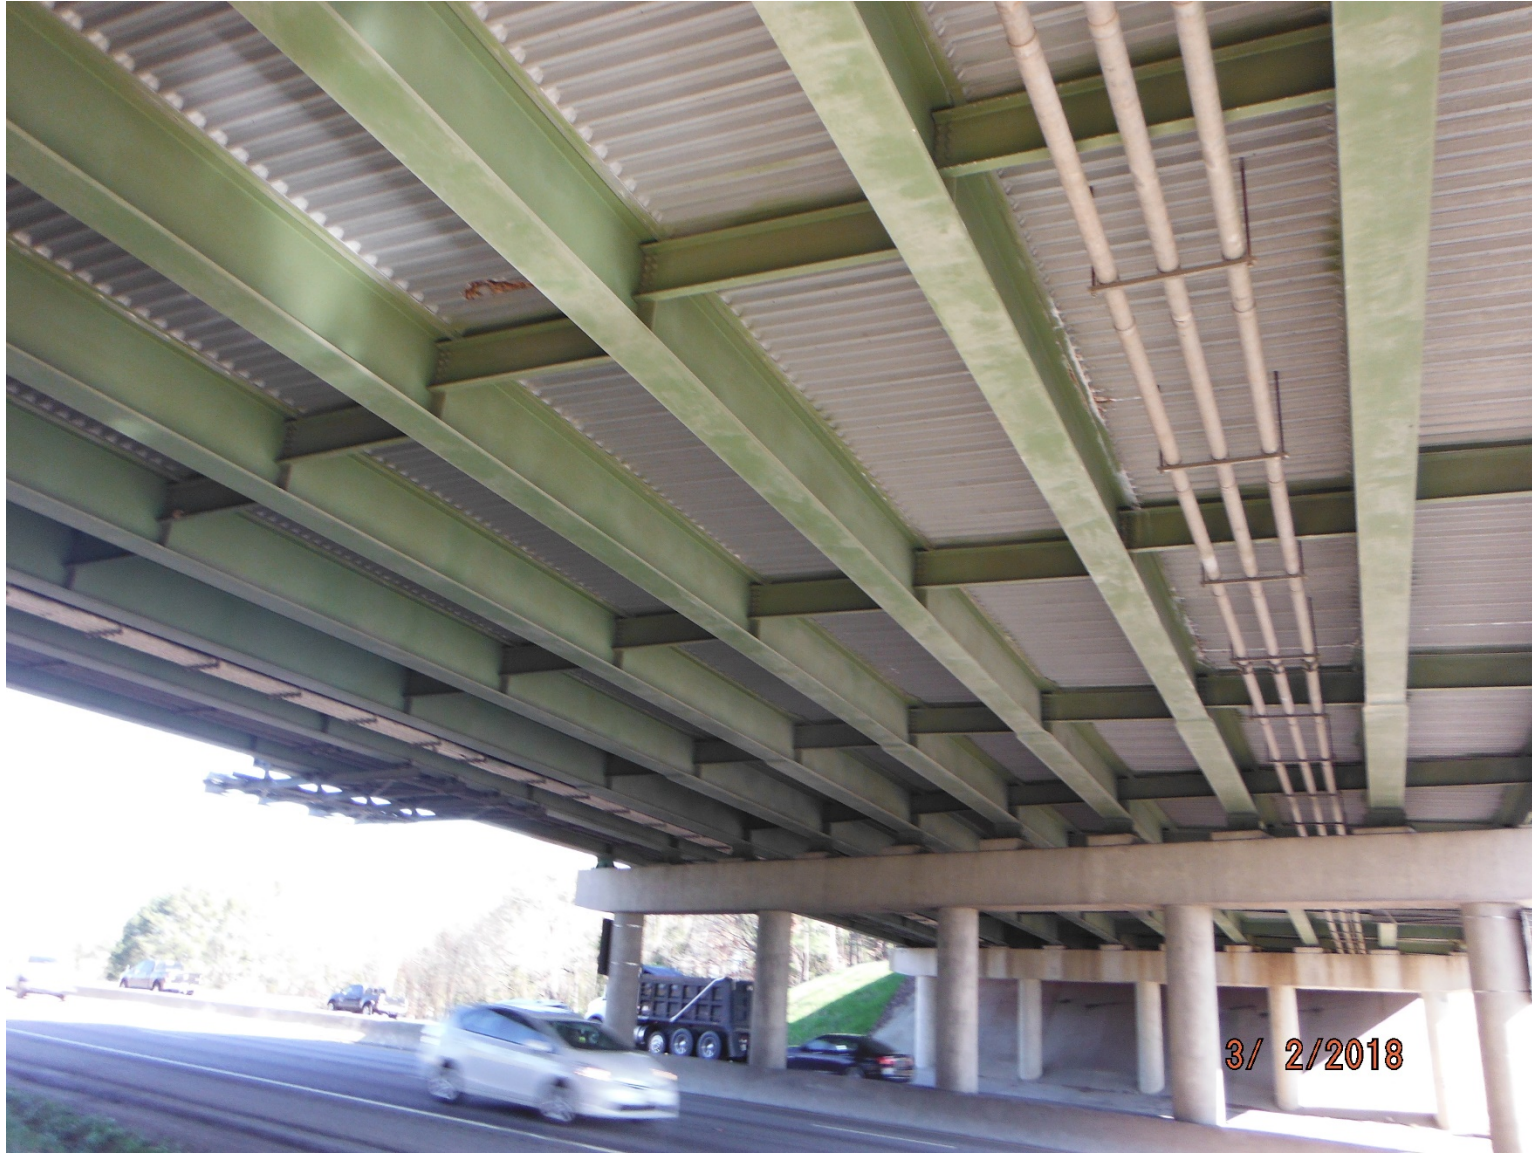
Photograph 3

View from underside of bridge looking north.

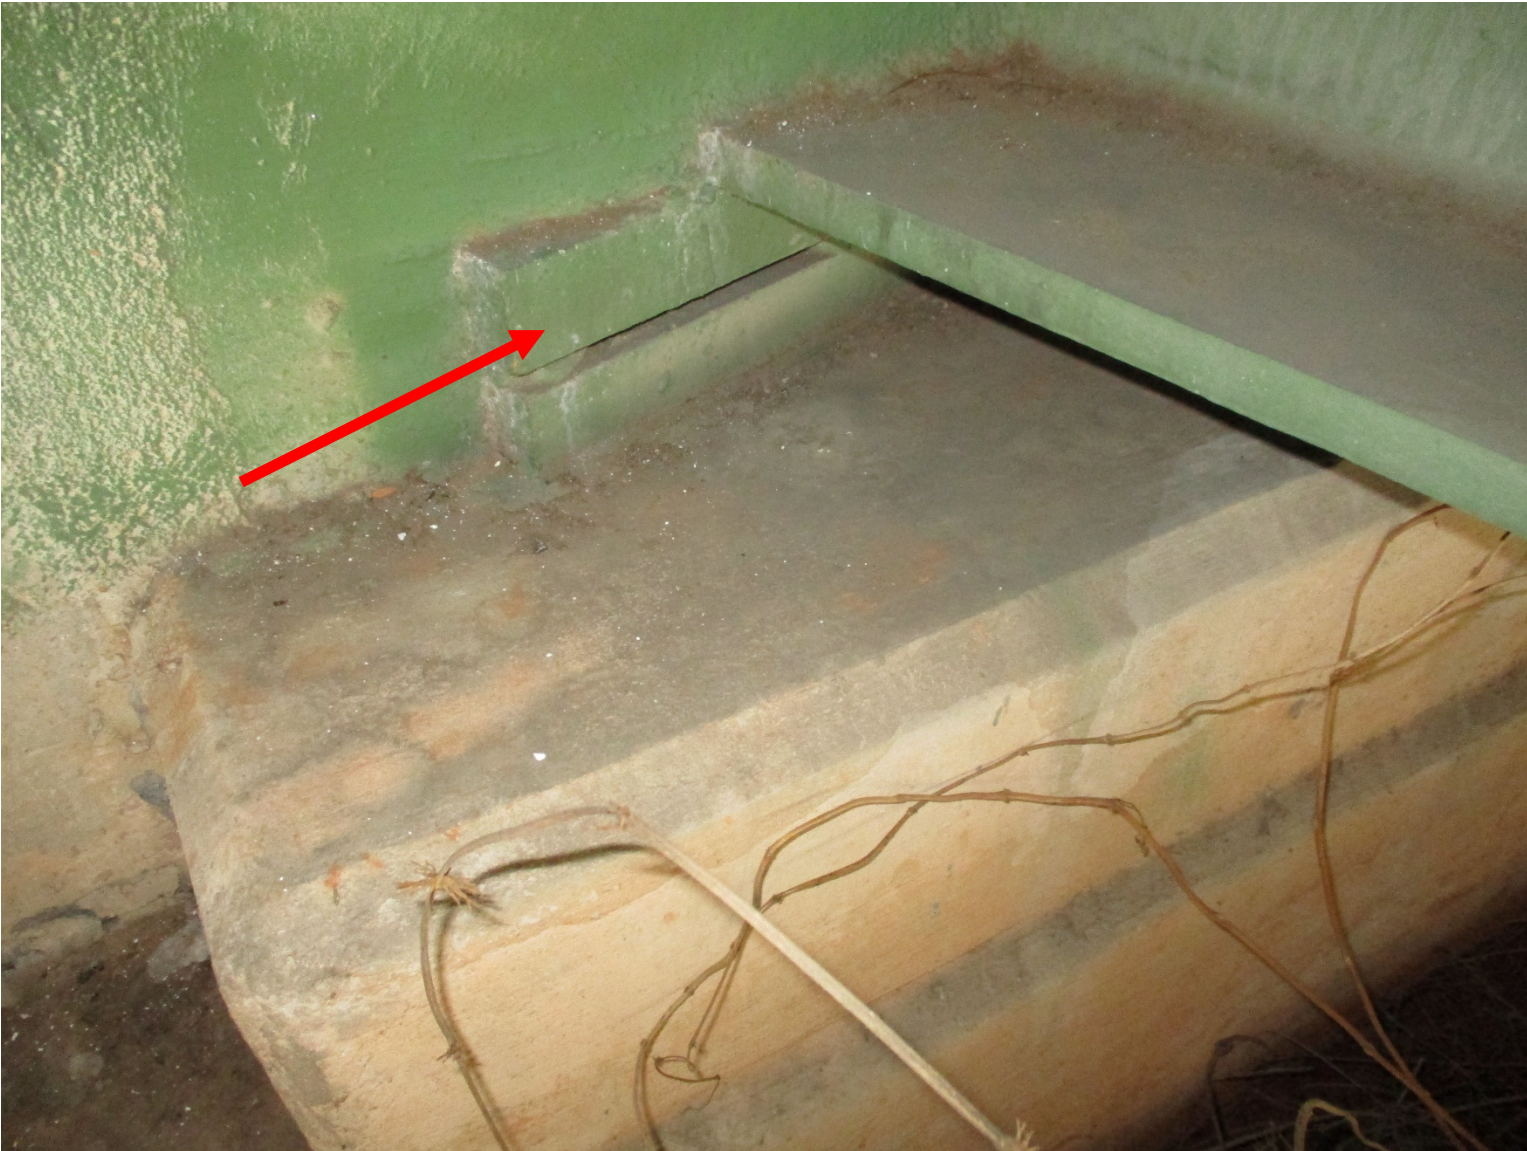
Photograph 4

The results from this Lead-Based Paint Investigation indicate that lead is present in paint and/or coatings at levels that equal to or exceed the SCDHEC threshold limit for lead (0.7 mg/cm^2) on the beam plates. Some components tested positive for lead at levels that would be a concern under OSHA regulations. Therefore, OSHA regulations and procedures should be followed when handling these components. Refer to the blue highlighted components listed on the XRF Data Summary Table found in Appendix C for a list of these items.

Underside view of the beam plates that are positive for LBP.

Components found to contain lead should be handled appropriately. It is recommended that work tasks which require grinding, sanding, cutting torch, or other disturbance of the LBP surfaces identified herein be performed in accordance with federal regulations pertaining to worker protection from exposure to LBP. When lead containing items are disturbed or begin to decay they become a concern regarding human health and the environment. The typical routes of exposure to lead are through the inhalation or ingestion of lead-contaminated materials. Minimal risk of exposure exists where the lead-containing paint and coating are intact (e.g., has not been aerosolized, free of chipping or flaking, etc.).

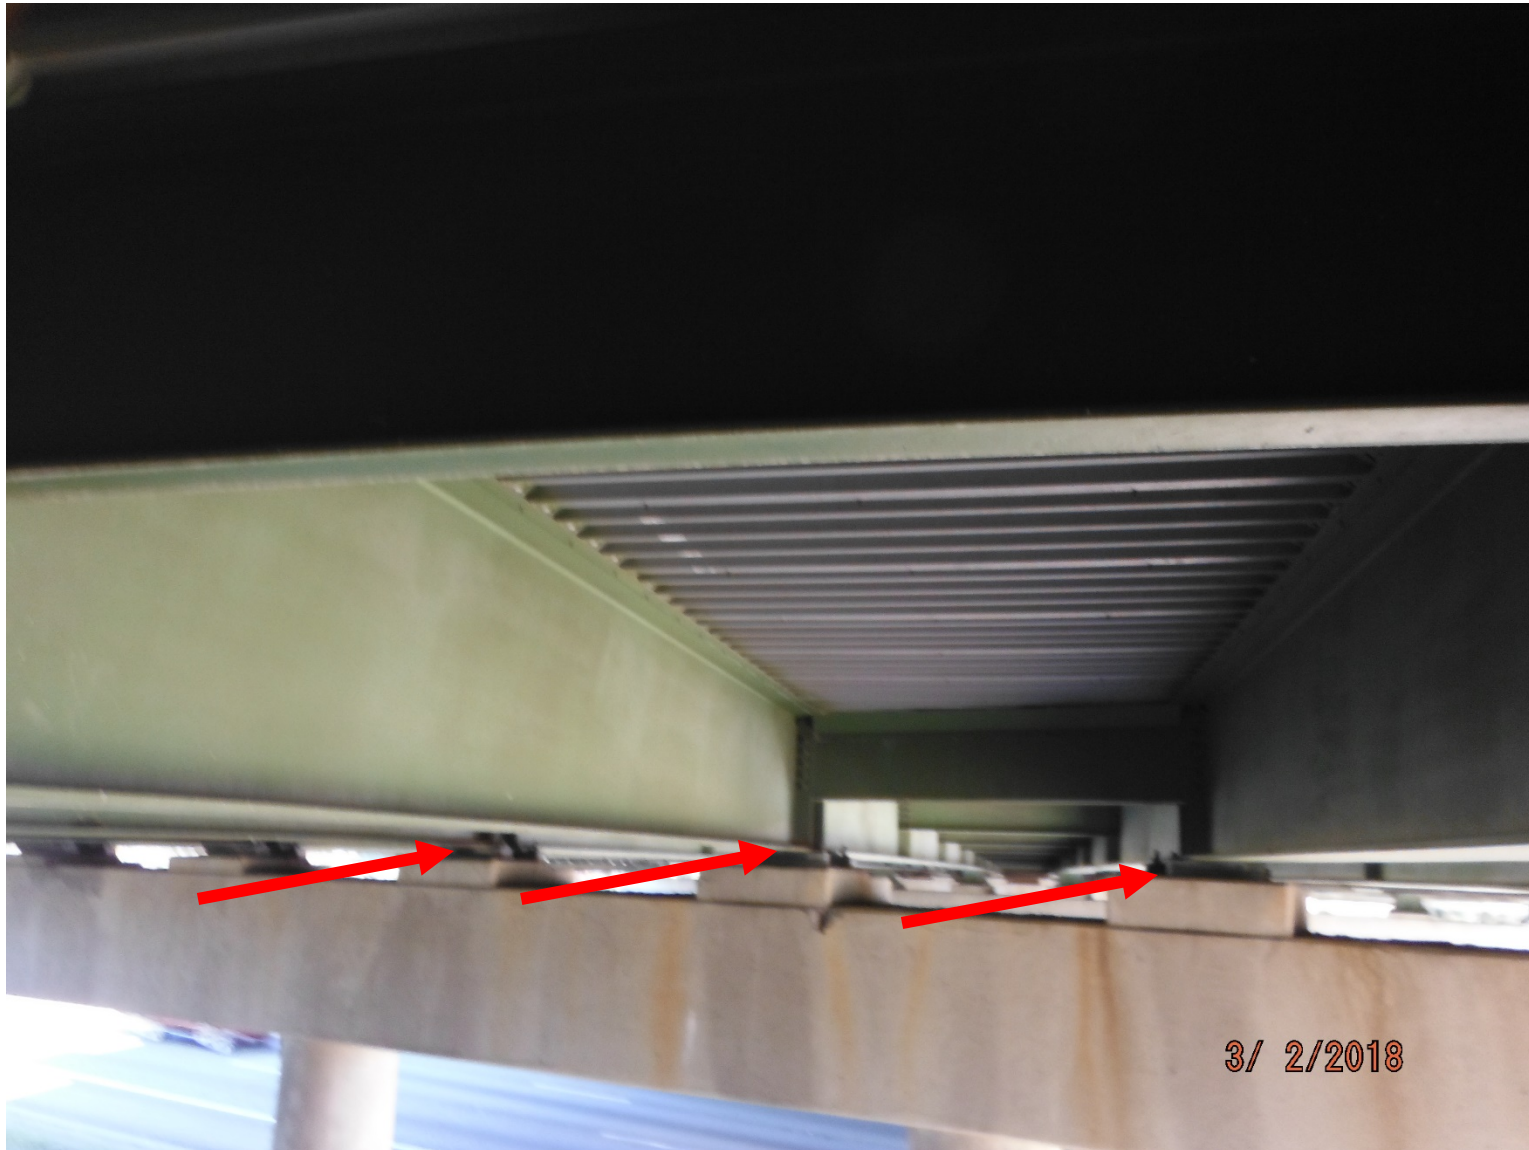
Photograph 5

Another underside view of the beam plates that are positive for LBP.

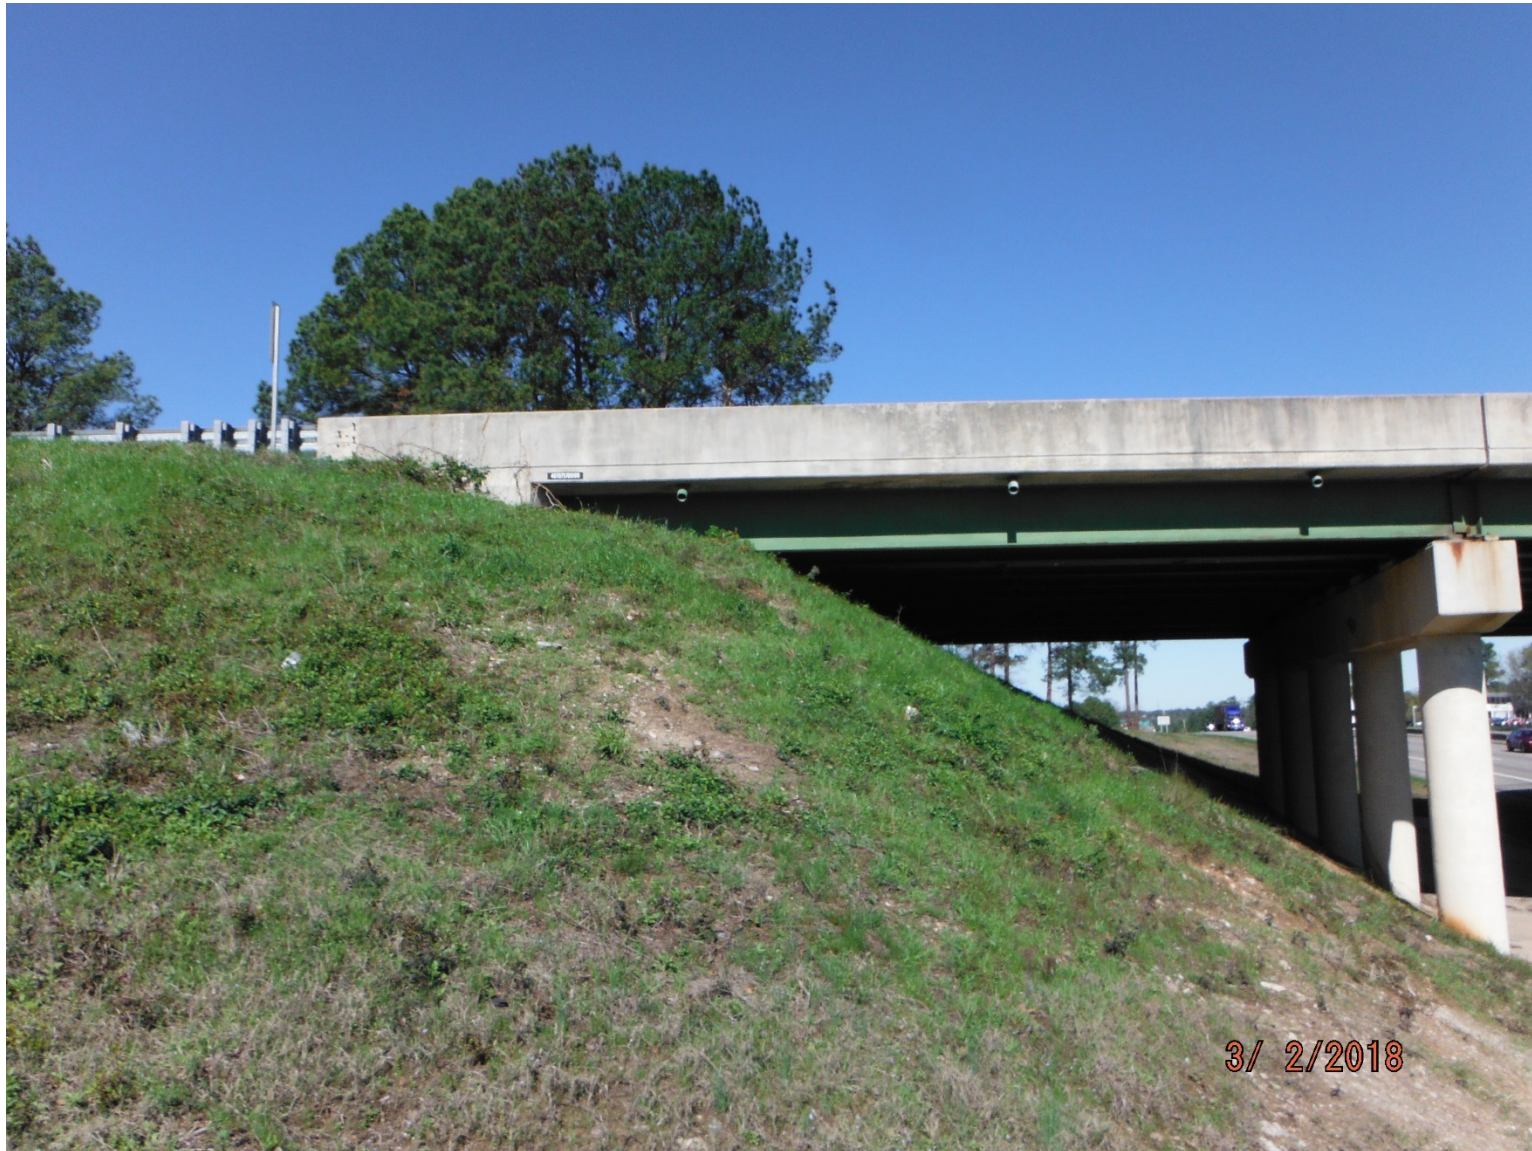
Photograph 6

View of the south end bent.
