## **LEAD-BASED PAINT (LBP) INVESTIGATION REPORT**

**S-32-36 (ST. ANDREWS RD.) BRIDGE  
OVER I-26 (EAST & WEST BOUND LANES)  
SCDOT BRIDGE #327003600200  
LEXINGTON COUNTY, SOUTH CAROLINA**

**March 20, 2018**

F&ME Project No.: G5662.010

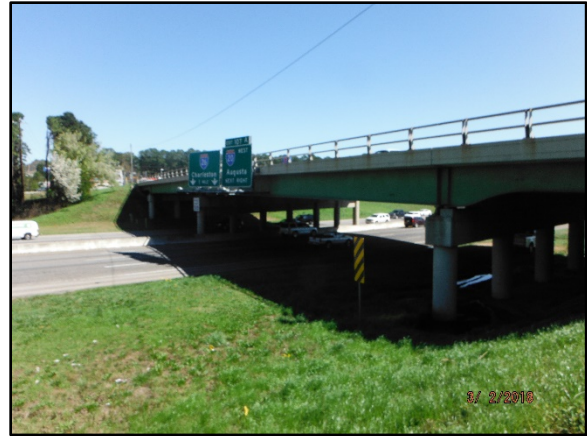
*Photo 1 – View of the subject bridge, S-32-36 (St. Andrews Rd.) Bridge over I-26 looking up-station (Westward).*

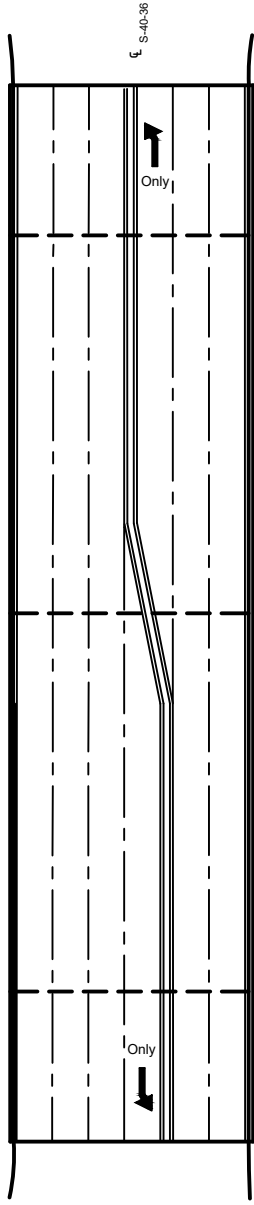
**Sample Location Plan**  
Prepared for: HDR, Inc.  
3955 Faber Place Drive, Suite 300  
North Charleston, SC 29405

F&ME Consultants has completed a Lead-Based Paint (LBP) Investigation on the S-32-36 (St. Andrews Rd.) Bridge Over I-26 in Lexington County, South Carolina, for HDR, Inc (David Kinard, P.E. - Project Manager), on March 2, 2018. Appendix A – Site Vicinity Map is provided to show the location of the bridge. Appendix B – Bridge Plan, is provided to show the bridge lay-out and locations of XRF scans taken on the bridge.

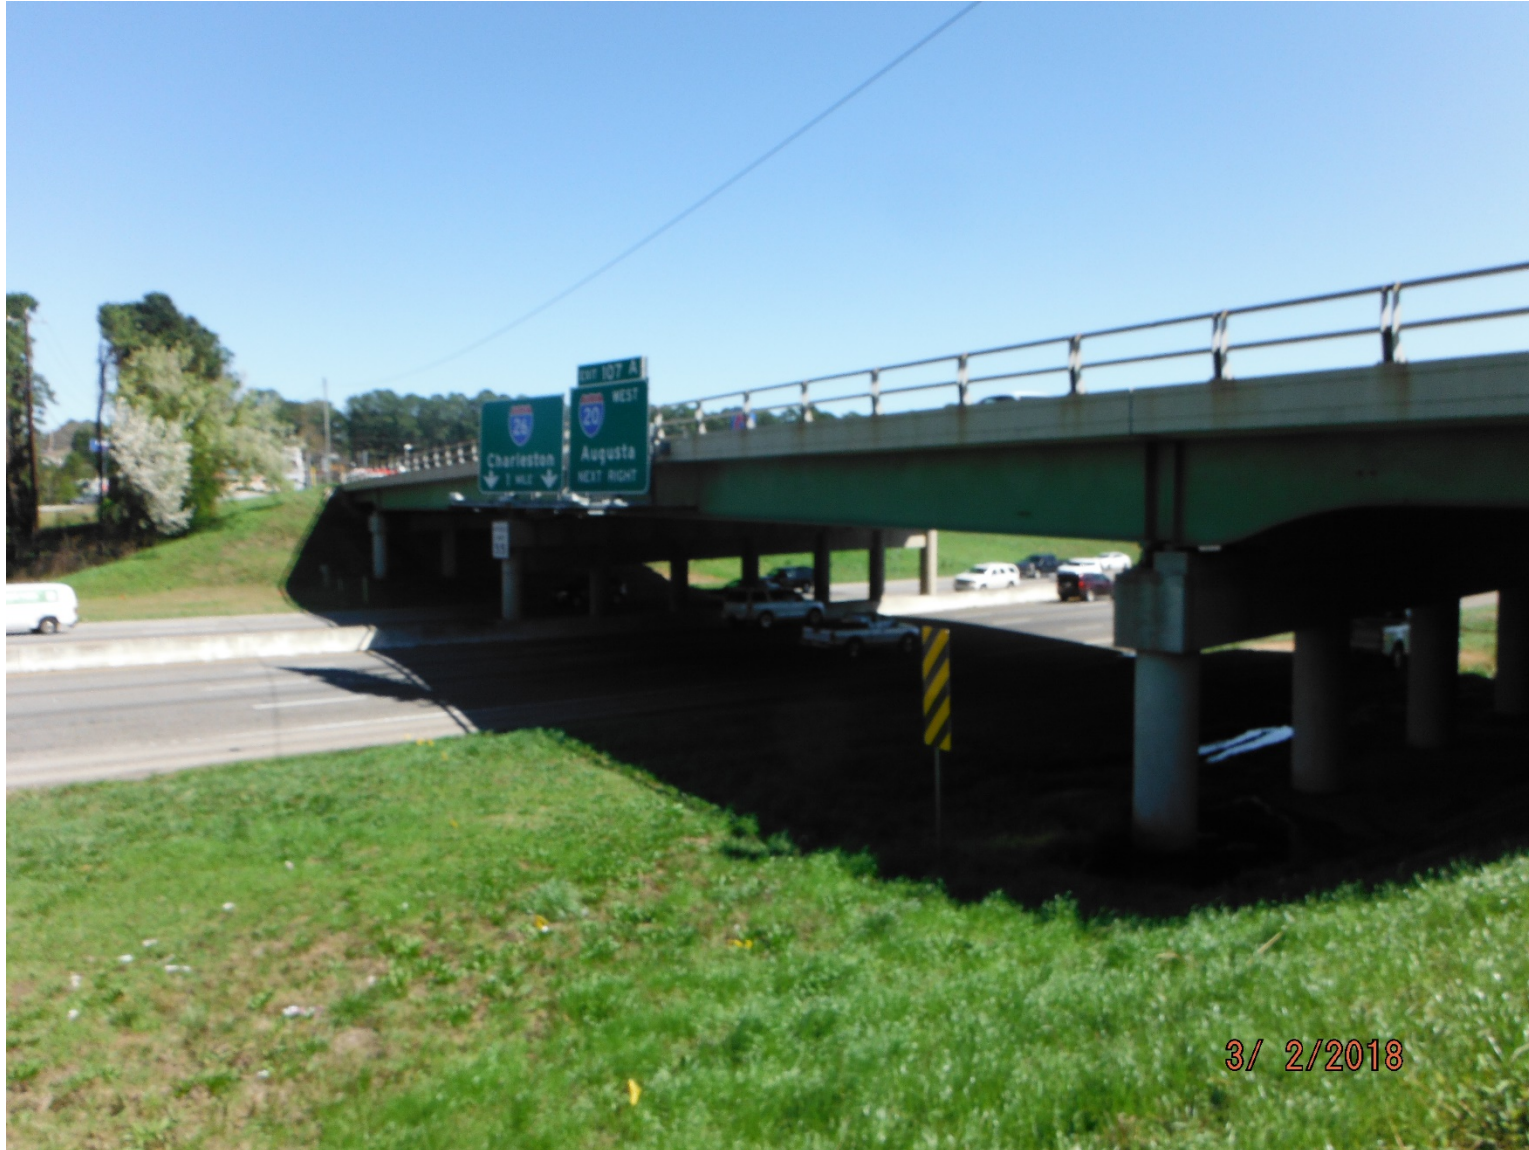
# Photograph 1

West side view of bridge.

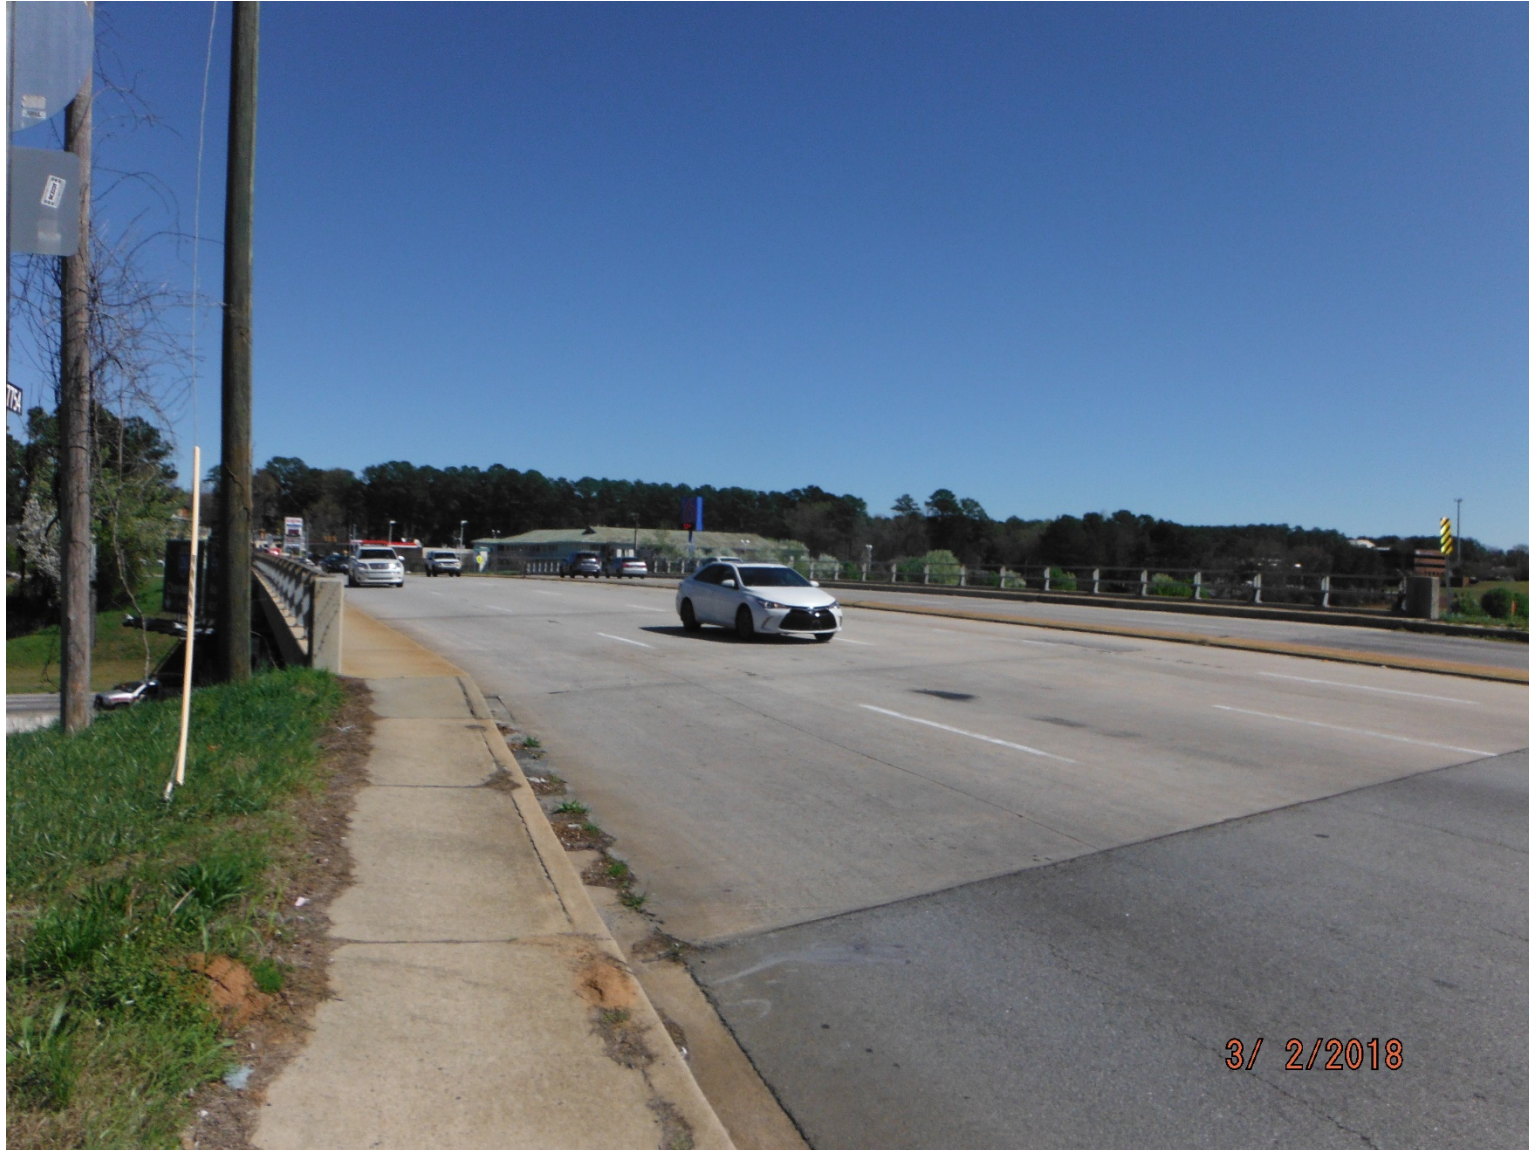
# Photograph 2

View of the top of  
bridge deck looking  
north.

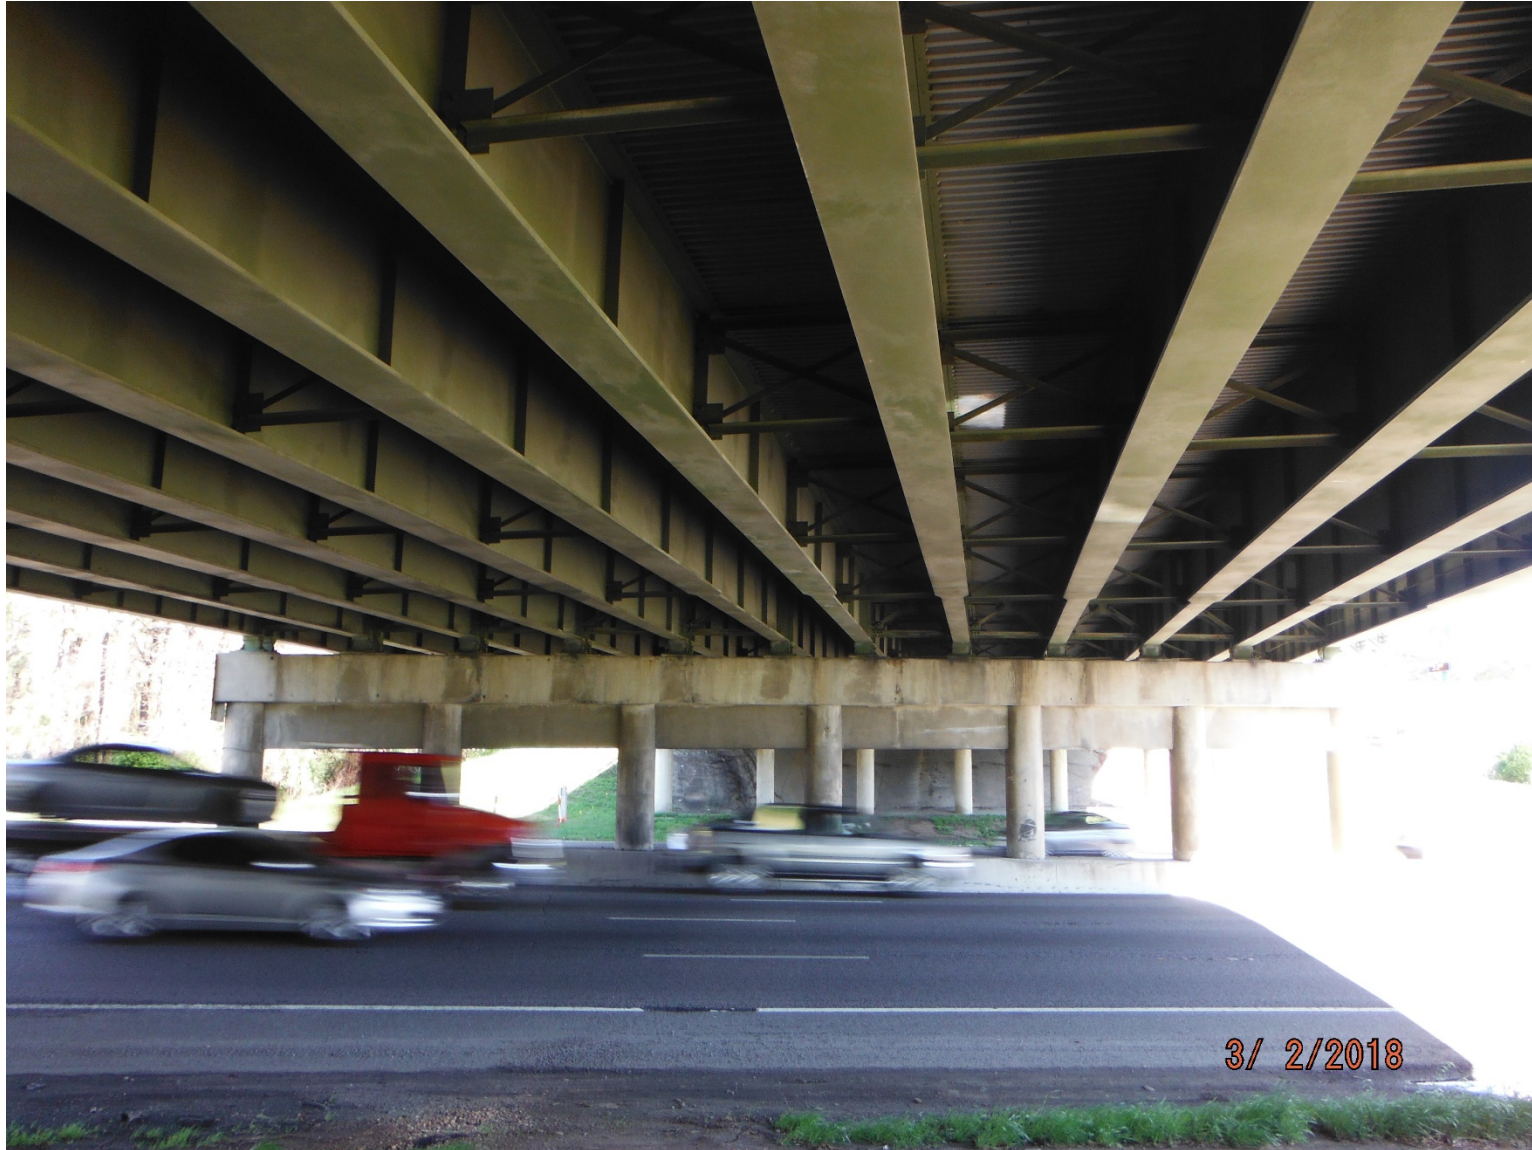
# Photograph 3

Underside view of bridge beams, diaphragms, bent caps and columns.

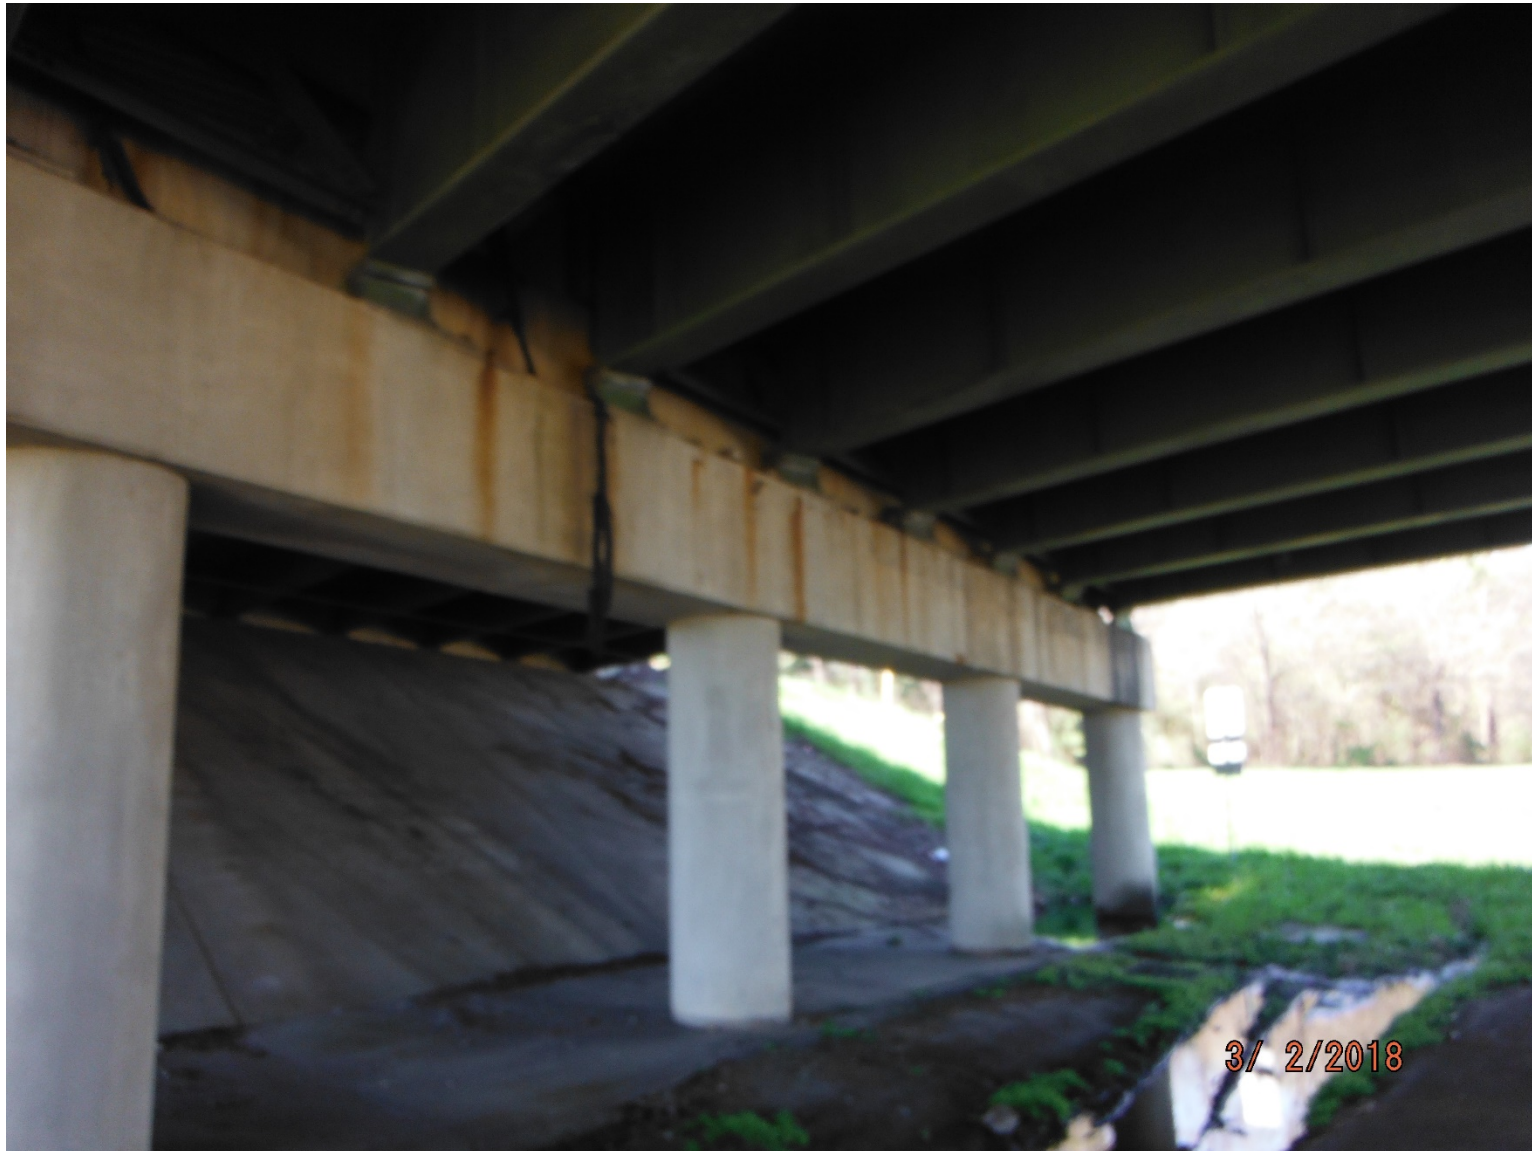
# Photograph 4

Underside view of bent #2 looking south west.

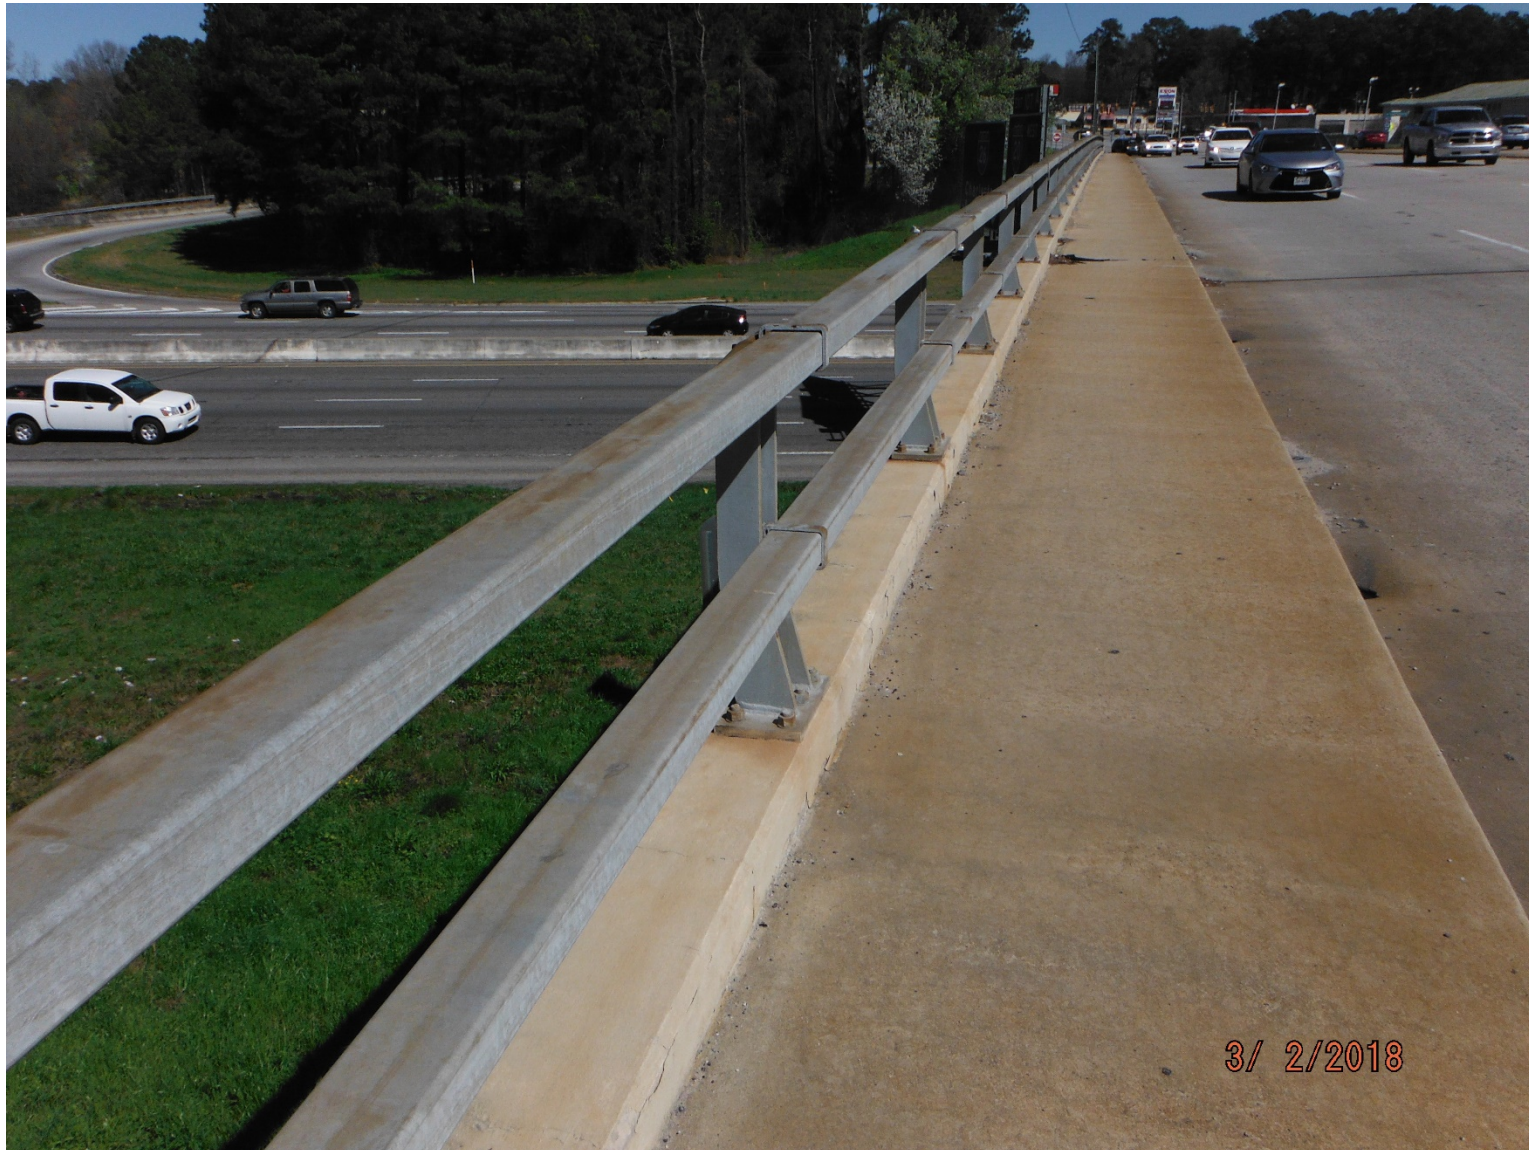
# Photograph 5

View of sidewalk on top deck of bridge looking north.

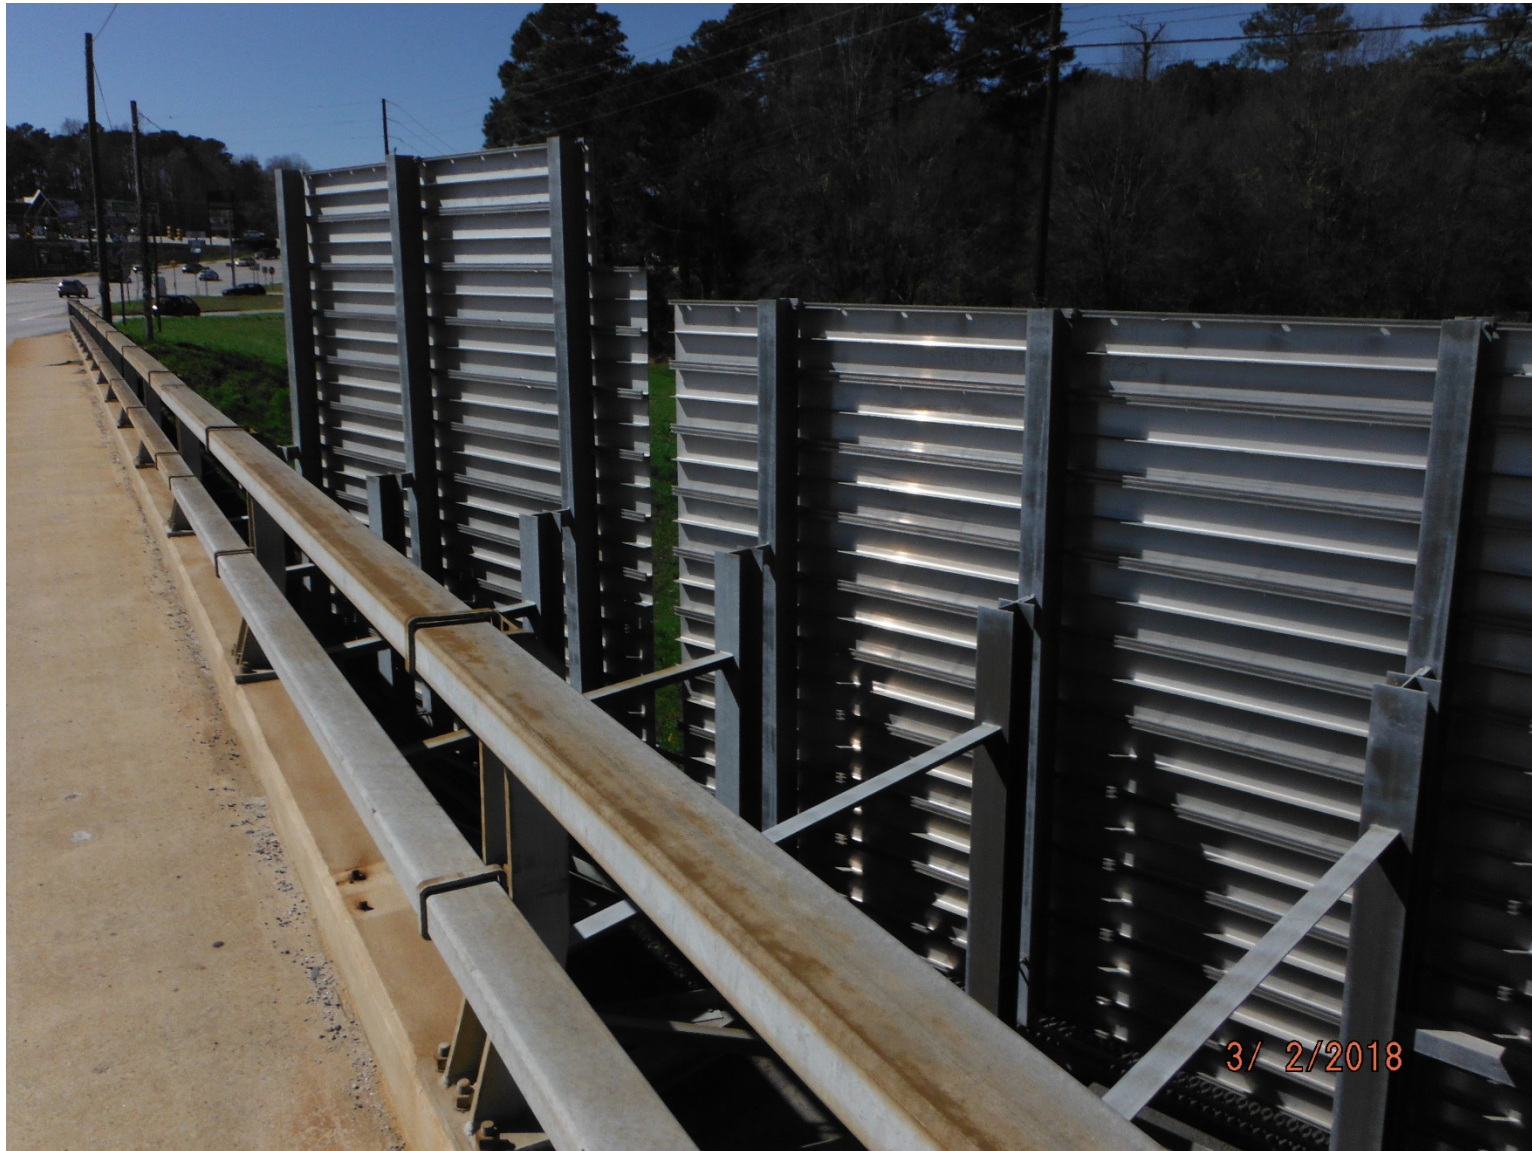
# Photograph 6

View of mechanically affixed road signs on the west side of the bridge.
