**Asbestos & Lead-Based Paint Assessment  
Carolina Crossroads I-20/26/126 Project  
Bush River Road Bridge over I-26  
Structure No. 407003100100  
Columbia, Richland County, South Carolina  
S&ME Project No. 1461-16-047**

**Travis Knight & Bobby McAllister  
SCDHEC Lic. BI-00885 & BI-01429  
Inspection Dates: February 19, 2018**

**May 22, 2018**

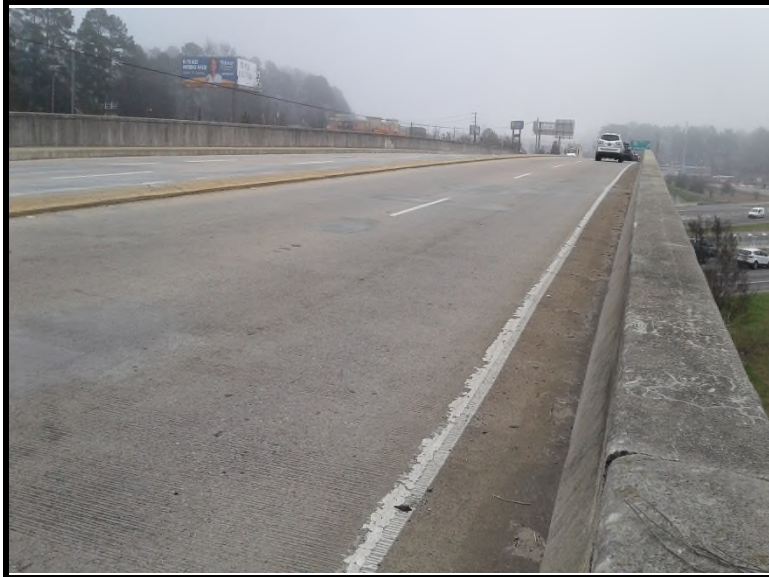
**1** View of the Bush River Road Bridge over I-26.

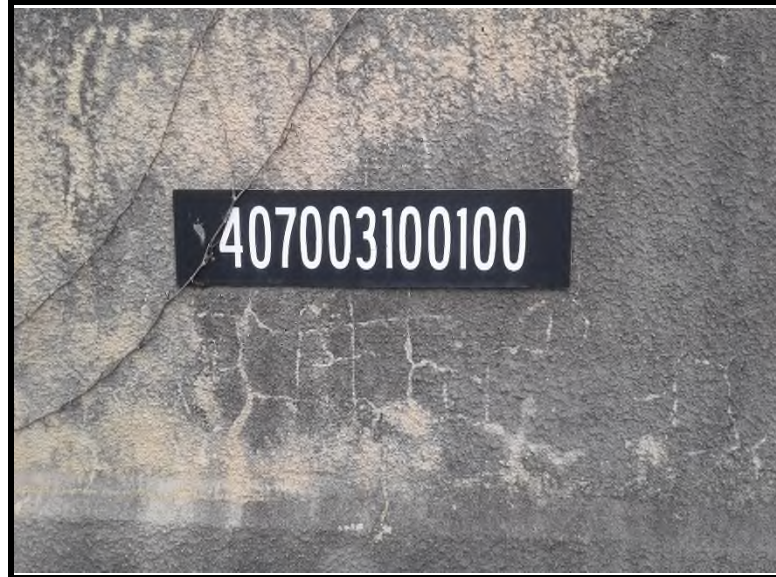
**2** The bridge is identified as structure # 407003100100.

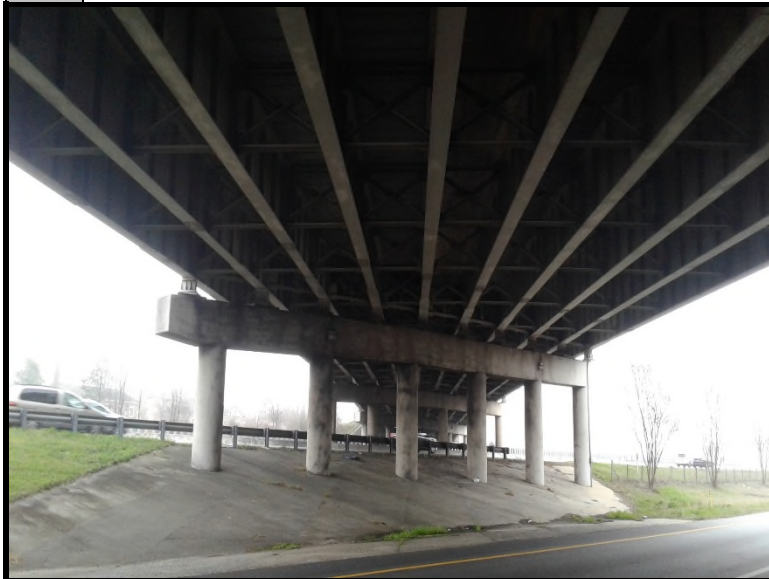
**3** View of the underside of the bridge. Shows metal decking, steel beams, and concrete piers.

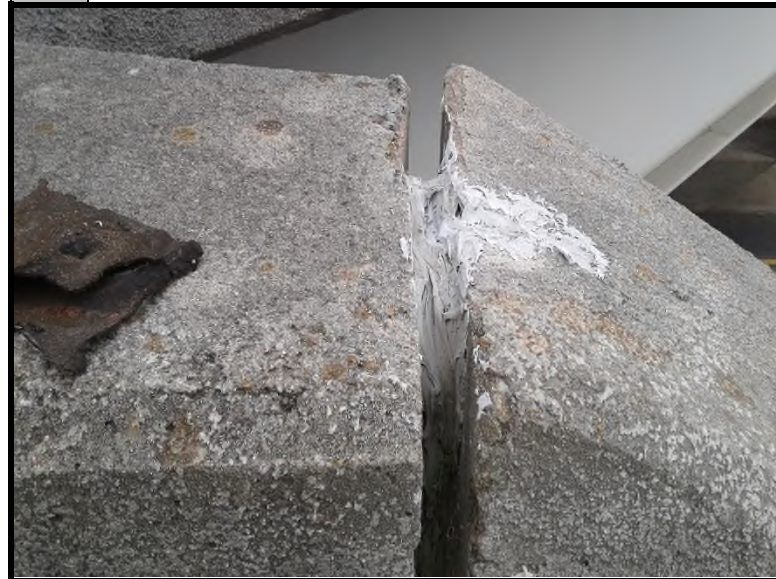
**4** The gray caulking tested negative for asbestos via PLM and TEM analysis.

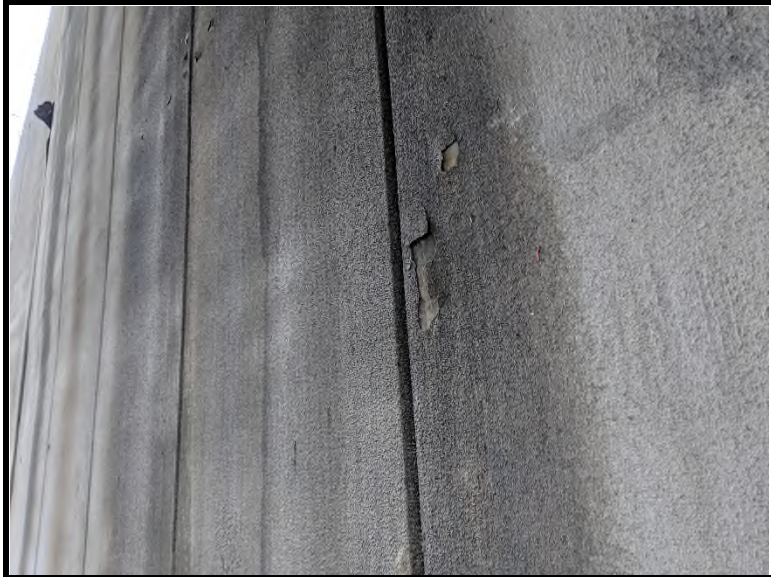
**5** The expansion joint material located on the boundary wall tested negative for asbestos via PLM and TEM analysis. The textured material tested negative for asbestos via PLM analysis.

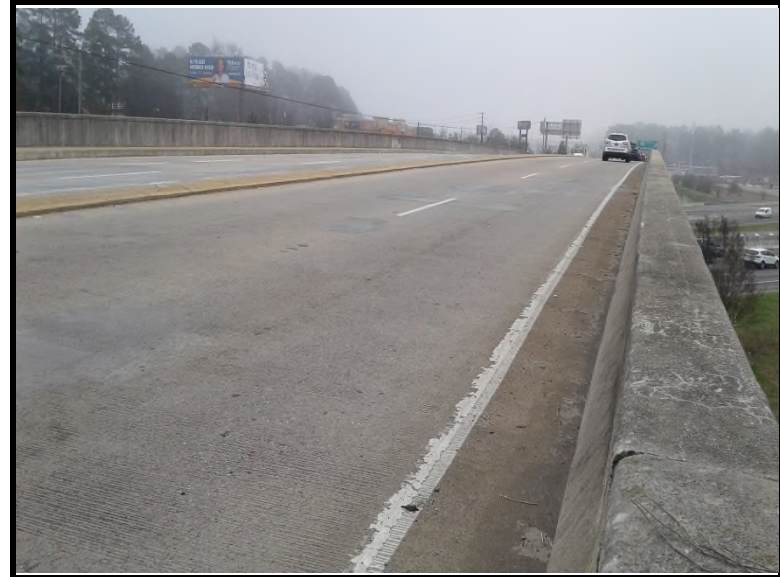
**6** No scuppers were observed during the assessment of the bridge.
