**Asbestos & Lead-Based Paint Assessment
Carolina Crossroads 1-20/26/126 Project
Colonial Life Eastbound Bridge over
Gracern Road & I-126
Structure No. 401012620072
Columbia, Richland County, South Carolina
S&ME Project No. 1461-16-047**

**Travis Knight & Bobby McAllister
SCDHEC Lic. BI-00885 & BI-01429
Inspection Dates: February 19 & 21, 2018**

Reference: **Asbestos & Lead-Based Paint Assessment**
Carolina Crossroads I-20/26/126 Project
Colonial Life Eastbound over Gracern Road & I-126
Structure No. 401012620072
Columbia, Richland County, South Carolina
S&ME Project No. 1461-16-047

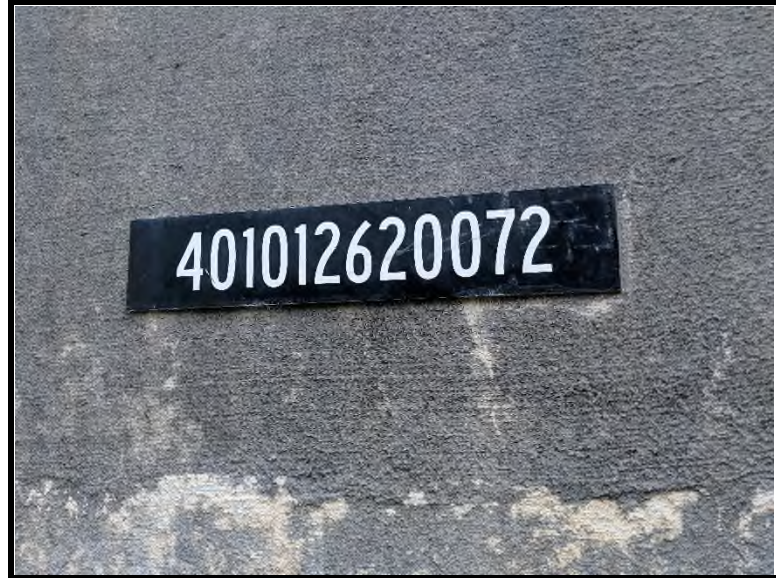
2 The bridge is identified as structure # 401012620072.

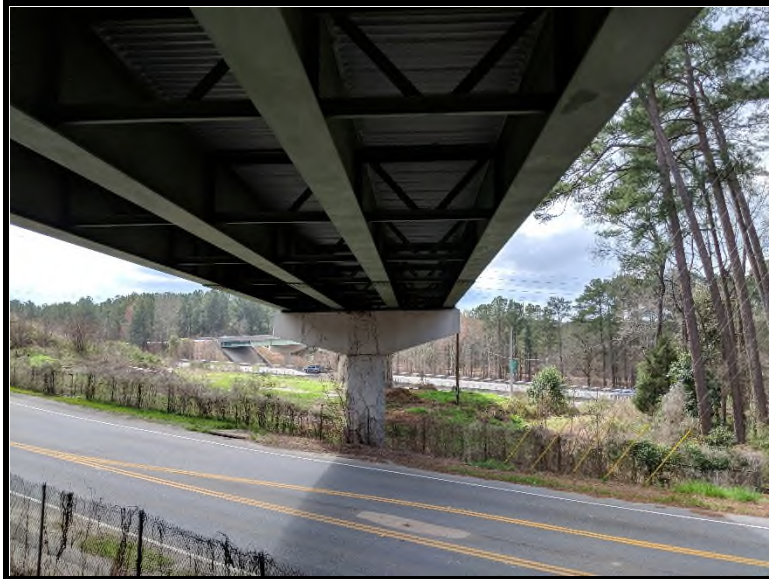
3 View of the underside of the bridge. Shows steel beams, metal decking and concrete piers.

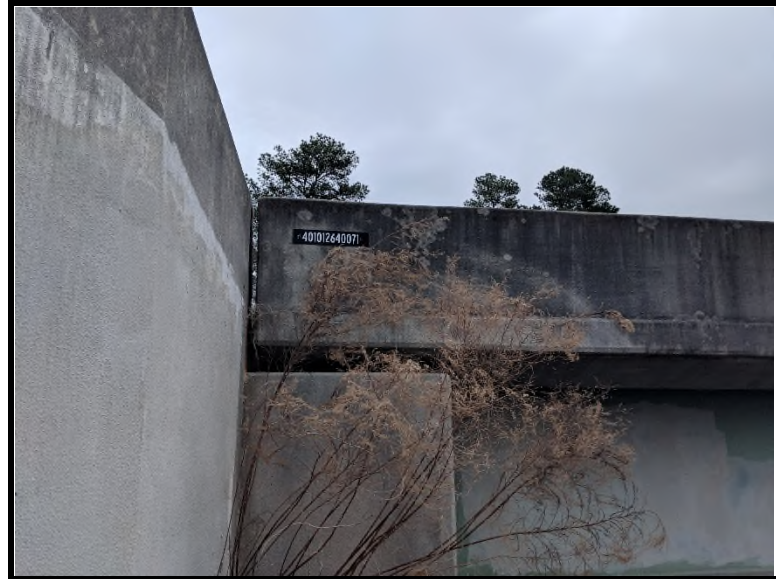
4 Textured coating located on retaining wall tested negative for asbestos via PLM analysis.

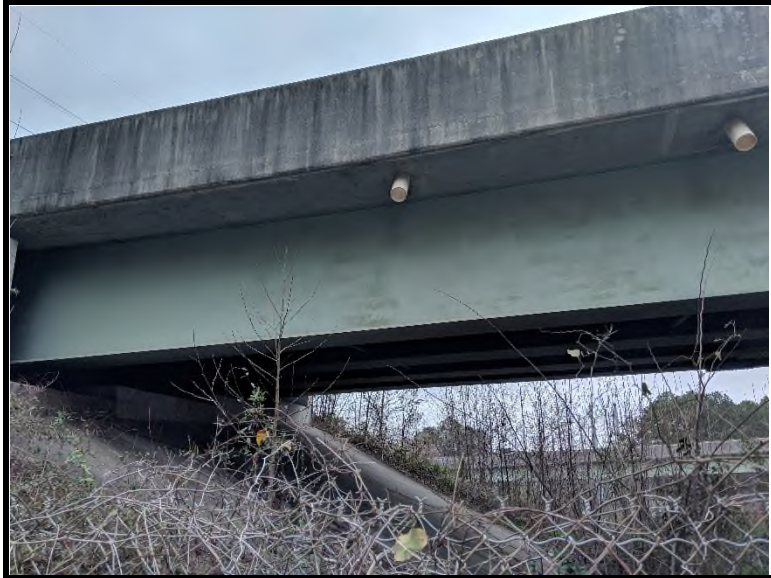
5 Expansion joint located on concrete retaining wall and the joint at the slope and foot tested negative for asbestos via PLM and TEM analysis.

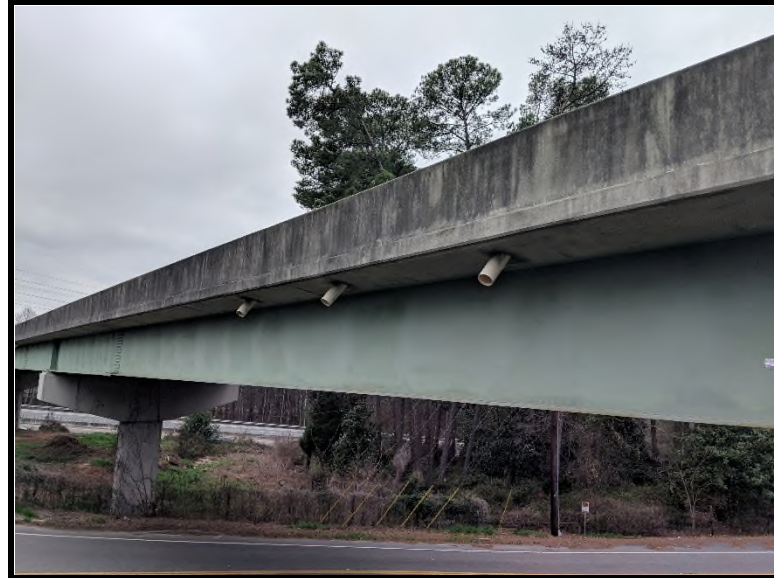
6 PVC scuppers were observed during the assessment of the bridge.
