**Asbestos & Lead-Based Paint Assessment
Carolina Crossroads 1-20/26/126 Project
Colonial Life Westbound Bridge over
Gracern Road
Structure No. 401012640071
Columbia, Richland County, South Carolina
S&ME Project No. 1461-16-047**

**Travis Knight & Bobby McAllister
SCDHEC Lic. BI-00885 & BI-01429
Inspection Dates: February 20, 21 &
March 28, 2018**

May 21, 2018

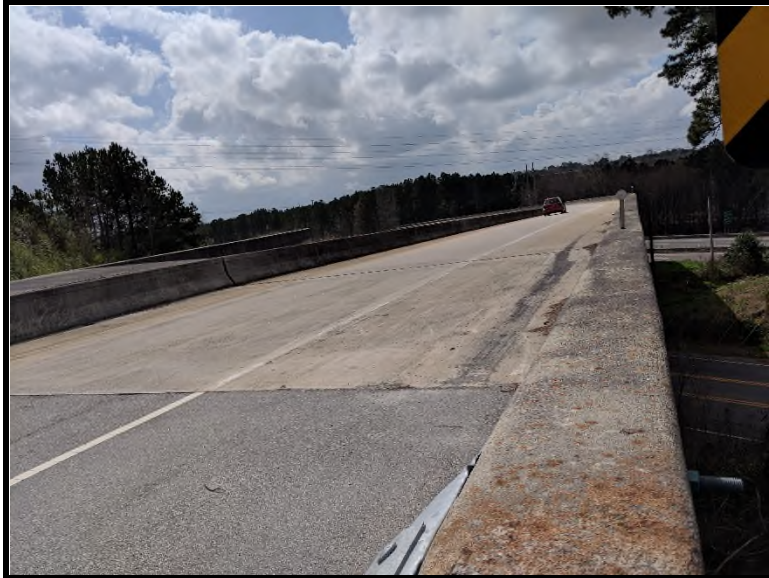
1 View of the Colonial Life Westbound over Gracern.

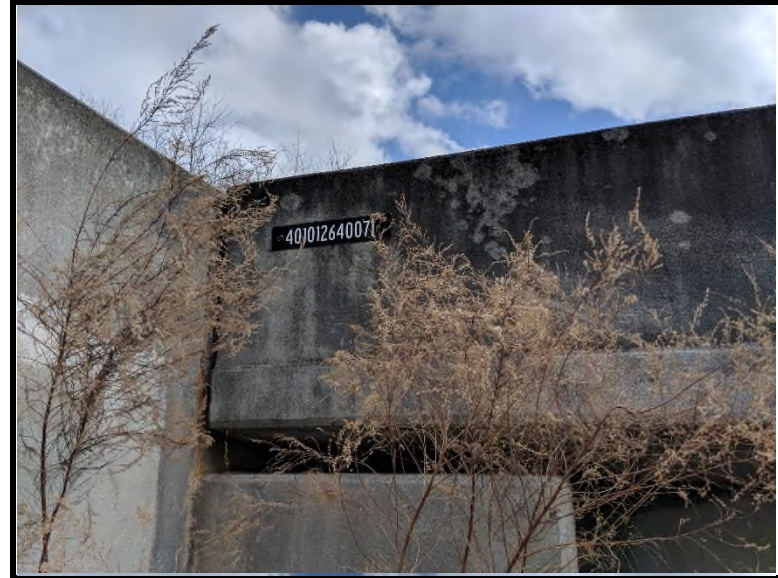
2 The bridge is identified as structure # 401012640071.

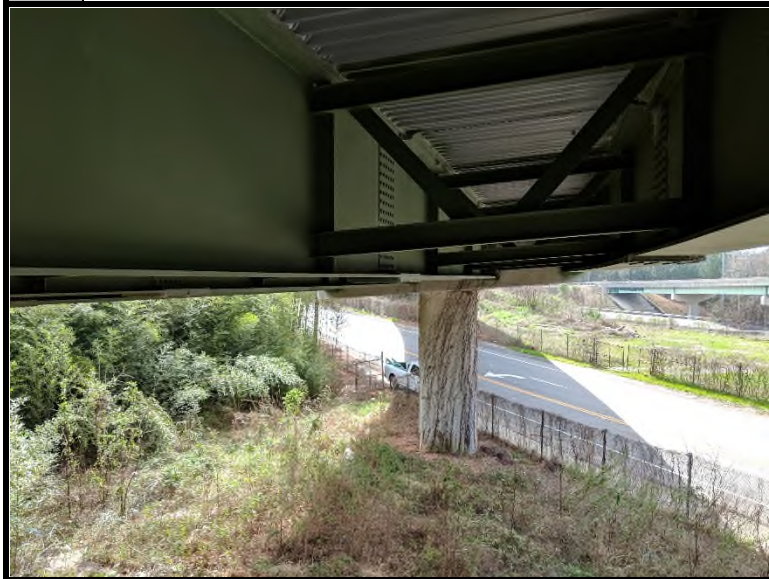
3 View of the underside of the bridge. Shows steel beams, metal decking and concrete piers.

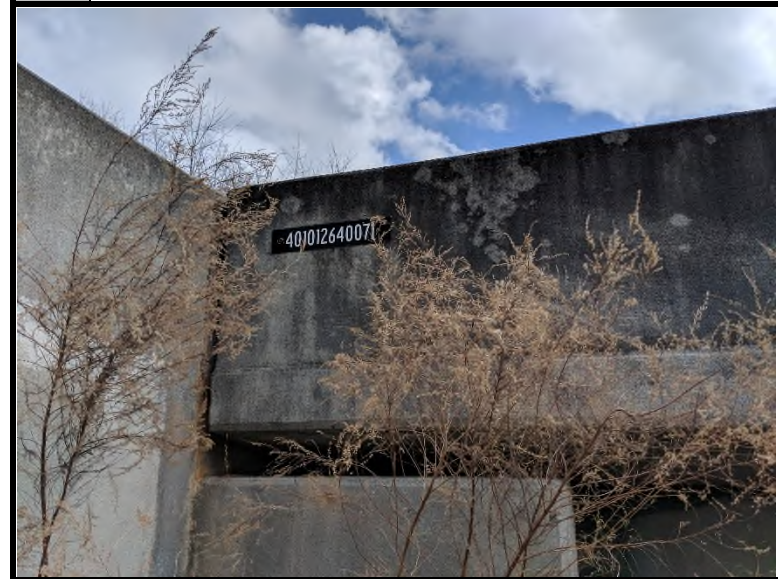
4 Textured coating located on retaining wall tested negative for asbestos via PLM analysis.

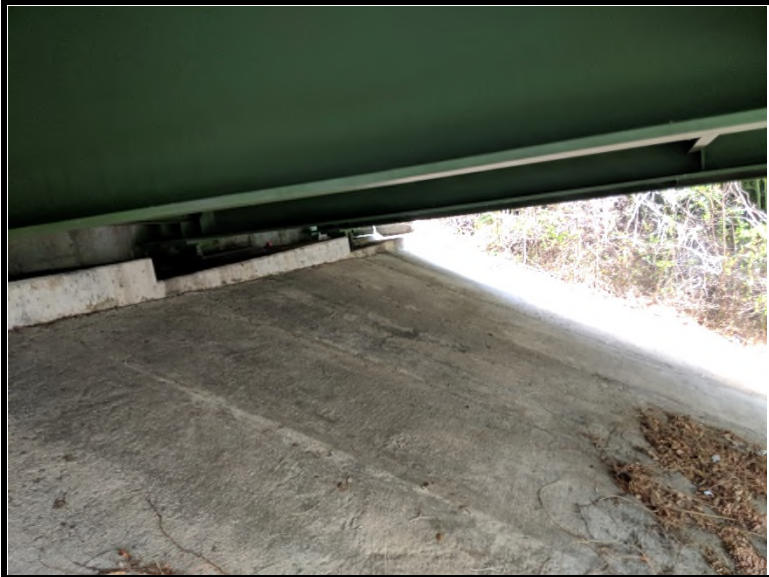
5 Expansion joint located on concrete retaining wall and the joint at the slope and foot tested negative for asbestos via PLM and TEM analysis.

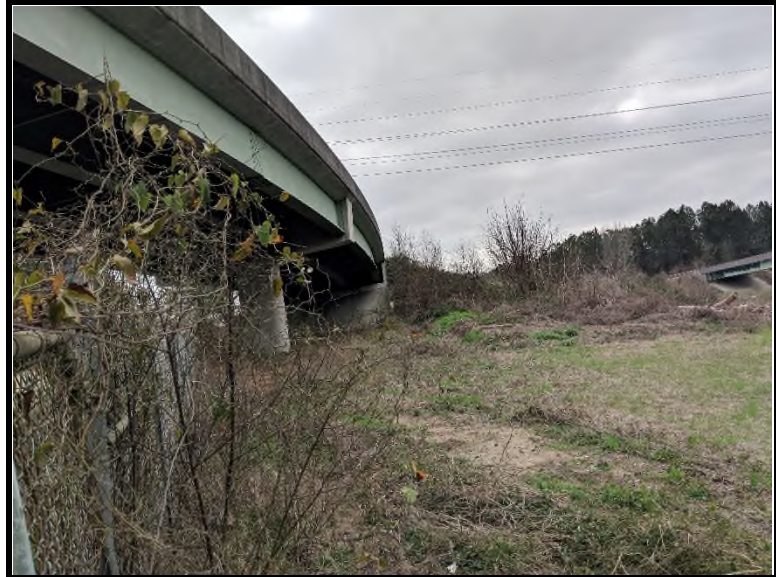
6 No scuppers were observed during the assessment of the bridge.
