**Asbestos & Lead-Based Paint Assessment
Carolina Crossroads 1-20/26/126 Project
I-26 Bridge over I-20
Structure No. 401002600200
Columbia, Richland County, South Carolina
S&ME Project No. 1461-16-047**

Inspection Dates: February 19 & 21, 2018

Reference: **Asbestos & Lead-Based Paint Assessment**
Carolina Crossroads I-20/26/126 Project
I-26 Bridge over I-20
Structure No. 401002600200
Columbia, Richland County, South Carolina
S&ME Project No. 1461-16-047

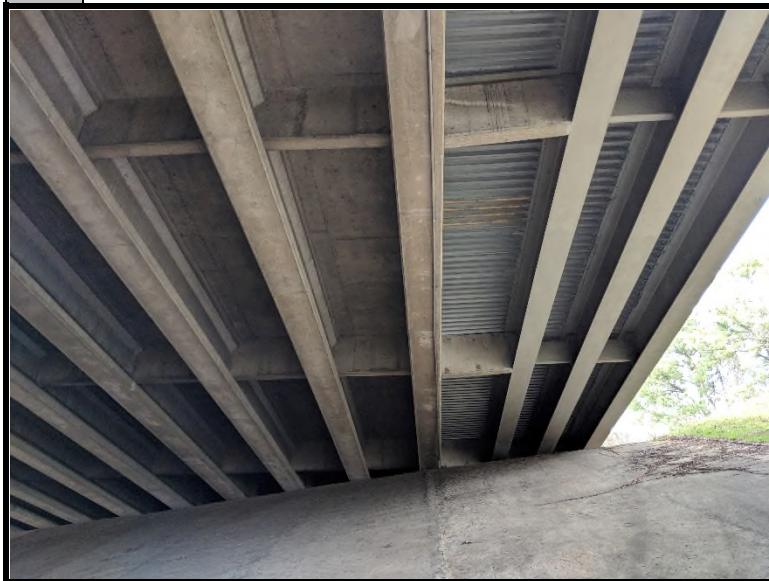
3 View of the underside of the bridge. Shows concrete beams and metal decking on center lanes and steel beams with metal decking on outside lanes.

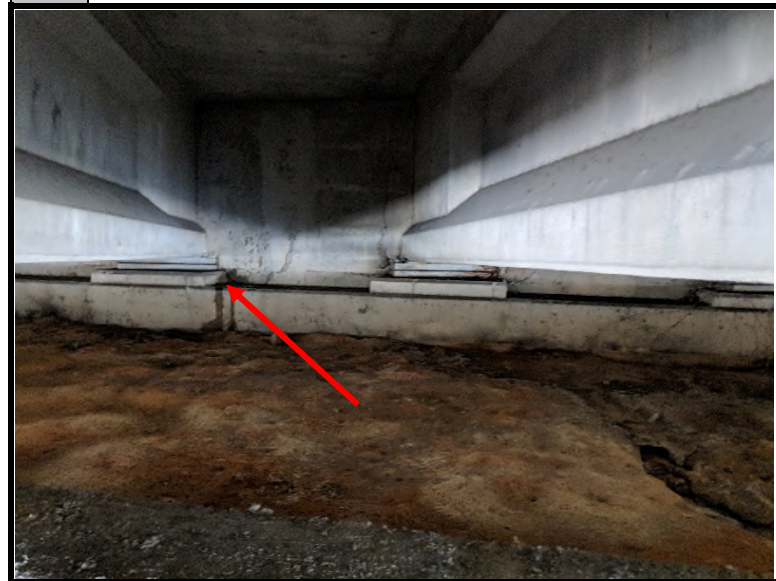
- Gray foot plates located underneath bridge ($23.0 \text{ mg}/\text{cm}^2$)

The gray foot plates located underneath bridge (23.0 mg/cm^2) exceeded the SCDHEC 0.7 mg/cm^2 limit for lead-based paint. Refer to **Appendix II** for photographs of the identified lead-based paint systems.

4 The felt paper beneath bent plates tested negative for asbestos via PLM and TEM analysis. The gray bent plate tested positive for lead-based paint (23.00 mg/cm²).

Painted surfaces associated with the structure exhibited detectable levels of lead and the disturbance of these materials is regulated by the OSHA regulation 29 CFR 1926.62 (Lead in Construction). The client is advised that OSHA does not recognize a threshold level of lead for definition purposes, only the presence or absence of lead. Consequently, the OSHA regulations governing worker protection for lead-based paint may apply to work practices including the disturbance of paint systems with detectable levels of lead. Destructive actions (sanding, burning, demolition, component removal, paint preparation) to the lead-containing paint surfaces will require the contractor comply with the standards of OSHA, including but not limited to initial exposure monitoring, the use of personal protective equipment, and medical surveillance.

SCDHEC Regulation 61-107.19 permits demolition materials painted with lead-based paint ($\geq 0.7 \text{ mg/cm}^2$) to be disposed in a permitted Class Two (C&D) or Class Three Subtitle D, Municipal Solid Waste (MSW) landfill.

Accumulations of paint waste (chips, dust, or flakes) must be tested by the Toxicity Characteristic Leaching Procedure (TCLP) to determine if the waste is classified as hazardous, which requires disposal in a Subtitle C (hazardous waste) landfill. Lead waste, at a minimum, must be disposed in a Class Two or Three landfill.

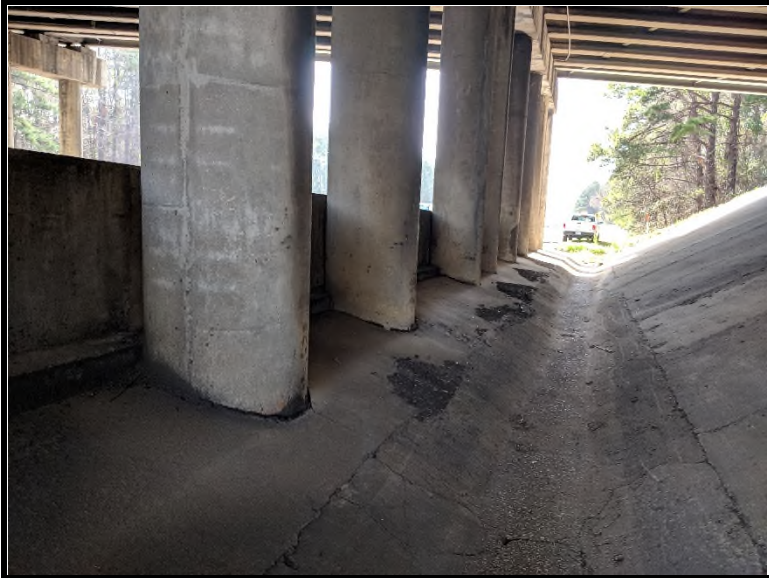
5 Expansion joint located around base of columns tested negative for asbestos via PLM and TEM analysis.

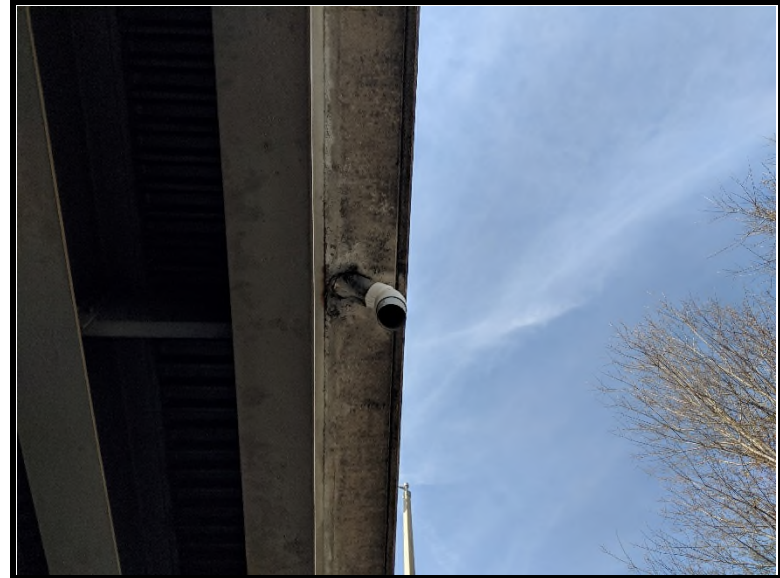
6 Non-suspect scuppers were observed during the assessment of the bridge.
