**Asbestos & Lead-Based Paint Assessment
Carolina Crossroads I-20/26/126 Project
I-26 WB Bridge over I-126
Structure No. 401002600300
Columbia, Richland County, South Carolina
S&ME Project No. 1461-16-047**

Reference: **Asbestos & Lead-Based Paint Assessment
Carolina Crossroads I-20/26/126 Project
I-26 West Bound Bridge over I-126
Structure No. 401002600300**
Columbia, Richland County, South Carolina
S&ME Project No. 1461-16-047

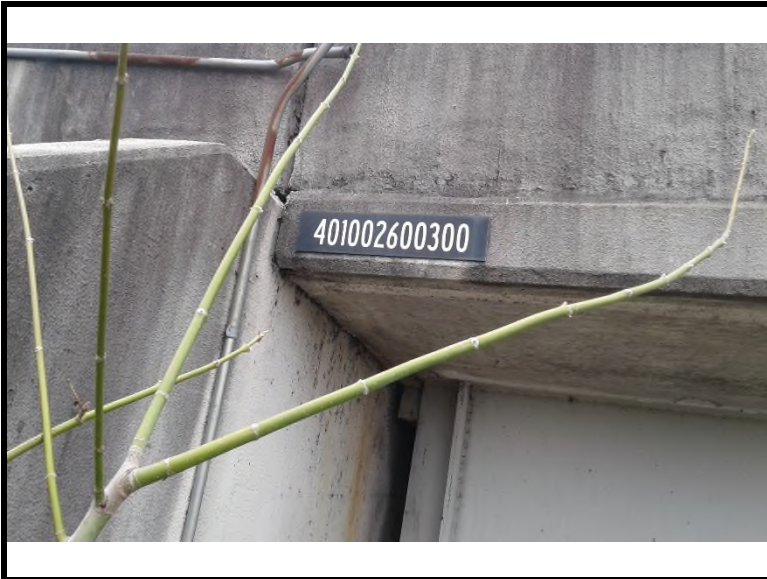
1 View of the structure number.

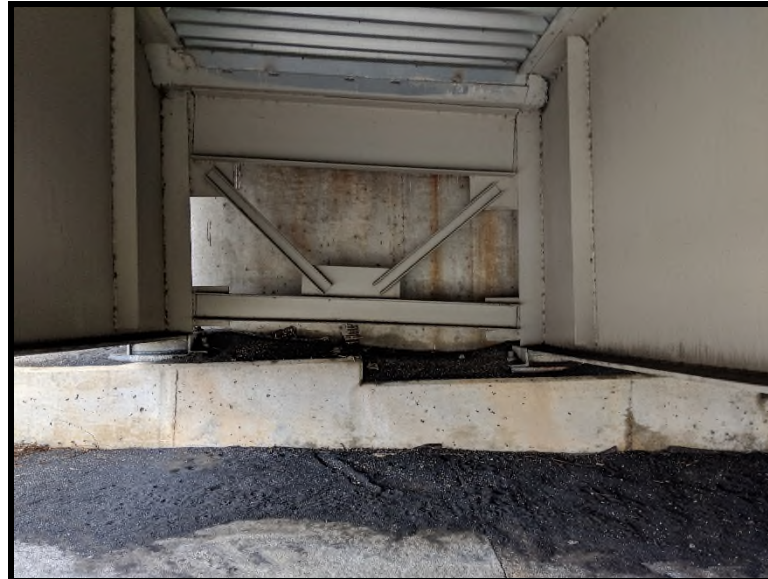
2 View of the underside of the bridge.

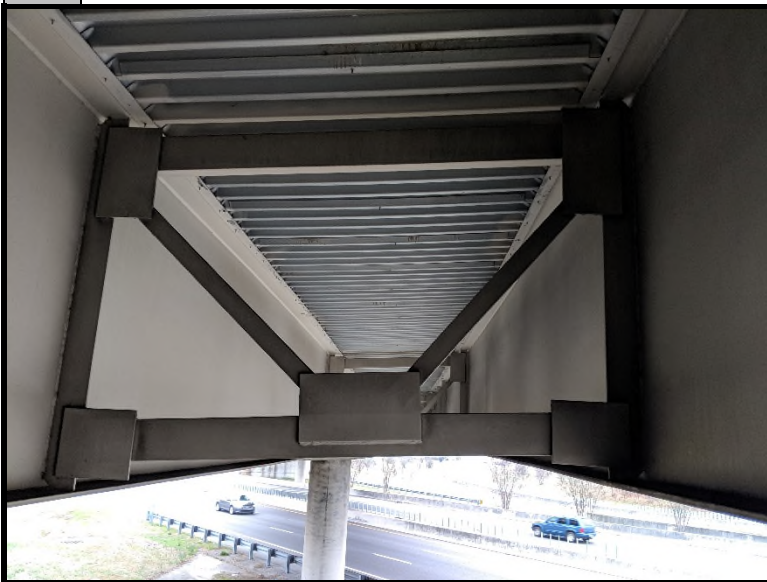
3 Additional view of the underside of the bridge.

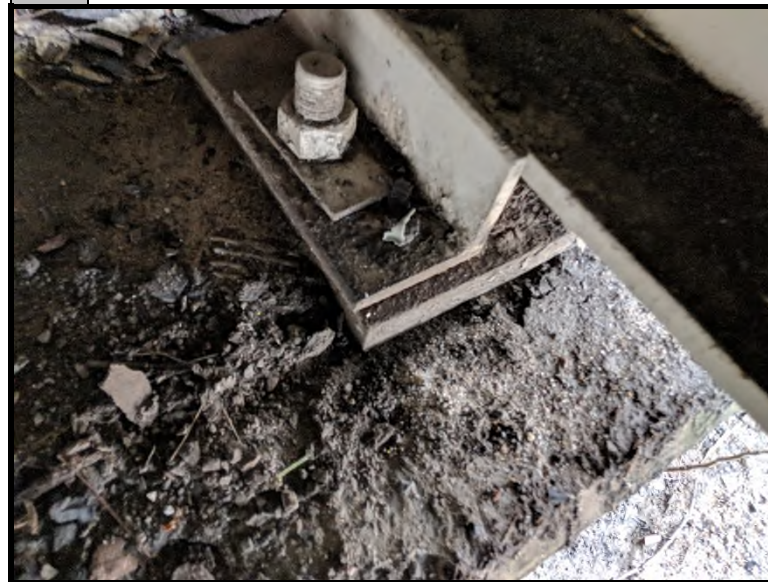
4 View of the plates located at the foot of the bridge.
