**Asbestos & Lead-Based Paint Assessment
Carolina Crossroads 1-20/26/126 Project
I-126 Westbound to I-26 Eastbound
Columbia, Richland County, South Carolina
S&ME Project No. 1461-16-047**

Inspection Dates: February 20 & 21, 2018

May 23, 2018

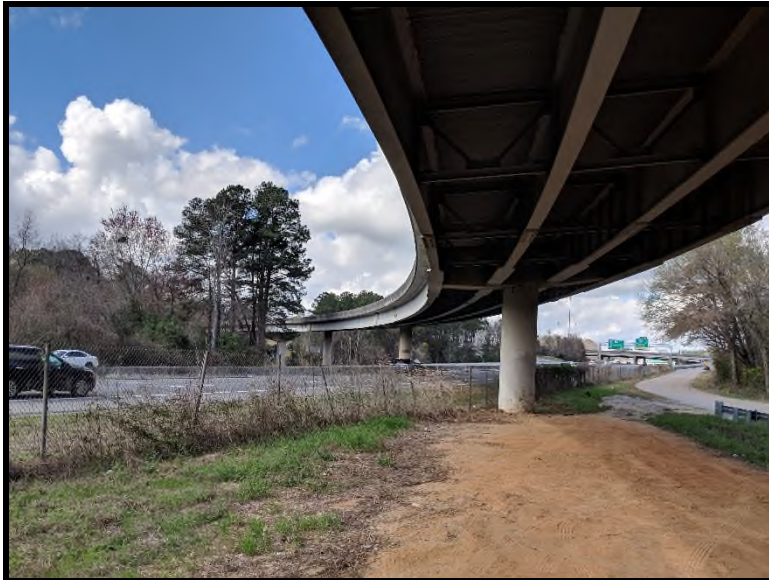
1 View of the I-126 Westbound bridge to I-26 Eastbound.

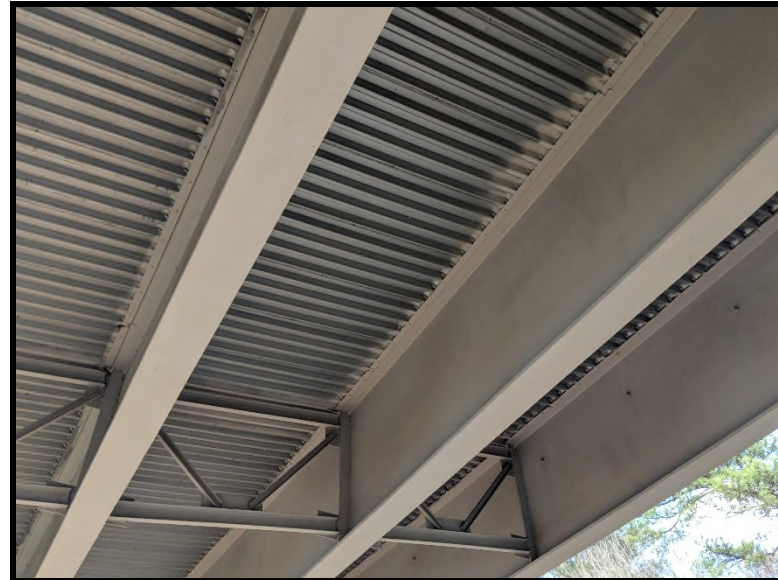
2 View of the metal deck and metal support beams.

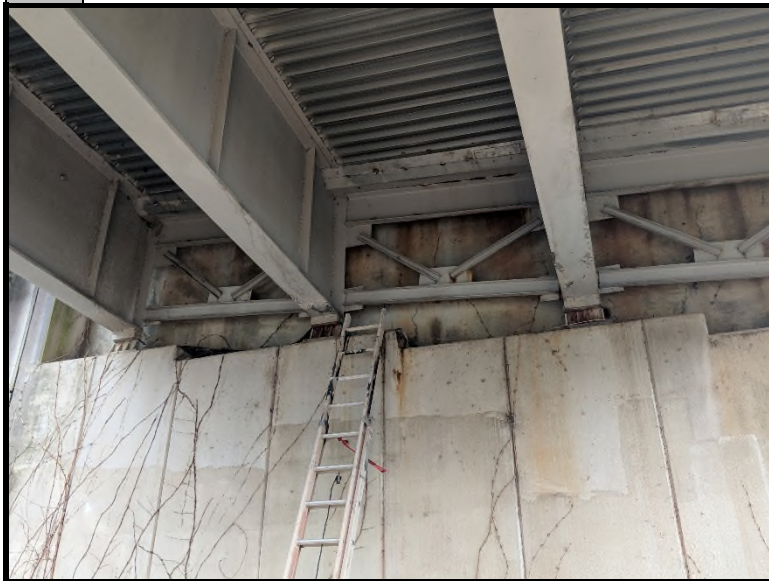
3 View of the underneath of the foot of the bridge.

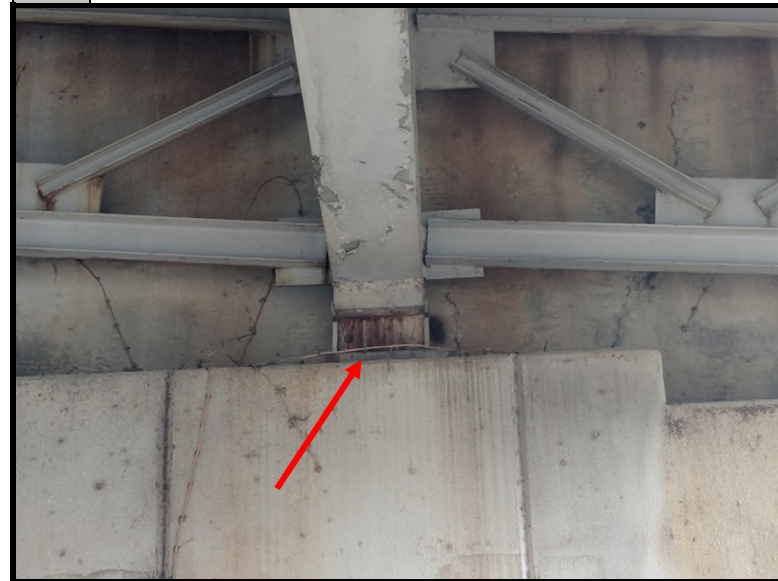
- Gray foot plates located underneath bridge ($1.70 \text{ mg}/\text{cm}^2$)

The gray foot plates located underneath bridge ($1.70 \text{ mg}/\text{cm}^2$) exceeded the SCDHEC $0.7 \text{ mg}/\text{cm}^2$ limit for lead-based paint. Refer to **Appendix II** for photographs of the identified lead-based paint systems.

4 The gray metal support plate tested positive for lead-based paint (1.70 mg/cm²).

The client is advised that OSHA does not recognize a threshold level of lead for definition purposes, only the presence or absence of lead. Consequently, the OSHA regulations governing worker protection for lead-based paint may apply to work practices including the disturbance of paint systems with detectable levels of lead. Destructive actions (sanding, burning, demolition, component removal, paint preparation) to the lead-containing paint surfaces will require the contractor comply with the standards of OSHA, including but not limited to initial exposure monitoring, the use of personal protective equipment, and medical surveillance.

SCDHEC Regulation 61-107.19 permits demolition materials painted with lead-based paint ($\geq 0.7 \text{ mg/cm}^2$) to be disposed in a permitted Class Two (C&D) or Class Three Subtitle D, Municipal Solid Waste (MSW) landfill.

Accumulations of paint waste (chips, dust, or flakes) must be tested by the Toxicity Characteristic Leaching Procedure (TCLP) to determine if the waste is classified as hazardous, which requires disposal in a Subtitle C (hazardous waste) landfill. Lead waste, at a minimum, must be disposed in a Class Two or Three landfill.

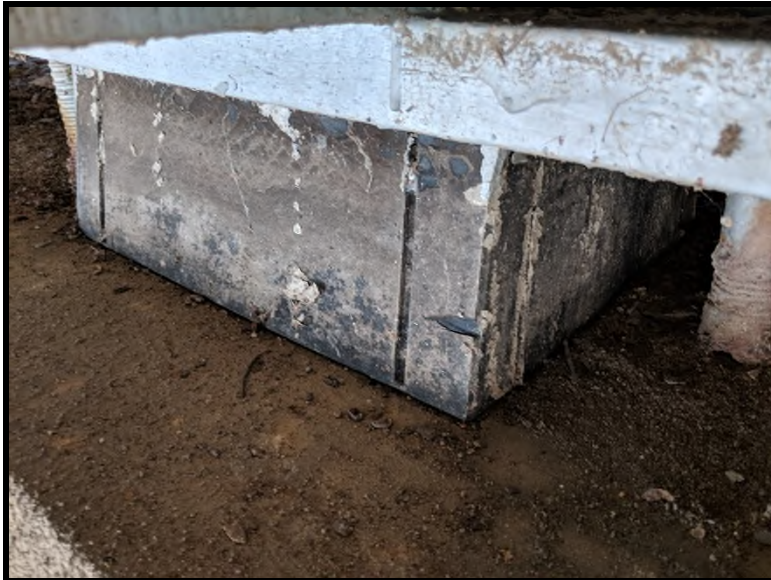
5 The rubber blocks located on the east side of the bridge were considered non-suspect material.

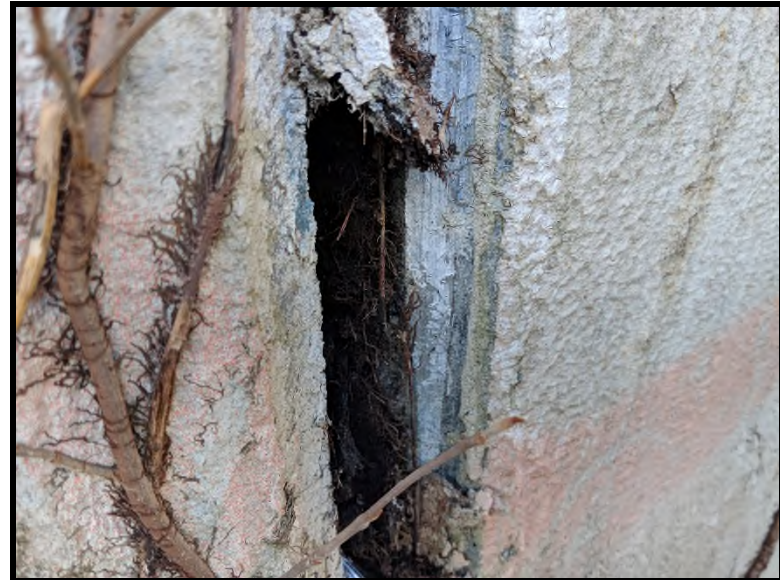
- Expansion joint material

6 The expansion joint material and textured material tested negative for asbestos.

No asbestos containing materials were identified on the structure. If additional suspect materials are discovered during future renovation or demolition activities, destructive actions to the suspect ACM should not proceed until bulk samples are collected and analyzed for asbestos content.
