**Asbestos & Lead-Based Paint Assessment
Carolina Crossroads 1-20/26/126 Project
I-26 Westbound Ramp to Bush River Road
Structure No. 401002640372
Columbia, Richland County, South Carolina
S&ME Project No. 1461-16-047**

Inspection Dates: February 20 & 21, 2018

May 21, 2018

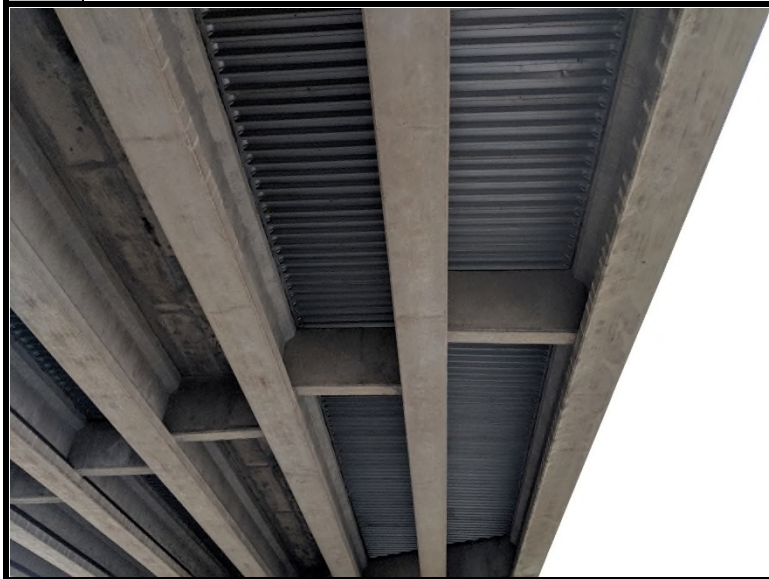
3 View of the underside of the bridge. Shows concrete beams and metal decking on the west side of the bridge.

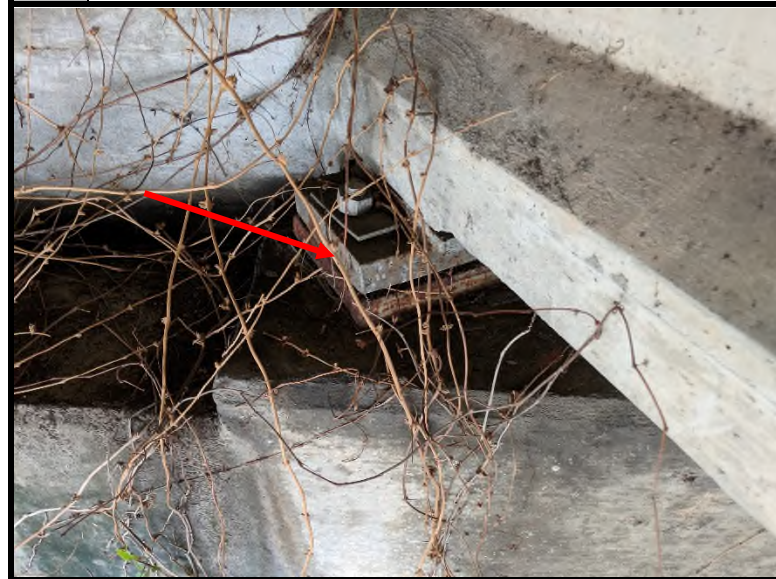
The gray foot plate located underneath bridge on the east side (23.9 mg/cm^2) exceeded the SCDHEC 0.7 mg/cm^2 limit for lead-based paint. Refer to **Appendix II** for photographs of the identified lead-based paint systems.

4 The vibration dampeners tested negative for asbestos via PLM and TEM analysis. The gray bent plate tested positive for lead-based paint (23.90 mg/cm²).

The client is advised that OSHA does not recognize a threshold level of lead for definition purposes, only the presence or absence of lead. Consequently, the OSHA regulations governing worker protection for lead-based paint may apply to work practices including the disturbance of paint systems with detectable levels of lead. Destructive actions (sanding, burning, demolition, component removal, paint preparation) to the lead-containing paint surfaces will require the contractor comply with the standards of OSHA, including but not limited to initial exposure monitoring, the use of personal protective equipment, and medical surveillance.

SCDHEC Regulation 61-107.19 permits demolition materials painted with lead-based paint ($\geq 0.7 \text{ mg/cm}^2$) to be disposed in a permitted Class Two (C&D) or Class Three Subtitle D, Municipal Solid Waste (MSW) landfill.

Accumulations of paint waste (chips, dust, or flakes) must be tested by the Toxicity Characteristic Leaching Procedure (TCLP) to determine if the waste is classified as hazardous, which requires disposal in a Subtitle C (hazardous waste) landfill. Lead waste, at a minimum, must be disposed in a Class Two or Three landfill.

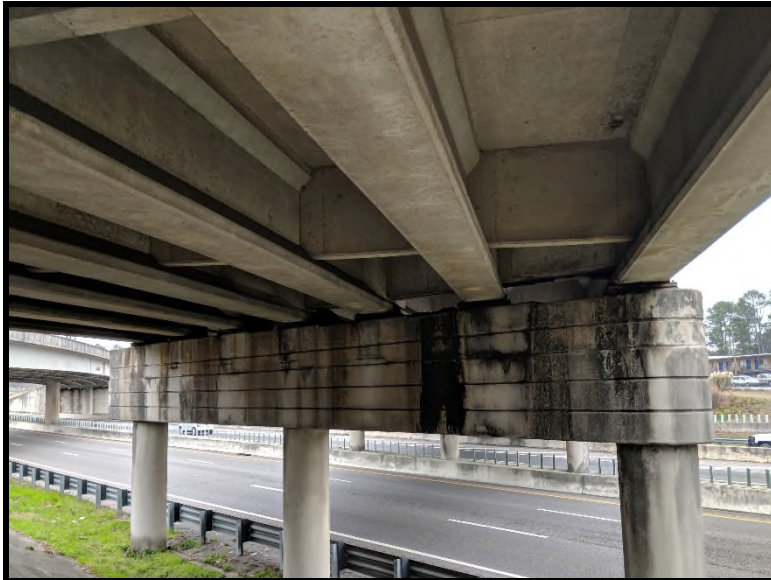
5 Tar material located on east side bents test negative for asbestos via PLM and TEM analysis.

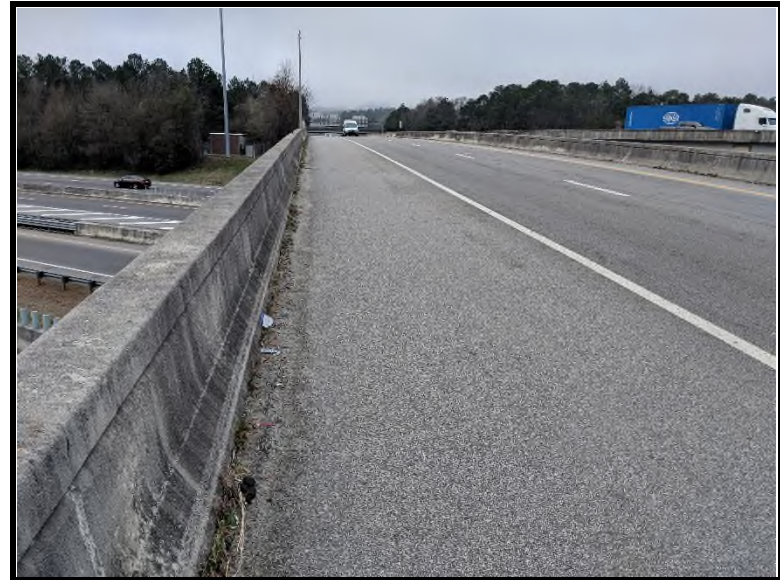
6 No scuppers were observed during the assessment of the bridge.
