LIMITED ASBESTOS AND LEAD-BASED PAINT SURVEY REPORT

S-45 Over the Little Pee Dee Swamp Bridge Replacements

Lester Road (S-45)

Issue Date: March 19, 2018

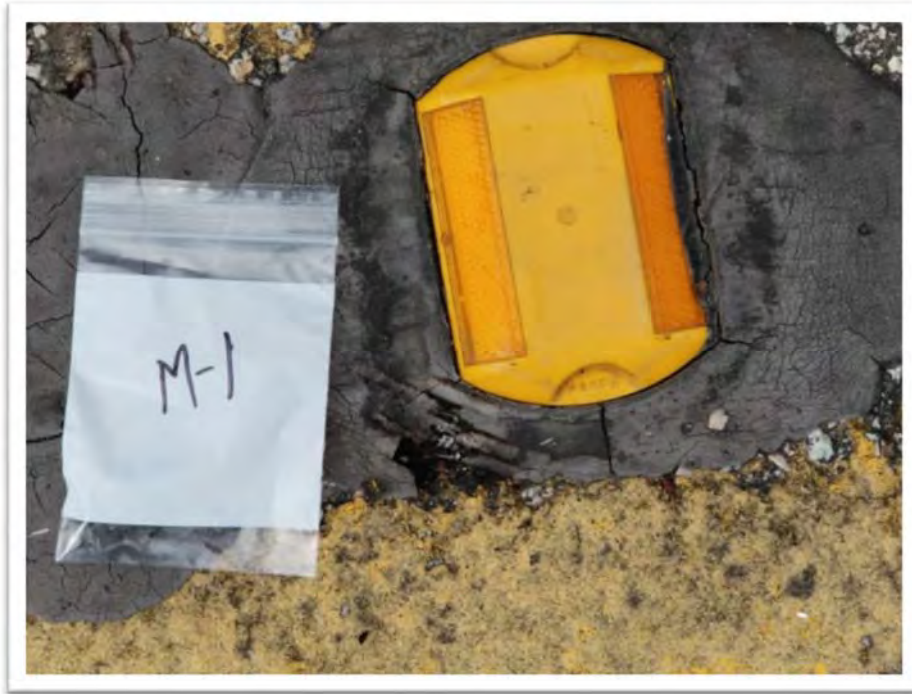
Photograph #07

View of Sample M-1 – Black Mastic Sampling Point Associated with One Observed Reflector on Bridge 2 (None Detected)

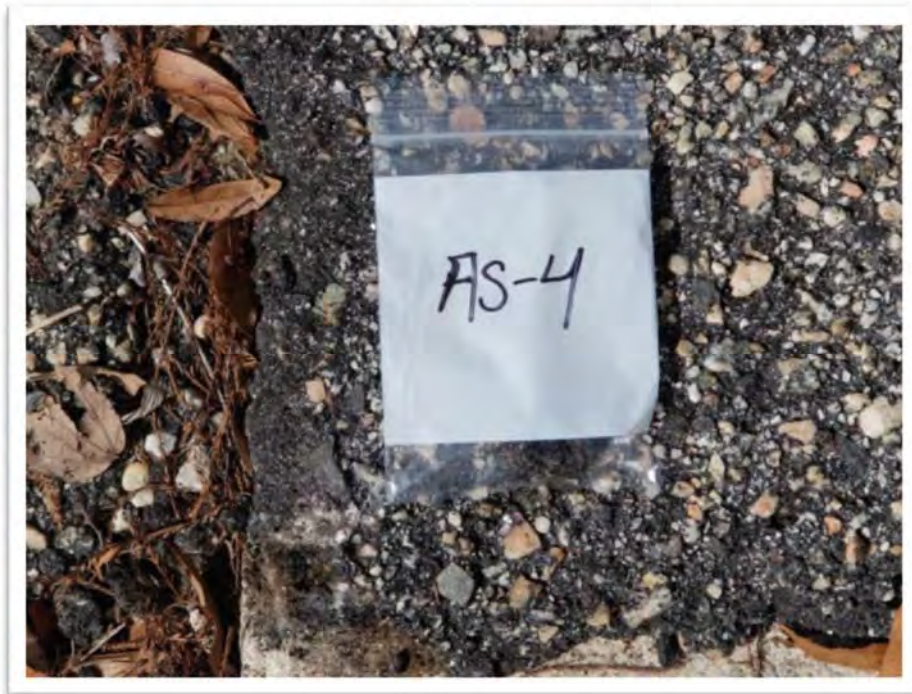
Photograph #08

View of Sample AS-4 – Asphalt Sampling Point on the Paved Roadway at the South End of Bridge 2 (None Detected)

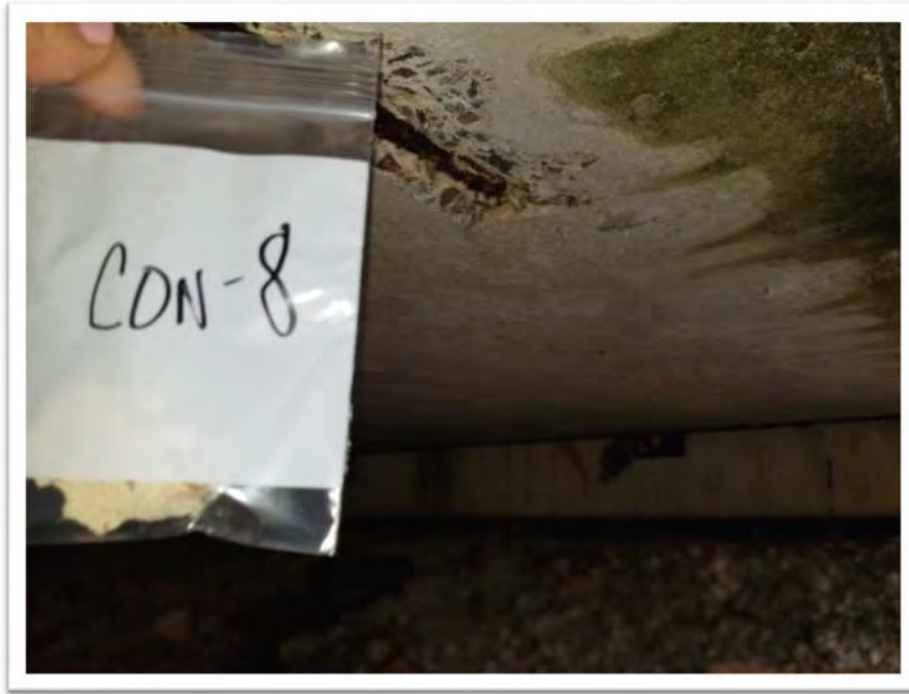
Photograph #09 View of Sample CON-8 – Concrete Sampling Point on the Underside of the Deck of Bridge 2 (None Detected)

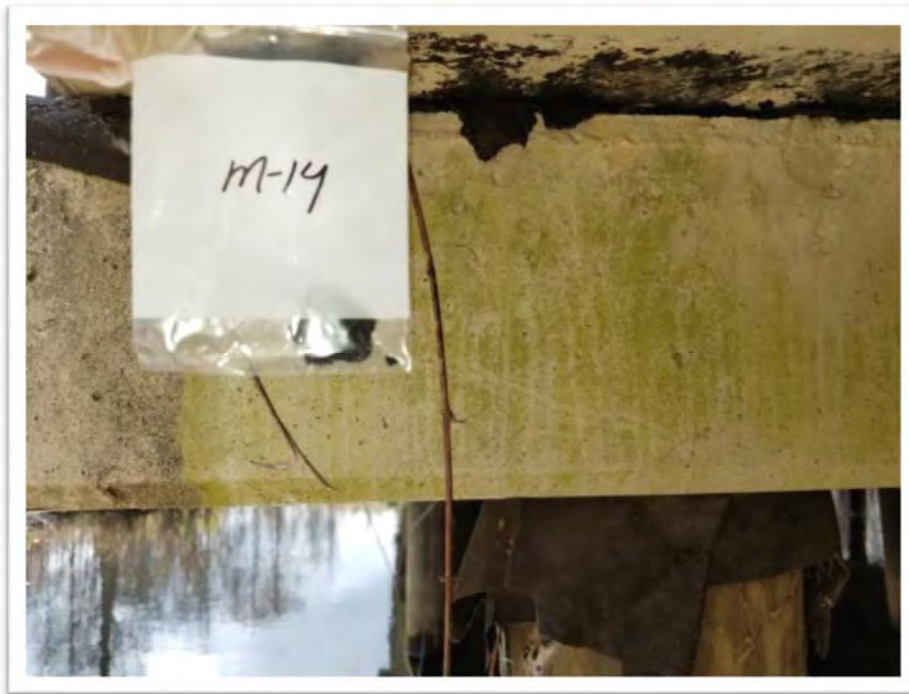
Photograph #10 Sample M-14– Black Mastic Sampling Point Between Concrete Beams and the Black Bearing Pad on the Underside of the Deck on Bridge 2 (None Detected)

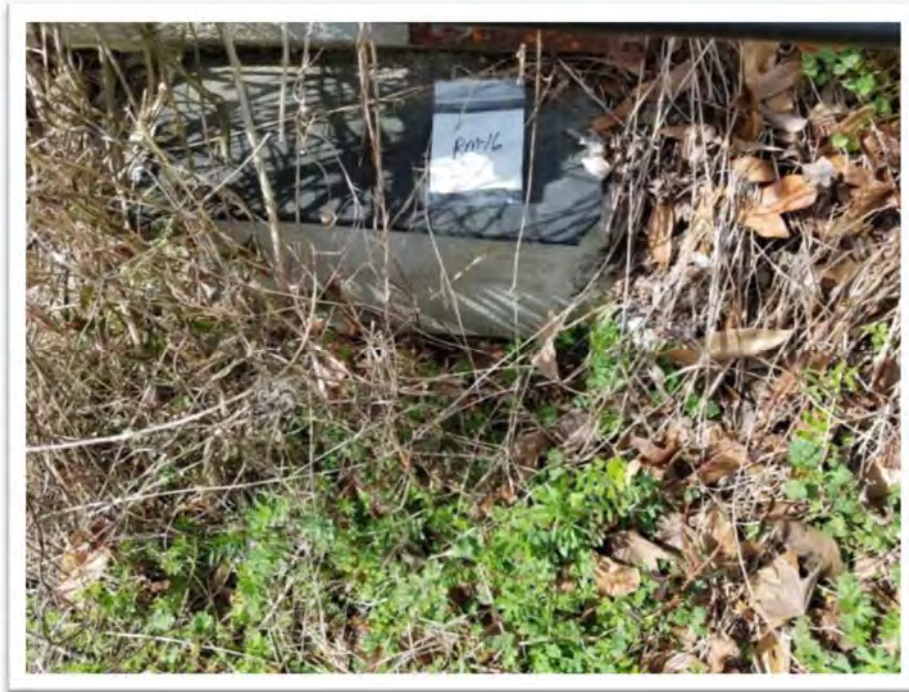
Photograph #11 Sample BM-16 – Black Bearing Pad Sampling Point Between the Deck of Bridge 2 and the Abutment at the North End of the Bridge, East Side (None Detected)

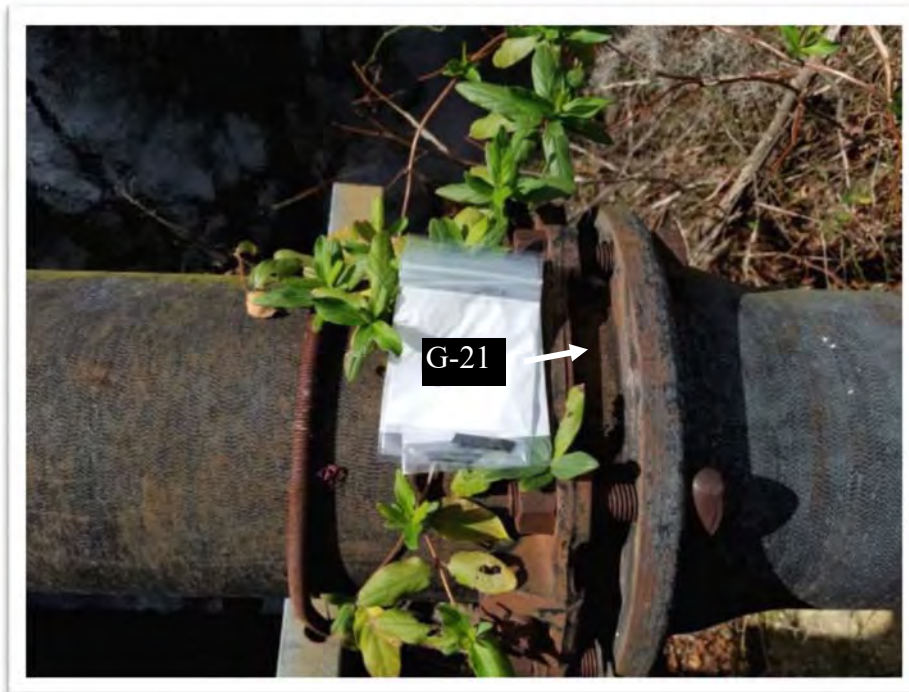
Photograph #12 Sample G-21 – Rubber Gasket Sampling Point on the Water Line Parallel to the West Side of Bridge 2 (None Detected)

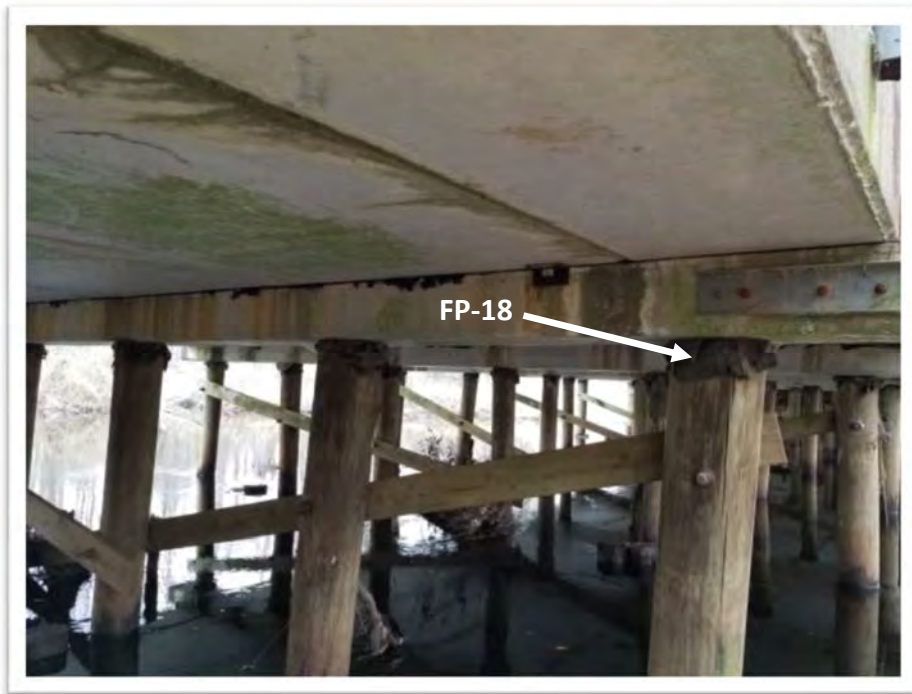
Photograph #14 Sample FP-18 – Felt Paper Sampling Point Located Between Wood Bent and Concrete Beam on Bridge 2 (None Detected)

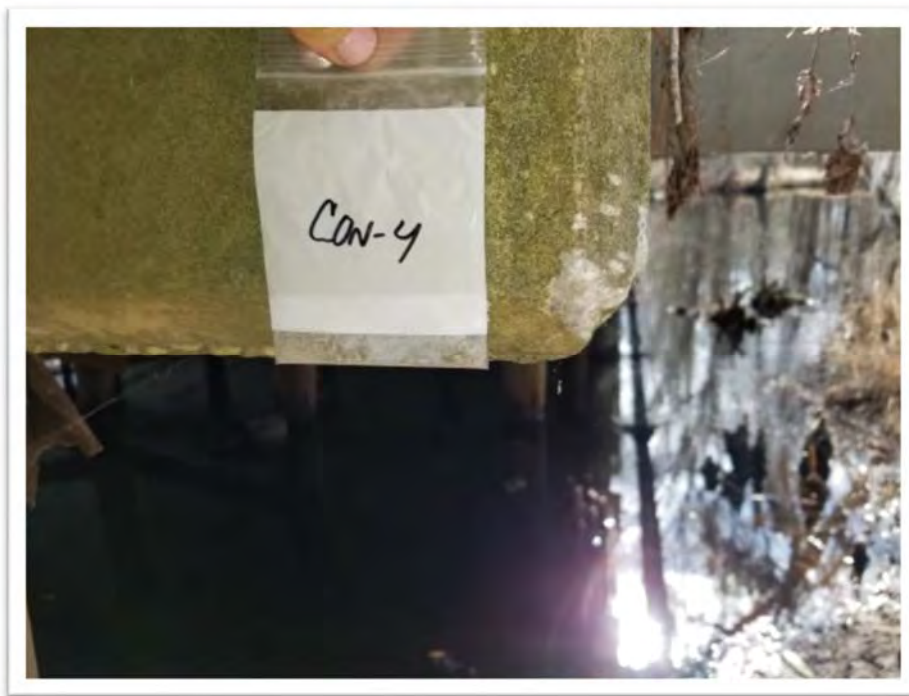
Photograph #20 Sample CON-4 – View of Concrete Sampling Point on a Beam on the Underside of Bridge 3 (None Detected)

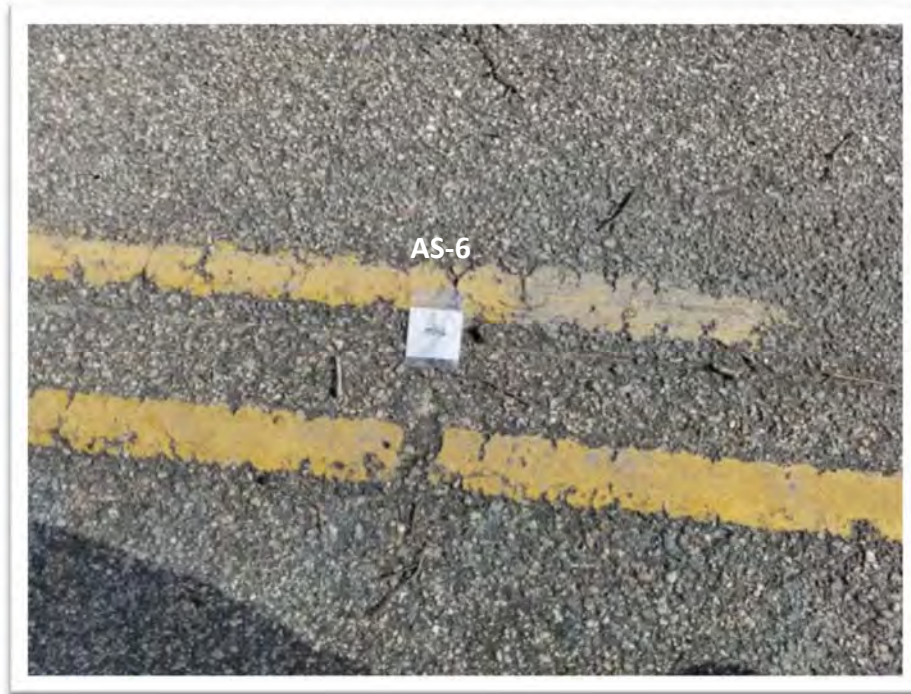
Photograph #21 Sample AS-6 – Asphalt Sampling Point on the Southwest End of Bridge 3
(None Detected)

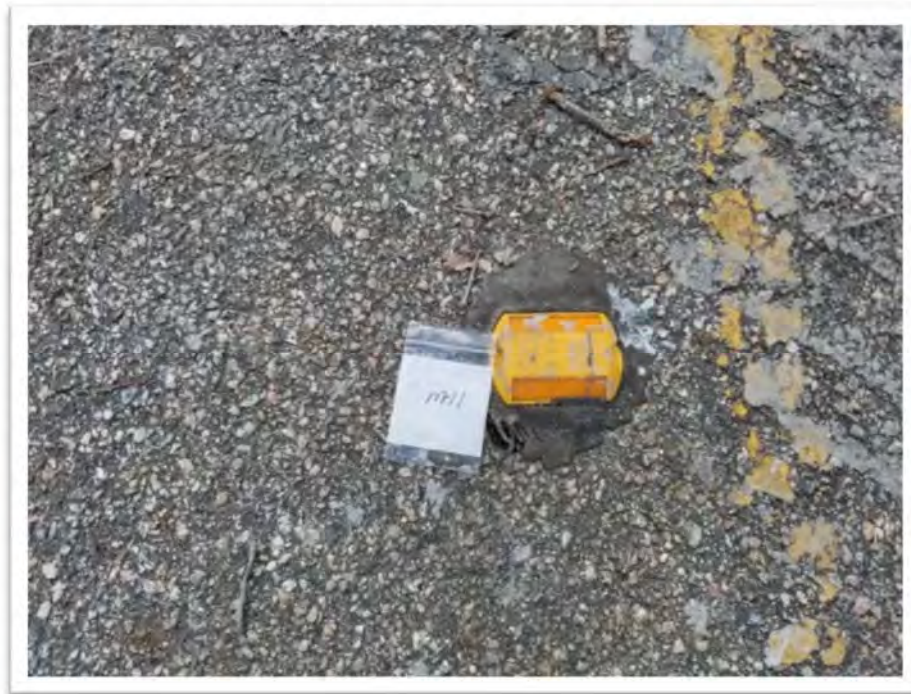
Photograph #22 Sample M-11 – Black Mastic Sampling Point at a Reflector on the Roadway of
Bridge 3 (None Detected)

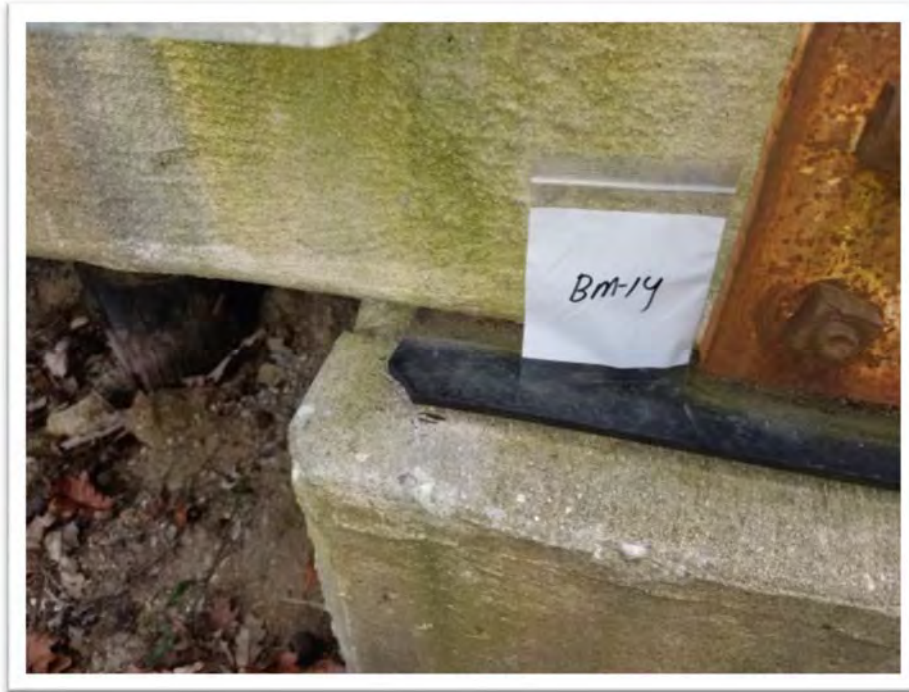
Photograph #23 Sample BM-14 – Black Bearing Pad Sampling Point Between the Deck of Bridge 2 and the Abutment at the Northeast End of the Bridge (None Detected)

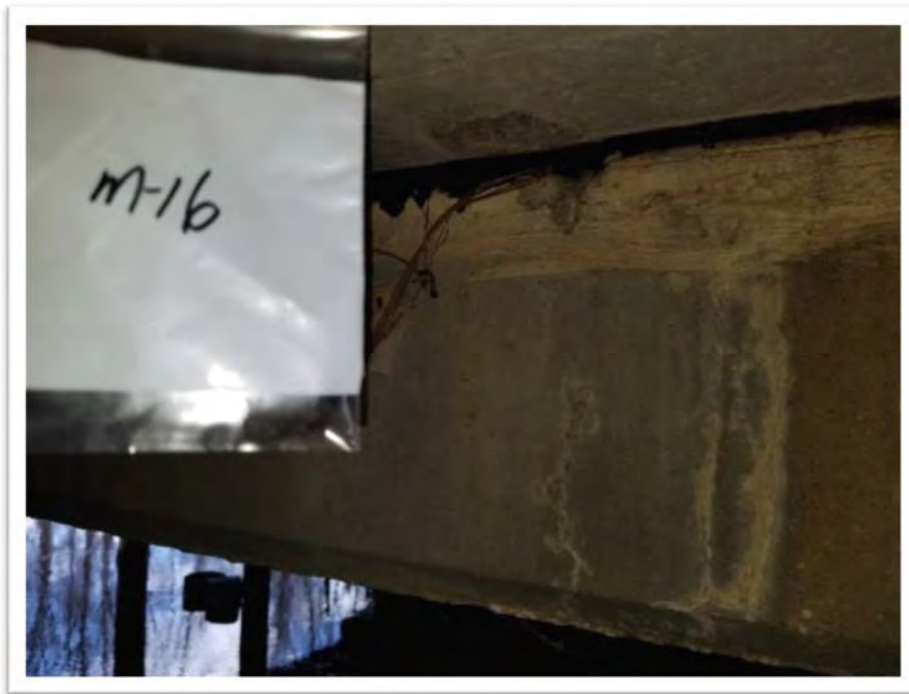
Photograph #24 Sample M-16 – Black Mastic Sampling Point Between Concrete Beams and the Black Bearing Pad on the Underside of the Deck on Bridge 2 (None Detected)

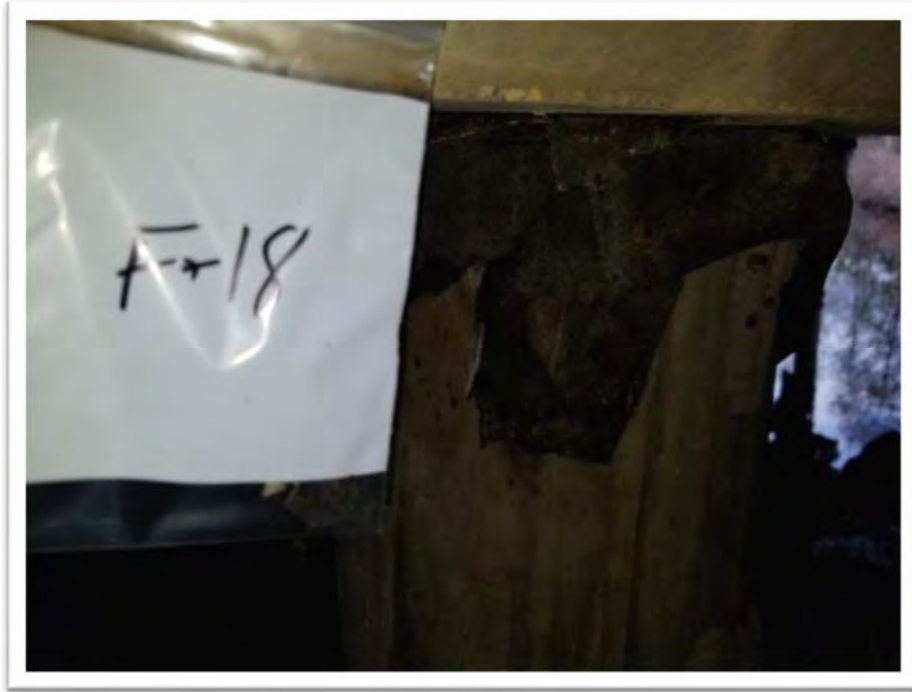
Photograph #25 Sample F-18 – Felt Paper Sampling Point Located Between Wood Piers and Concrete Beams on Bridge 3 (None Detected)

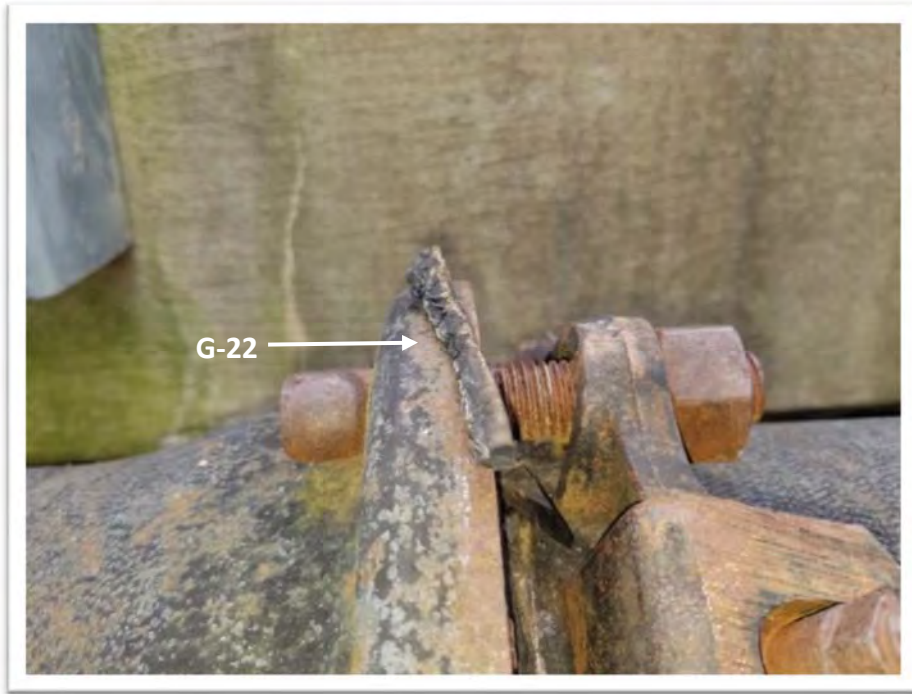
Photograph #26 Sample G-22 – Gasket Sampling Point on the Water Line Parallel to the West Side of Bridge 3 (None Detected)
