I-77 Interchange Exit 26 and Connection Roads
Project ID Number: P042443
Richland County

Proposed Repair Details & Quantities
I-77 Over US-21
Asset ID: 6917 & 6918

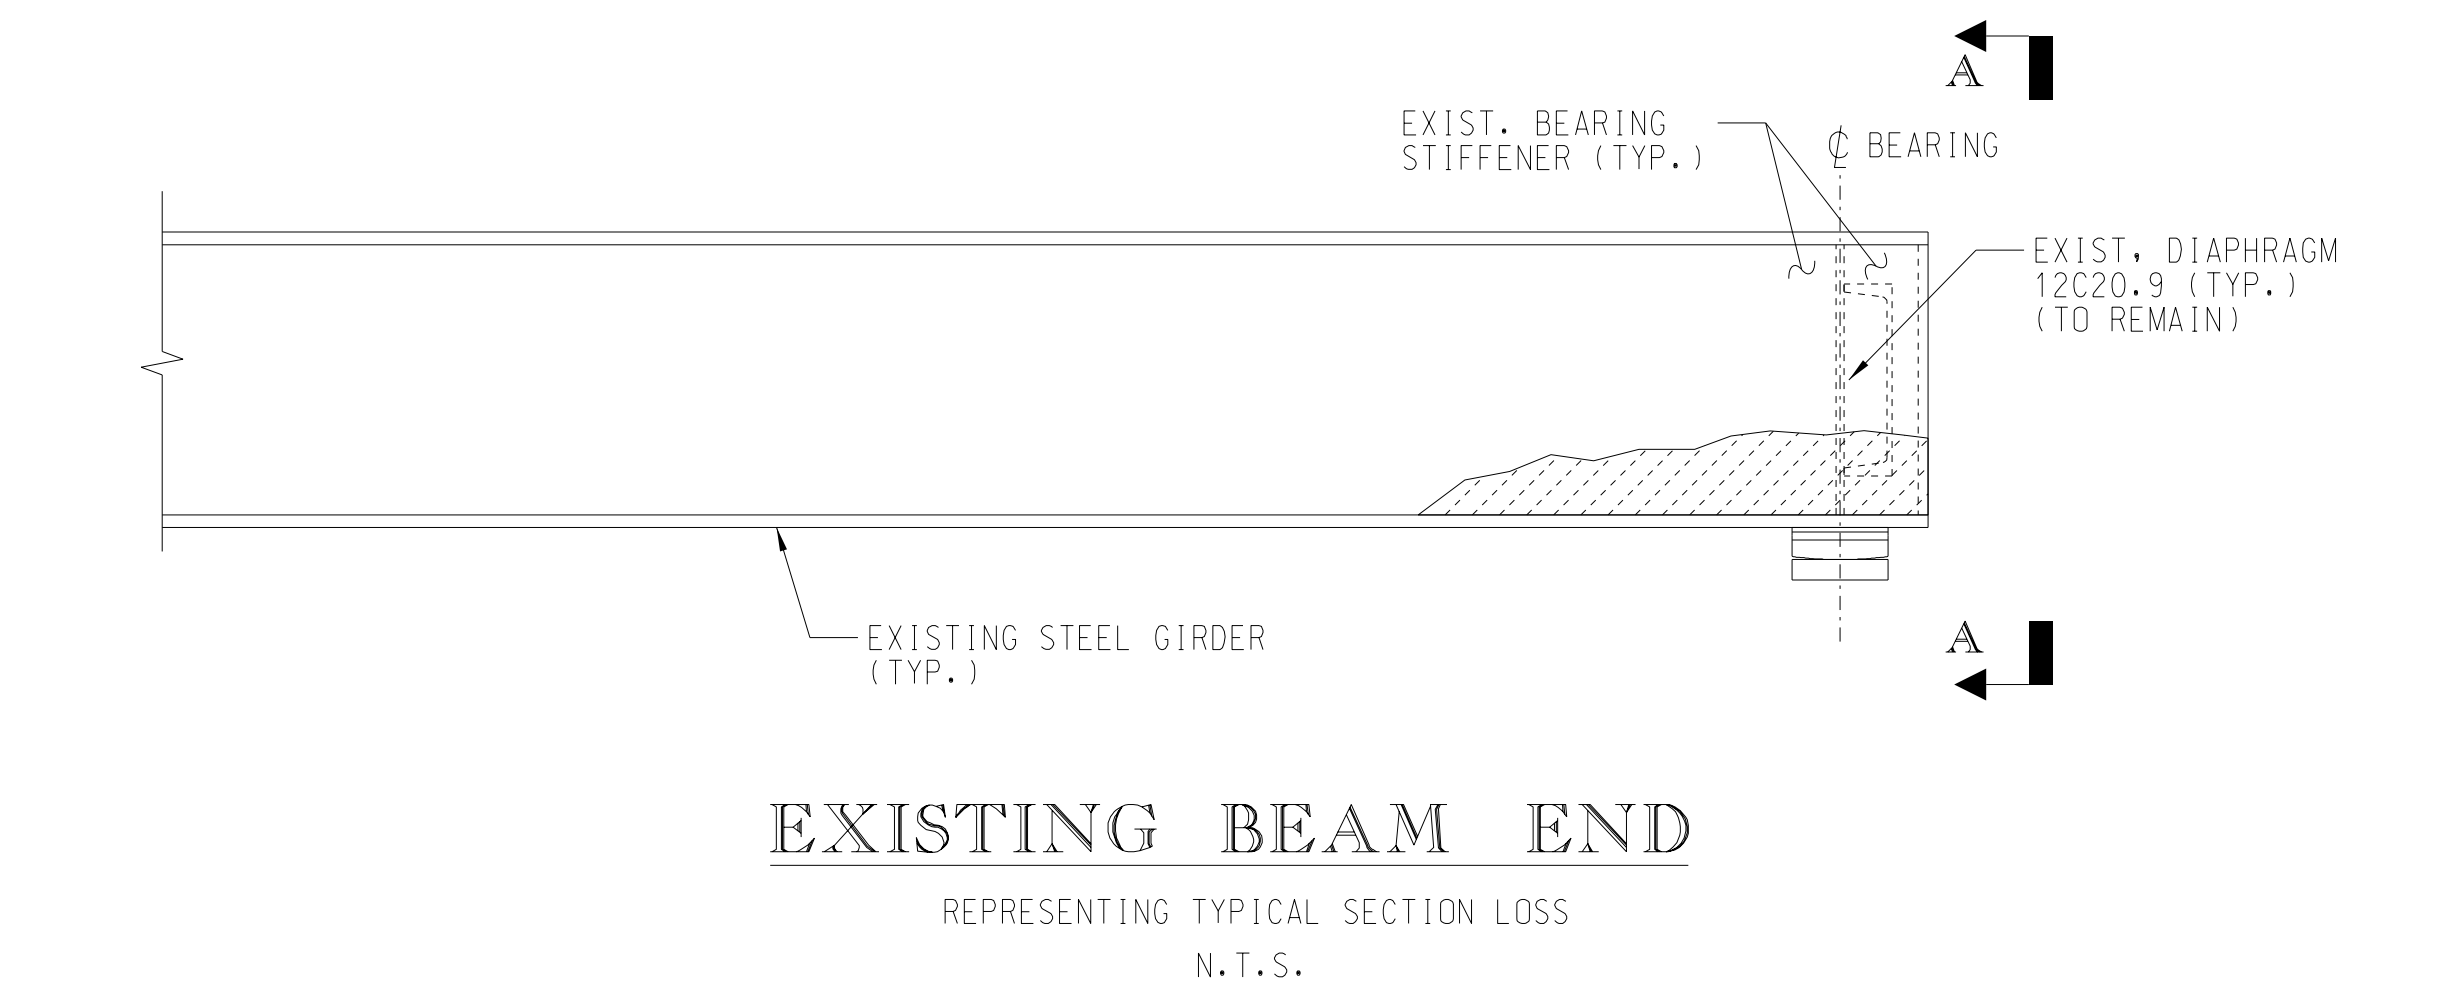
EXISTING BEAM END
REPRESENTING TYPICAL SECTION LOSS
N.T.S.

Beam end repairs shall be performed in all beams where section loss at the ends of the beams is in excess of 1/8", excessive pitting is occurring on the web or bottom flange or pack rust is occurring with the bottom flange and the existing bearing assembly. Obtain section loss measurements at all beam ends during the required inspection and report latest section loss values in the bridge rehabilitation plans.

Example steel girder end repair details have been provided in Appendix C. Final details shall be prepared and incorporated into the bridge rehabilitation plans. Web and bottom-flange repair plates shall be 1/2" thick. Provide flange repair plates on the top of the existing bottom flange and the plate width shall be sufficient to match the outside edge of the existing bottom flange. Flange and web repair plate length shall be, at a minimum: 2'-0" longer than the area of section loss where section remaining is less than 75% of the original section or 6-feet, whichever is greater. Repair plates shall be at a minimum 8" in height and top row of bolts shall be 2" minimum above the area

of section loss where section remaining is less than 75% of the original section. Bolt repair plates through the web and through the bottom flange using 7/8" diameter bolts. Use a minimum of three (3) horizontal rows of bolts through the web with bolts spaced at 6-inches in each row. Use one (1) row of bolts through the bottom flange on both sides of the web with bolts spaced at 6-inches in each row.
