Reference: Lead-based Paint Assessment Report
Exit 218 Spruill Avenue On and Off-ramp
Structure# 101002600991
North Charleston, South Carolina
S&ME Project No. 1413-15-075

LEAD-BASED PAINT ASSESSMENT REPORT
EXIT 218 SPRUILL AVENUE ON AND OFF-RAMP
STRUCTURE# 101002600991
NORTH CHARLESTON, SOUTH CAROLINA
S&ME Project No. 1413-15-075

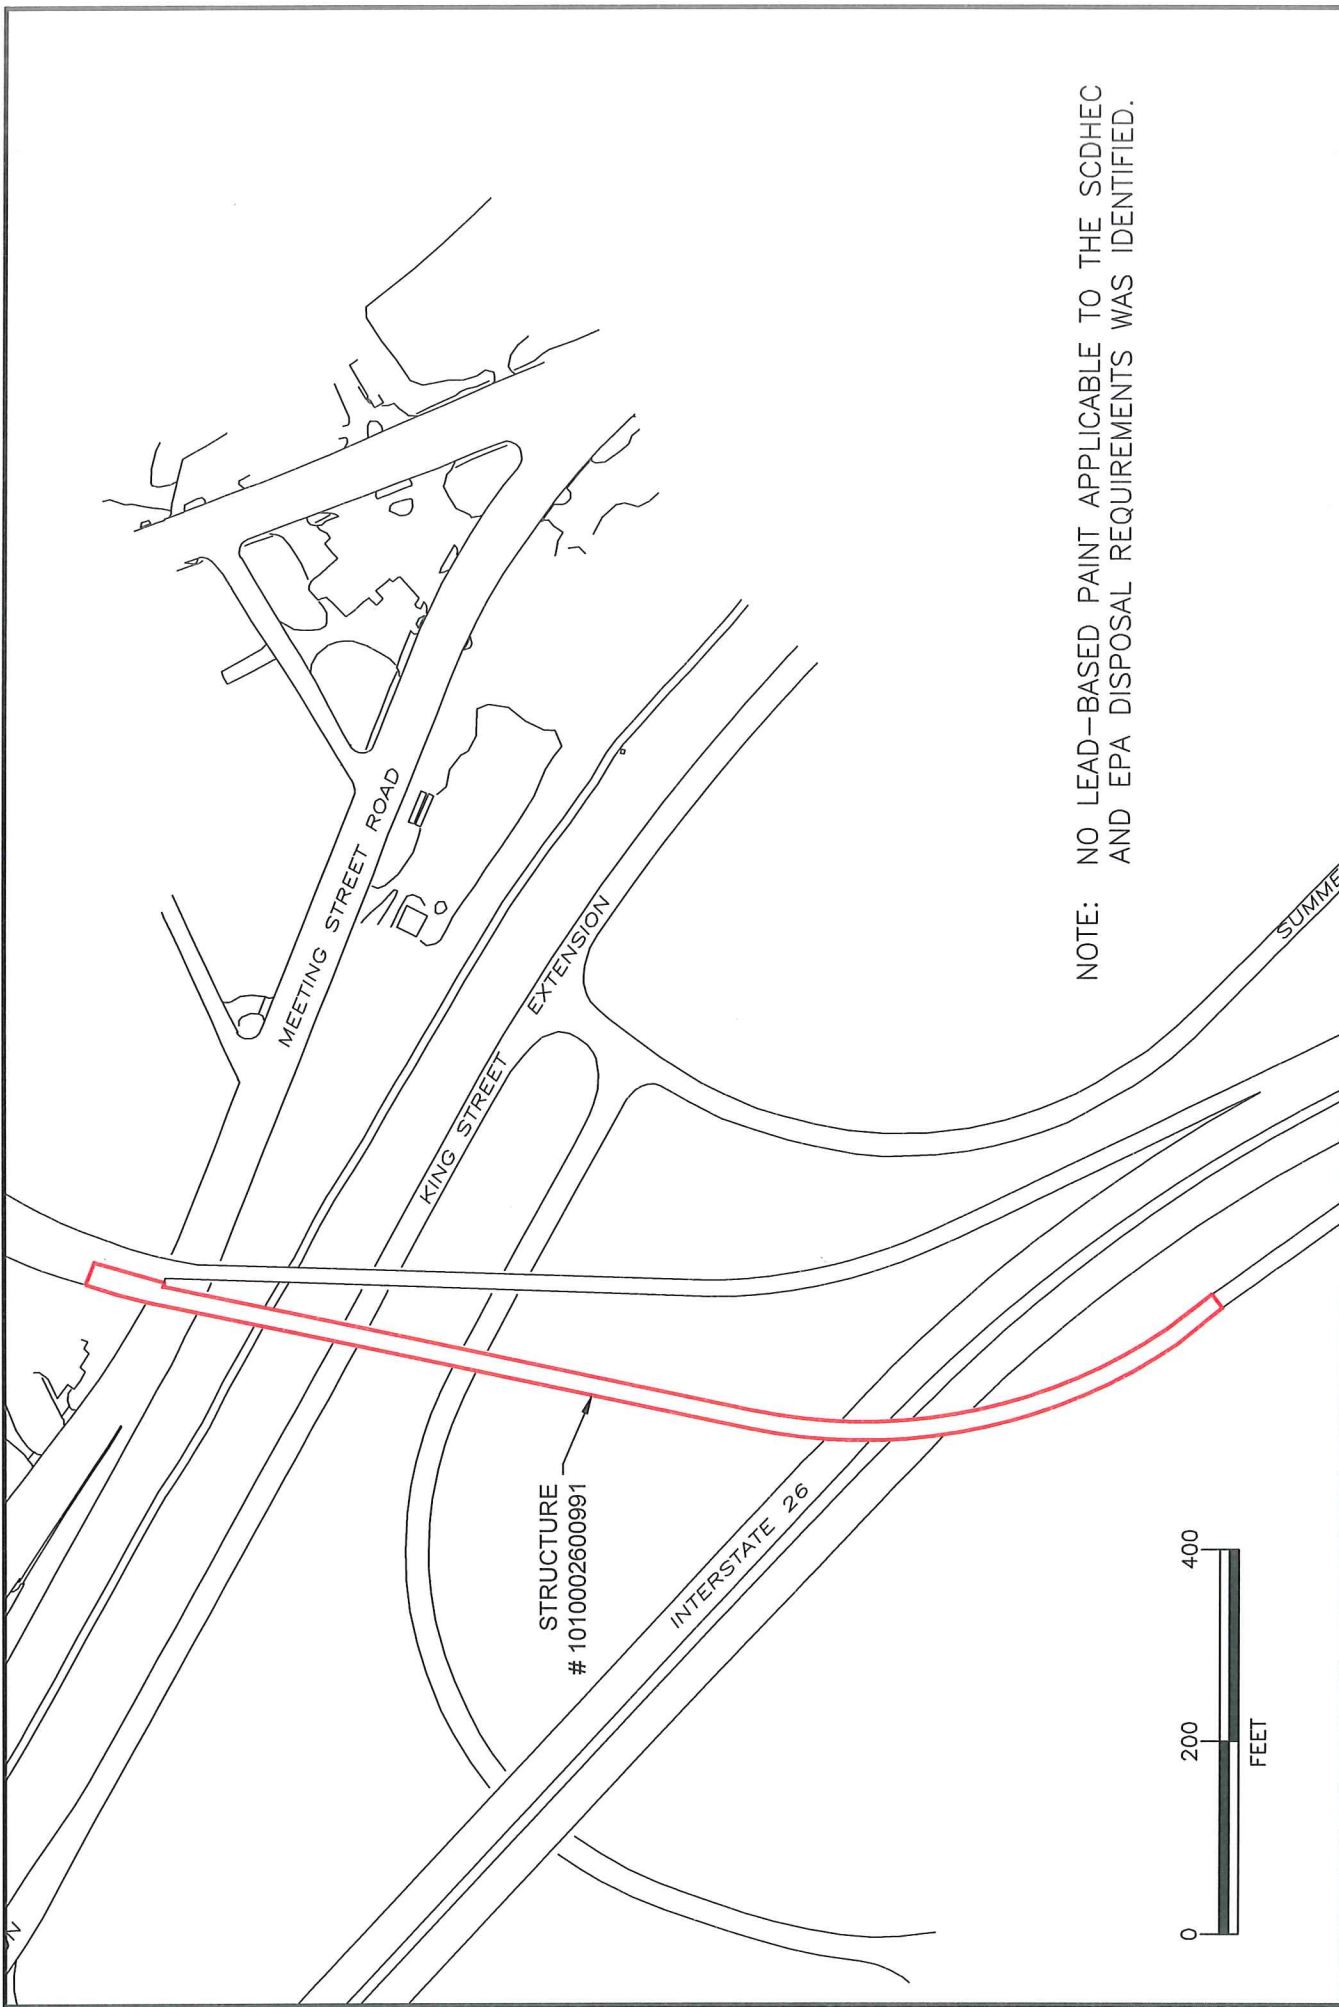
FIGURE NO.

NOTE: NO LEAD-BASED PAINT APPLICABLE TO THE SCDHEC AND EPA DISPOSAL REQUIREMENTS WAS IDENTIFIED.

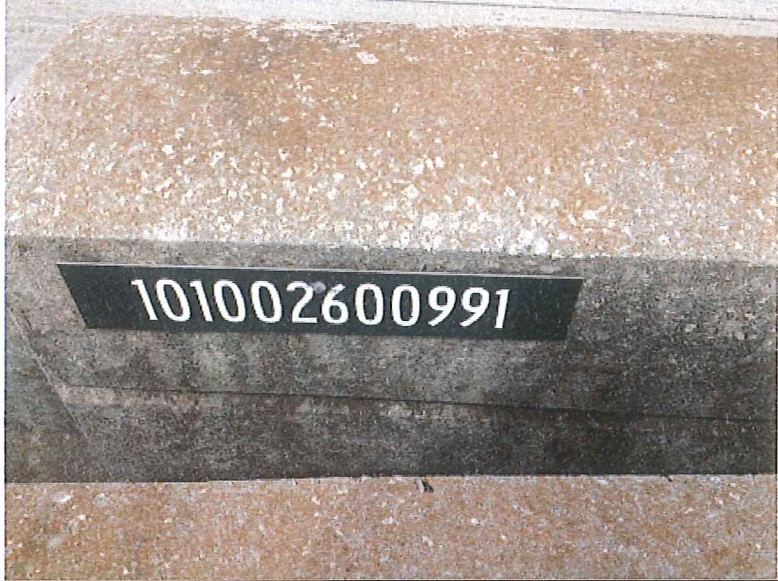
Photo 1

Date: 07-09-15	
Photographer: Seaborn	
Location/Orientation	ID label on exit ramp
Remarks
