# ASBESTOS CONTAINING MATERIAL INVESTIGATION REPORT

**I-26 BRIDGE OVER THE SALUDA RIVER  
RICHLAND/LEXINGTON COUNTY,  
SOUTH CAROLINA**

**February 27, 2019**

F&ME Project No.: G5662.010

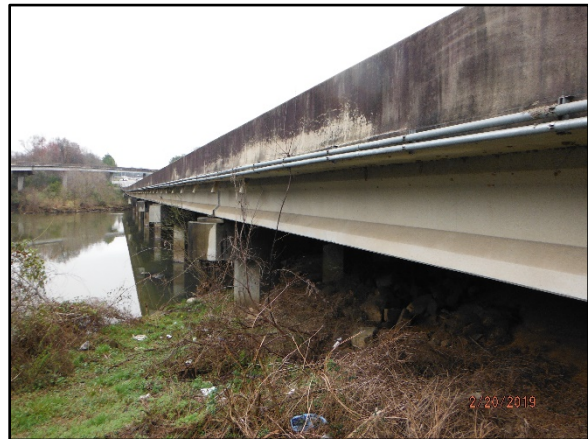
The existing bridge structure (~705.0'L x 116.0'W, inside curb to inside curb), is located on I-26 in Richland/Lexington County, South Carolina. The actual date of construction for the original bridge structure is unknown. The bridge was widened from it's original construction in the late 1980's. The structure is a six (6) lane bridge constructed with a poured-in-place concrete bridge deck, with concrete curb and gutters and consists of nine (9) bridge deck spans. The original bridge deck spans are supported by five (5) precast horizontal concrete beams and concrete diaphragms supported by concrete piers and poured in place concrete bent caps. The widened section of the bridge is supported by three (3) horizontal beams and concrete diaphragms supported by concrete piers. End bents are constructed with vertical concrete walls and wing walls and have soil and concrete covering the piles with only the top of the concrete bent cap exposed. Galvanized guardrails and posts are attached to both ends of the bridge structure. The bridge approach from both sides of the bridge consist of a six-lane asphalt paved roadway. Multiple communications and

*Photo 1 – I-26 Bridge over Saluda River in Richland/Lexington County, SC.*

utility lines were noted for communication lines attached to the underside of the bridge deck, along with six (6) 4" Transite Conduits.

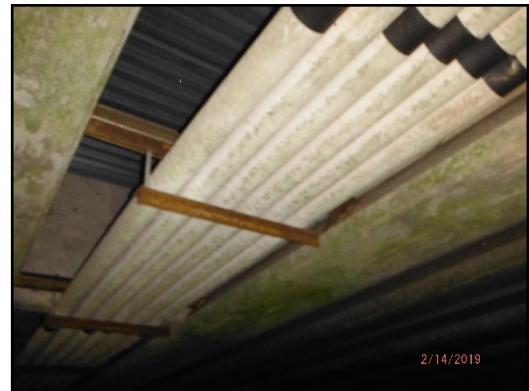
**HA-1 – Transite Communications Conduit (~4,230 LF).** ACM Transite conduit was found attached to the underside of the center section of the bridge. There are six (6) 4” conduit lines running the full length of the bridge. Overall, this material was intact with localized damage at the bents and one (1) broken section of conduit. At the end bents where the lines terminate, the material is in a friable condition and on the ground. Removal of these conduit lines may render the material friable depending on the means and methods utilized. This material must be abated prior to the start of demolition activities by a licensed abatement contractor.

It is our understanding that the existing bridge structure will to be demolished as part of the Carolina Crossroads Project. Prior demolition activities, the Transite conduit found attached to the underside of the bridge structure must be removed, handled and disposed of per SCDHEC regulations pertaining to asbestos waste. Removal of these types of bridge components (i.e. Transite Conduit Piping) prior to demolition activities is practical, and will require coordination with a licensed abatement contractor. Based on the quantities and type of ACM identified, a written abatement project design will not be required if non-friable abatement methods are utilized. However, if it is determined that the Transite conduit can only be removed by friable methods, an abatement design by certified Abatement Project Designer prior to the commencement of abatement activities may be required.

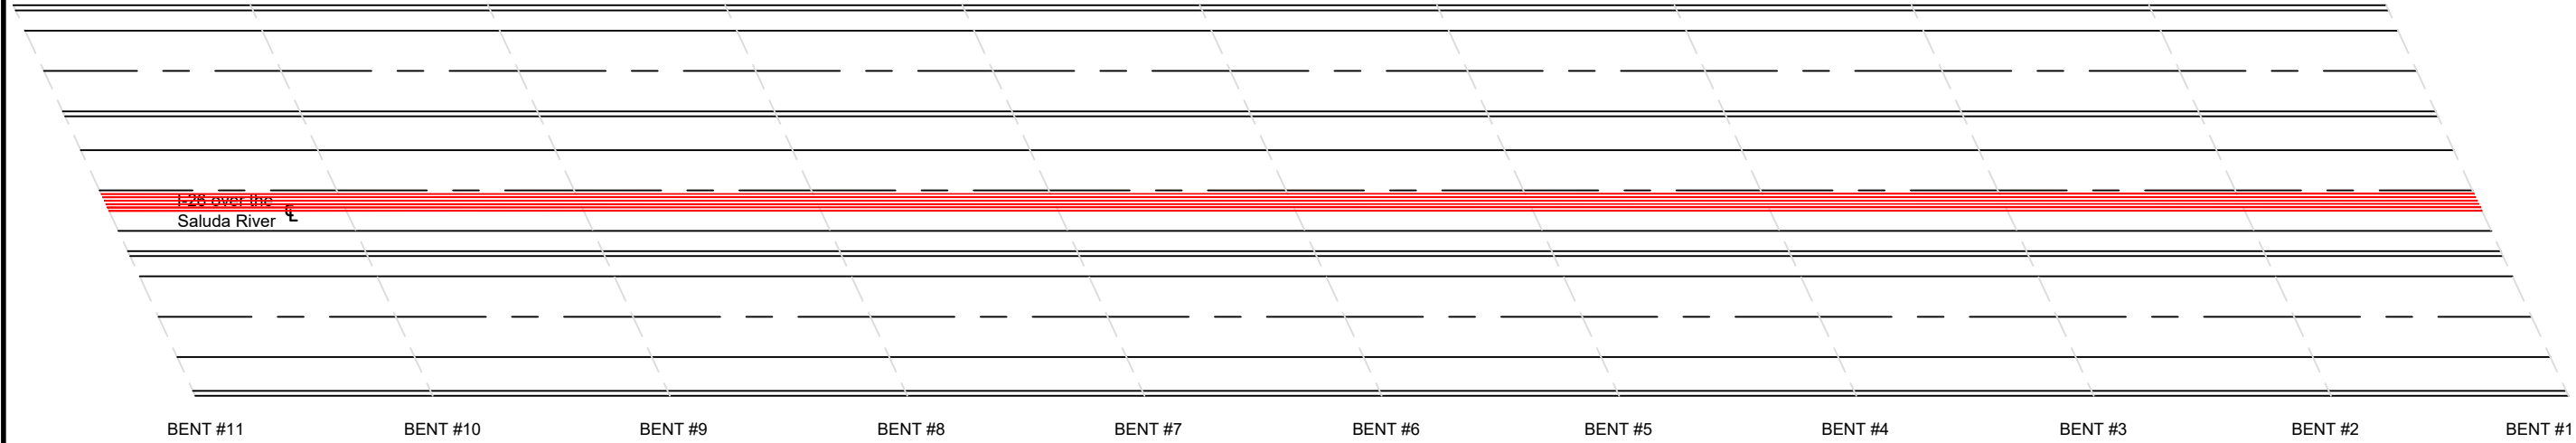
FIGURE NUMBER:  
**3**

HA-1 - Transite Conduit

**ASBESTOS CONTAINING MATERIALS  
INVESTIGATION**  
**I-26 over the Saluda River**  
Richland County, SC  
**Homogeneous Area Plan**  
Prepared for: HDR, Inc.  
3955 Faber Place Drive, Suite 300  
North Charleston, SC 29405

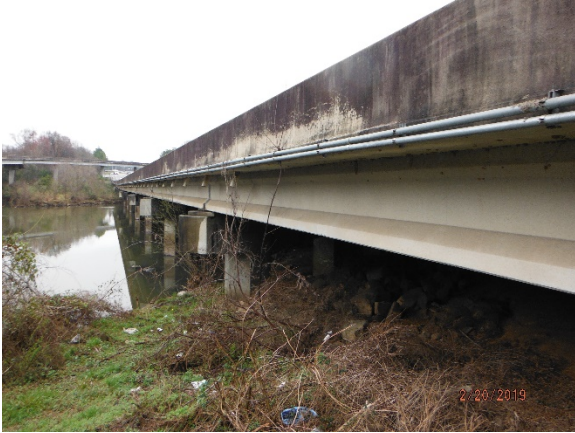
Photo 1. East Side View of Bridge.

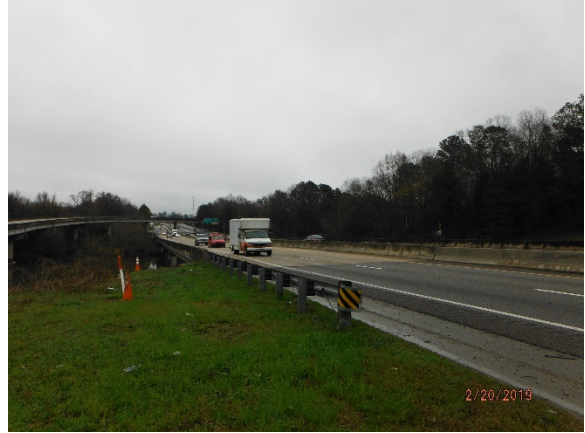
Photo 2. Top of Bridge Deck View.

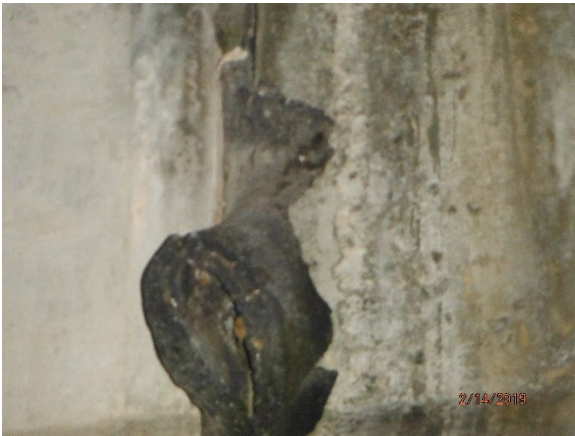
Photo 3. Expansion Joint Board

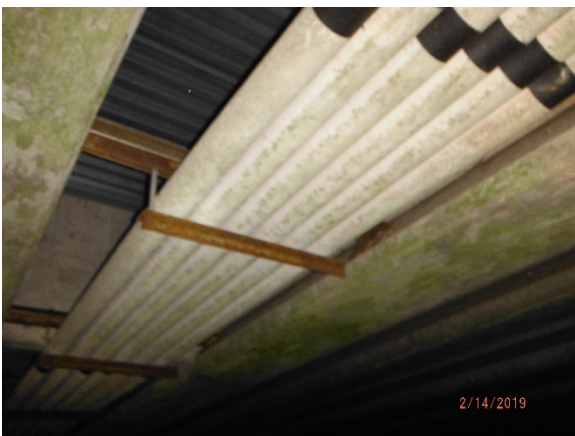
ACM Transite conduit was found attached to the underside of the center section of the bridge. There are six (6) 4" conduit lines running the full length of the bridge. Overall, this material was intact with localized damage at the bents and one (1) broken section of conduit. At the end bents where the lines terminate, the material is in a friable condition and on the ground.

Photo 5. Transite Conduit
