BASIS OF DESIGN EXCEPTION

County: Spartanburg & Cherokee Rd./Route: Interstate 85 Const. Pin: P027114

Accident Analysis Report

**I-85 Widening Project MM 80 to MM 96
Spartanburg and Cherokee Counties, SC**

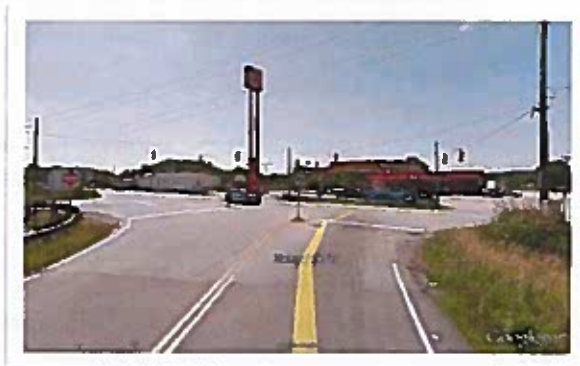
Photo: SC 18 at Hampshire Drive

were angle or sideswipe. Most crashes were classified as property damage only; however, two angle crashes on SC 18 between Hampshire Drive and the S-82 overpass were classified as incapacitating crashes (INJ3). This photo shows the approach to SC 18 from Hampshire Drive. As can be seen, this intersection is a nonstandard four-leg intersection with driveways that form two additional entry points to the intersection. The redesign of the SC 18 corridor including this intersection along with the intersections at Fatz Drive and Matthew Road would improve operations in this area.
