**Reference: Asbestos Assessment Report**  
Exit 217 North Meeting Street On and Off-ramps  
Structure# 101002600891 and 102005200191  
North Charleston, South Carolina  
S&ME Project No. 1413-15-075

**ASBESTOS ASSESSMENT REPORT**  
**EXIT 217 NORTH MEETING STREET ON AND OFF-RAMPS**  
**STRUCTURE# 101002600891 AND 102005200191**  
**NORTH CHARLESTON, SOUTH CAROLINA**  
S&ME Project No. 1413-15-075

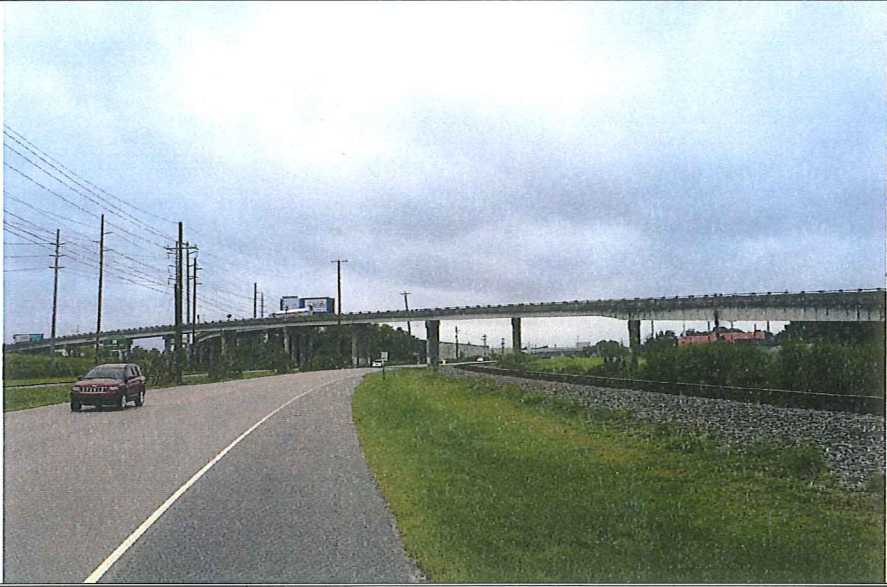
Photo 2

<b>Photographer:</b> Richburg	<b>Date:</b> 07-24-15
<b>Location/Orientation</b>	Photo taken on King Street Extension facing North
<b>Remarks</b>
