**Geotechnical Base Line Report  
New I-26 Volvo Interchange  
Berkeley County, South Carolina  
S&ME Project No. 1413-15-114**

Reference: **Geotechnical Base Line Report**  
New I-26 Volvo Interchange  
Berkeley County, South Carolina  
S&ME Project No. 1413-15-114

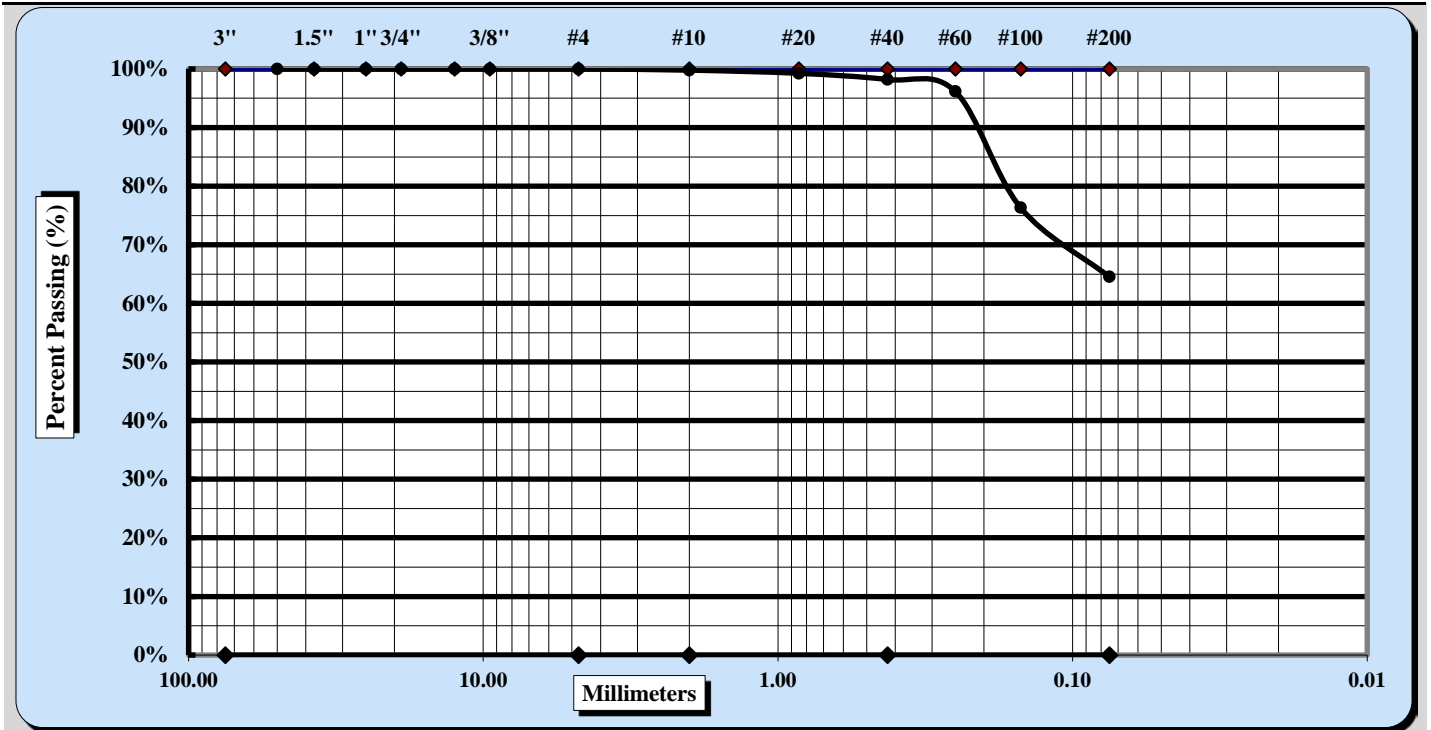
Maximum Particle Size	#4	Coarse Sand	0.2%	Fine Sand	33.7%
Gravel	0.0%	Medium Sand	1.6%	Silt & Clay	64.5%
Liquid Limit	31	Plastic Limit	13	Plastic Index	18
Specific Gravity				Moisture Content	21.7%
Coarse Sand	0.2%	Medium Sand	1.6%	Fine Sand	33.7%
Description of Sand & Gravel Particles:		Rounded	<input type="checkbox"/>	Angular	<input type="checkbox"/>
Hard & Durable	<input type="checkbox"/>	Soft	<input type="checkbox"/>	Weathered & Friable	<input type="checkbox"/>

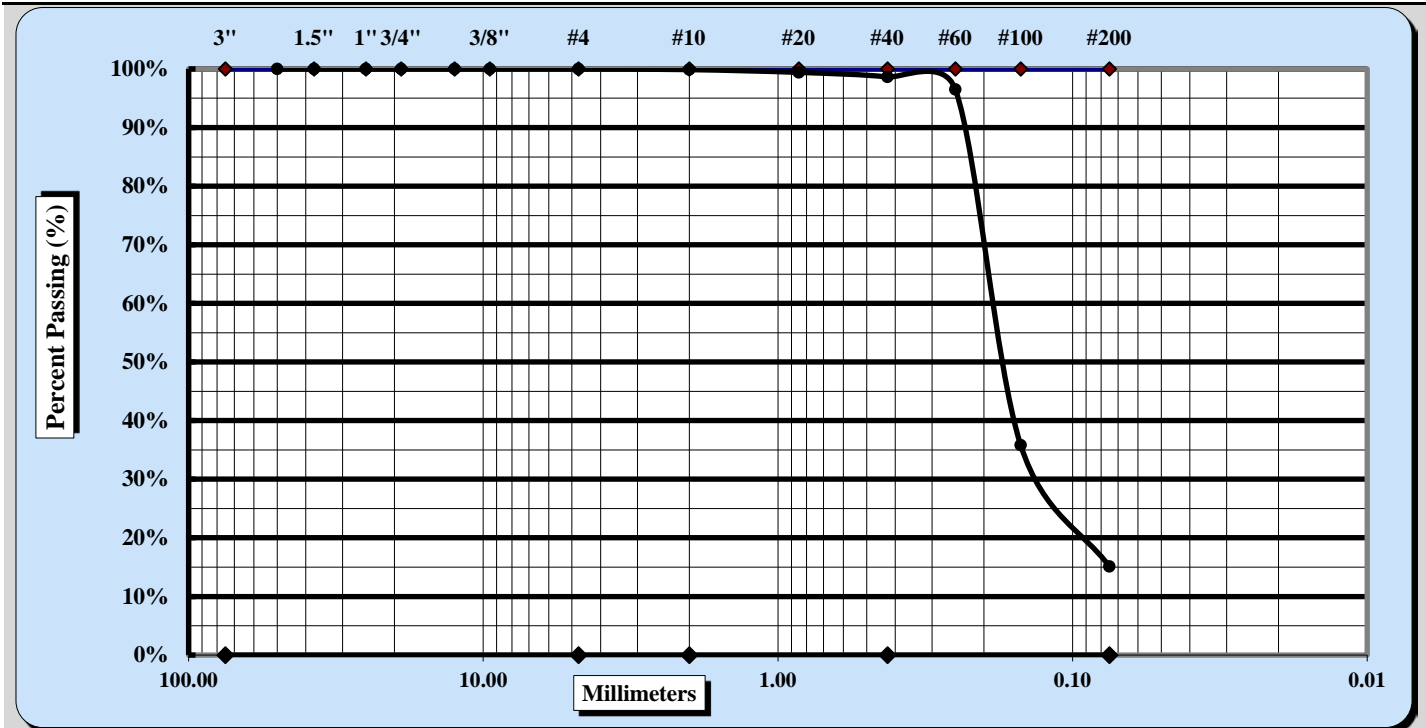
Maximum Particle Size	#10	Coarse Sand	0.1%	Fine Sand	83.5%
Gravel	0.0%	Medium Sand	1.3%	Silt & Clay	15.1%
Liquid Limit	NP	Plastic Limit	NP	Plastic Index	NP
Specific Gravity				Moisture Content	25.4%

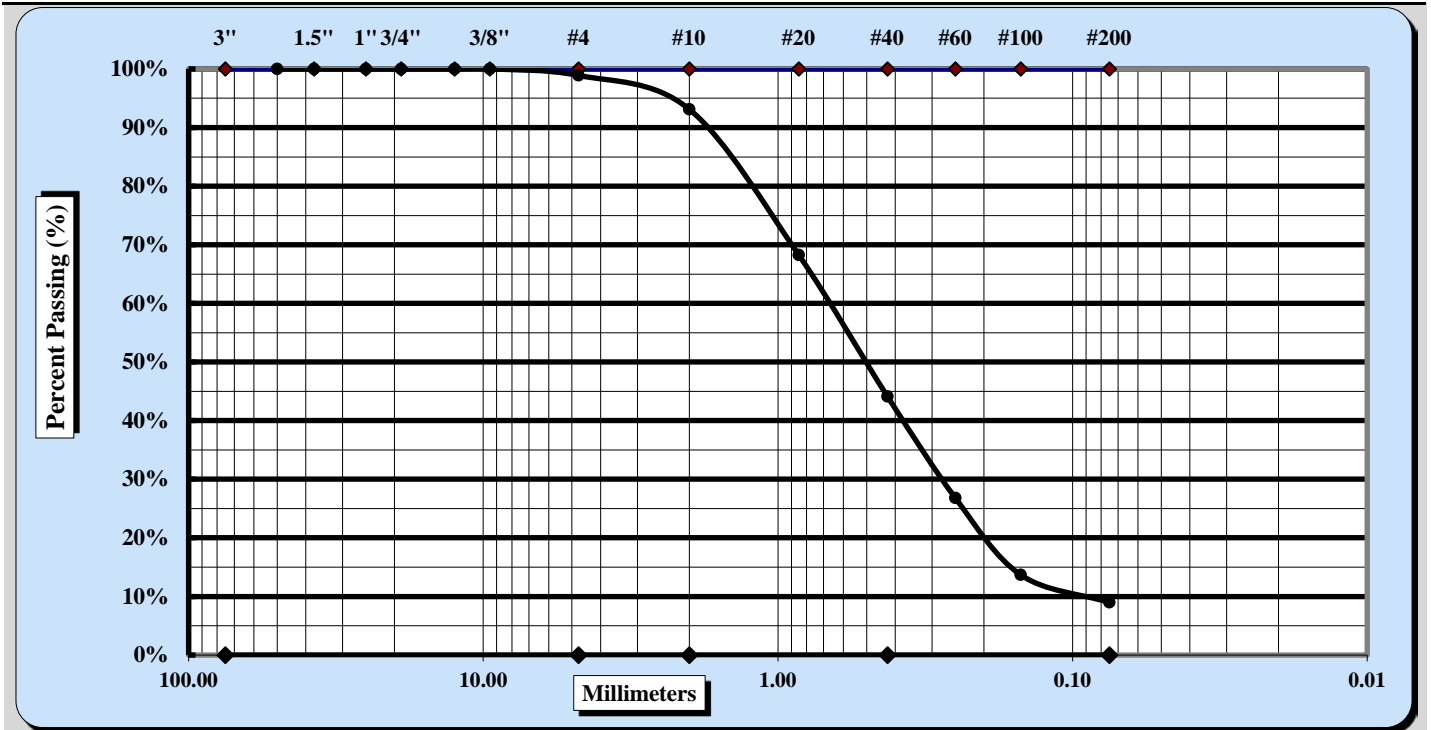
Maximum Particle Size	3/8"	Coarse Sand	5.8%	Fine Sand	35.2%
Gravel	1.1%	Medium Sand	49.0%	Silt & Clay	9.0%
Liquid Limit	NP	Plastic Limit	NP	Plastic Index	NP
Specific Gravity				Moisture Content	18.1%
Coarse Sand	5.8%	Medium Sand	49.0%	Fine Sand	35.2%
Description of Sand & Gravel Particles:		Rounded	<input type="checkbox"/>	Angular	<input type="checkbox"/>
Hard & Durable	<input type="checkbox"/>	Soft	<input type="checkbox"/>	Weathered & Friable	<input type="checkbox"/>

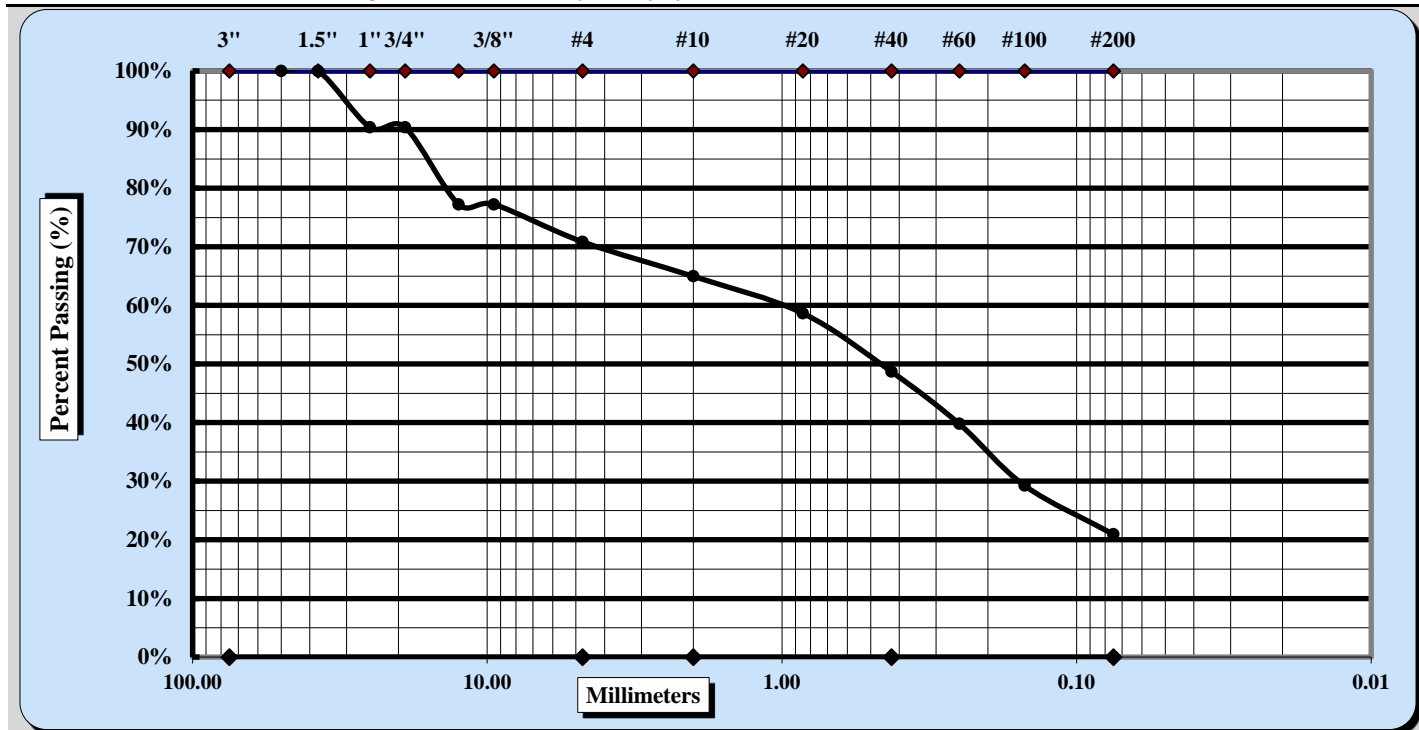
Maximum Particle Size	1.5"	Coarse Sand	5.9%	Fine Sand	27.7%
Gravel	29.2%	Medium Sand	16.3%	Silt & Clay	21.0%
Liquid Limit	NP	Plastic Limit	NP	Plastic Index	NP
Specific Gravity				Moisture Content	18.4%
Coarse Sand	5.9%	Medium Sand	16.3%	Fine Sand	27.7%
Description of Sand & Gravel Particles:		Rounded	<input type="checkbox"/>	Angular	<input type="checkbox"/>
Hard & Durable	<input type="checkbox"/>	Soft	<input type="checkbox"/>	Weathered & Friable	<input type="checkbox"/>

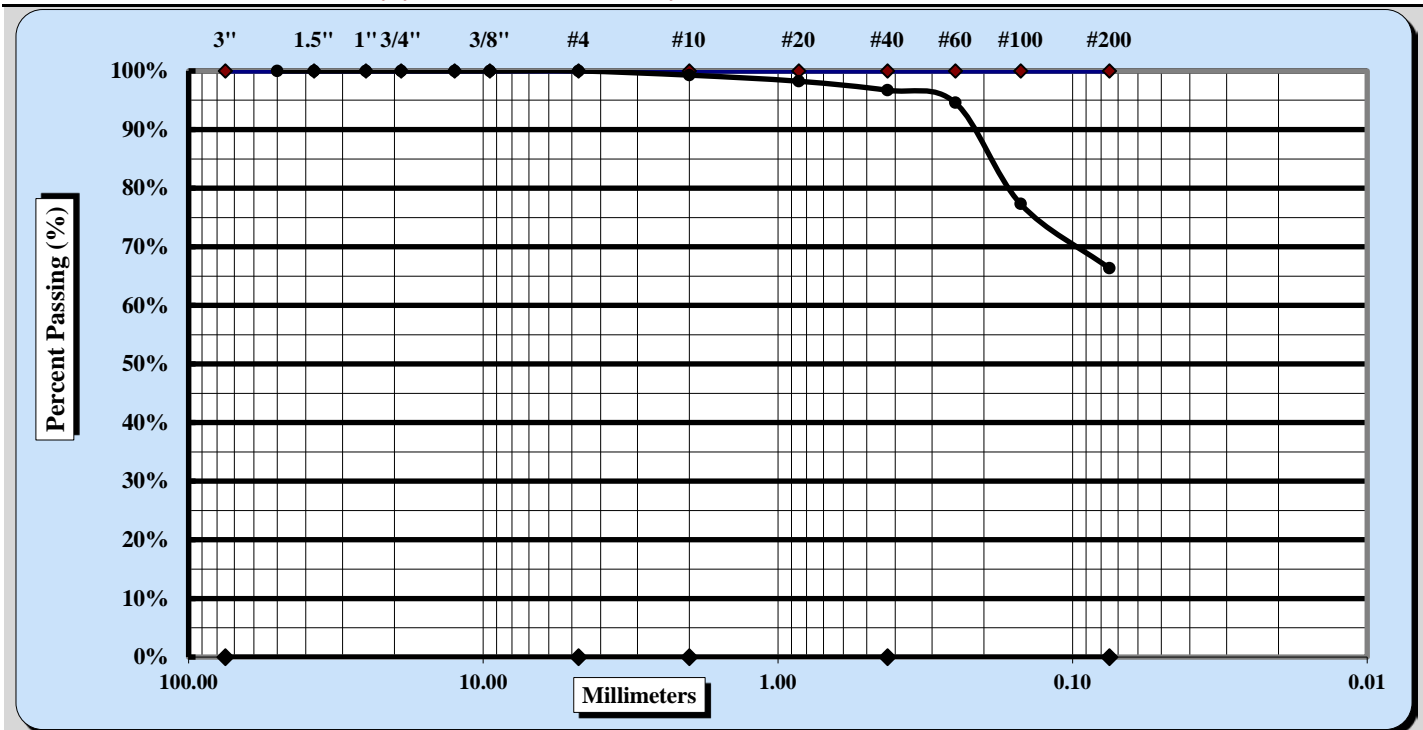
Maximum Particle Size	#4	Coarse Sand	0.7%	Fine Sand	30.4%
Gravel	0.0%	Medium Sand	2.6%	Silt & Clay	66.3%
Liquid Limit	23	Plastic Limit	13	Plastic Index	10
Specific Gravity				Moisture Content	14.8%
Coarse Sand	0.7%	Medium Sand	2.6%	Fine Sand	30.4%
Description of Sand & Gravel Particles:		Rounded	<input type="checkbox"/>	Angular	<input type="checkbox"/>
Hard & Durable	<input type="checkbox"/>	Soft	<input type="checkbox"/>	Weathered & Friable	<input type="checkbox"/>

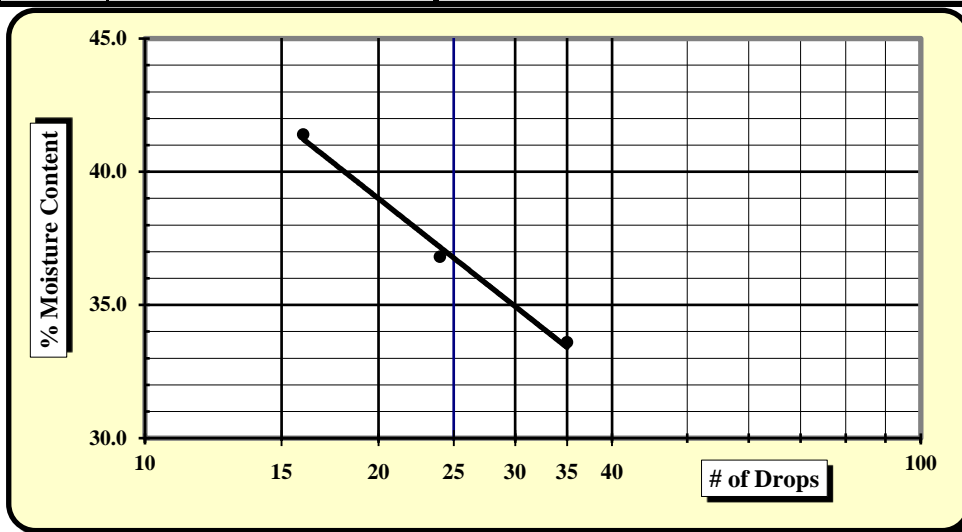
Pan #	Tare #:	Liquid Limit						Plastic Limit		
		1	2	3	4	5	6	7	8	9
A	Tare Weight	22.46	21.19	21.07				<b>21.43</b>	14.22	
B	Wet Soil Weight + A	52.56	45.31	45.10				29.60	23.08	
C	Dry Soil Weight + A	44.99	38.82	38.07				28.52	22.03	
D	Water Weight (B-C)	7.57	6.49	7.03				1.08	1.05	
E	Dry Soil Weight (C-A)	22.53	17.63	17.00				7.09	7.81	
F	% Moisture (D/E)*100	33.6%	36.8%	41.4%				15.2%	13.4%	
N	# OF DROPS	35	24	16						
LL	LL = F * FACTOR									
Ave.	Average									<b>14.3%</b>

One Point Liquid Limit			
N	Factor	N	Factor
20	0.974	26	1.005
21	0.979	27	1.009
22	0.985	28	1.014
23	0.99	29	1.018
24	0.995	30	1.022
25	1.000

NP, Non-Plastic	<input type="checkbox"/>
Liquid Limit	<b>37</b>
Plastic Limit	<b>14</b>
Plastic Index	<b>23</b>
Group Symbol	<b>CL</b>

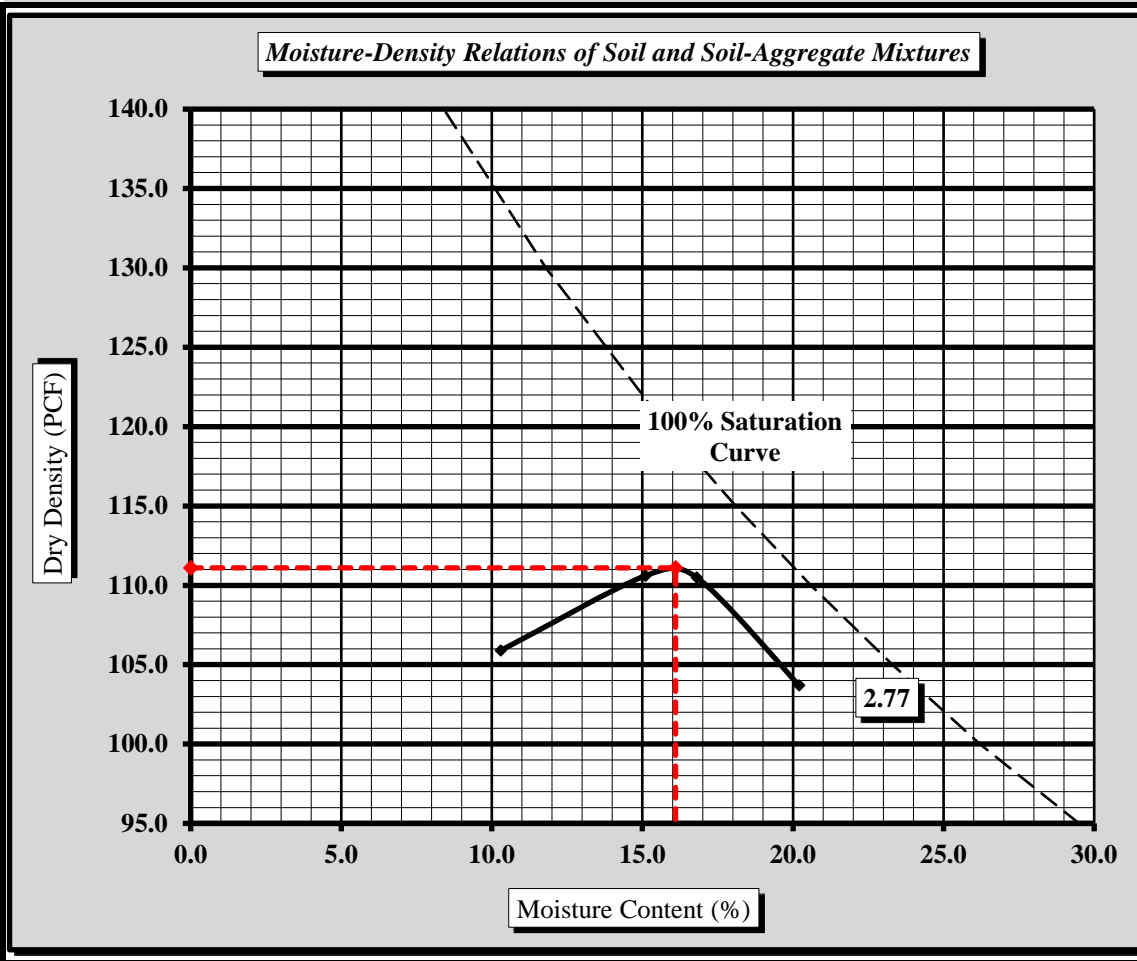
# Moisture - Density Report

Soil Properties	
Natural Moisture Content	<b>29.3%</b>
Specific Gravity of Soil	
Liquid Limit	<b>31</b>
Plastic Limit	<b>13</b>
Plastic Index	<b>18</b>
% Passing	
3/4"	100.0%
#4	99.7%
#10	99.4%
#20	98.3%
#40	94.8%
#60	88.2%
#100	61.6%
#200	53.8%
Oversize Fraction	
Bulk Gravity	
% Moisture	
% Oversize	
MDD	
Opt. MC

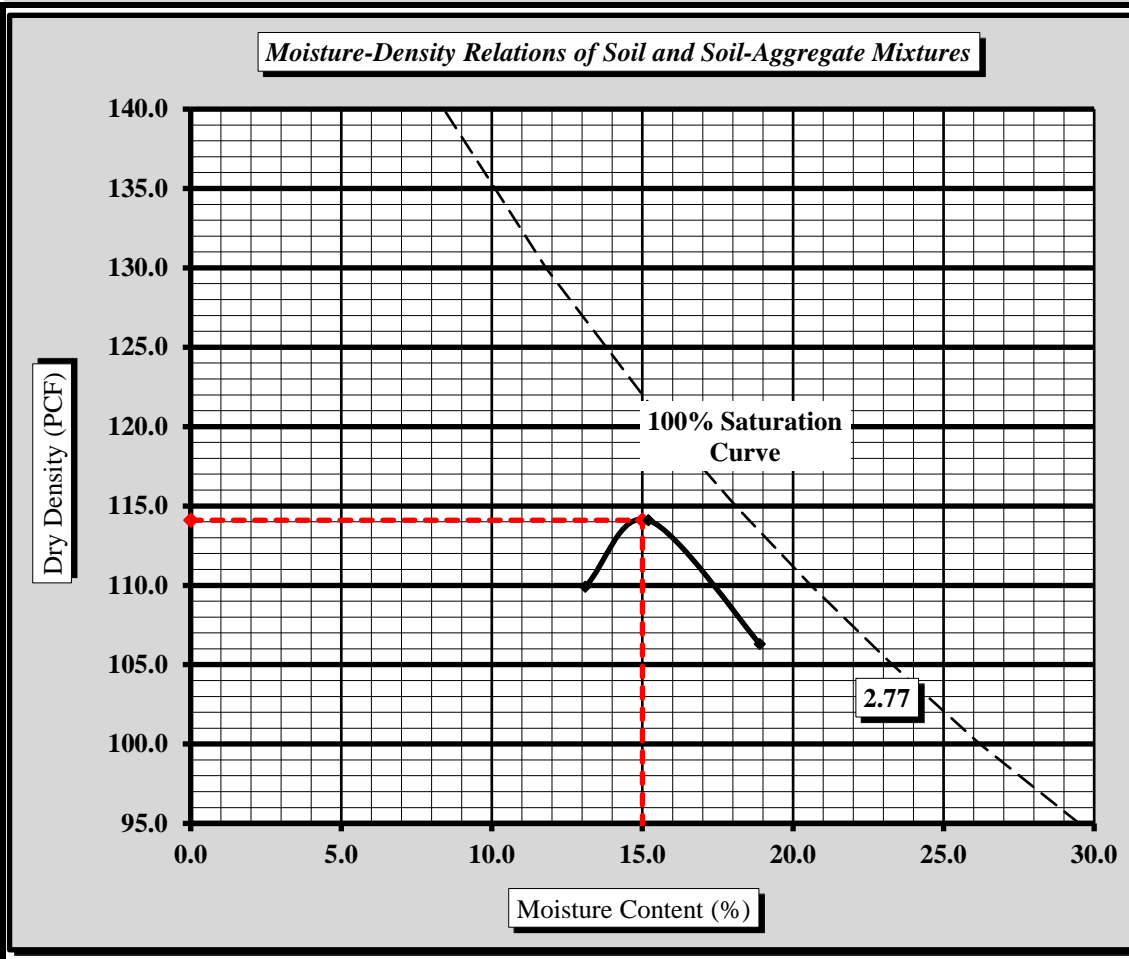
# Moisture - Density Report

Soil Properties	
Natural Moisture Content	<b>15.1%</b>
Specific Gravity of Soil	
Liquid Limit	<b>28</b>
Plastic Limit	<b>13</b>
Plastic Index	<b>15</b>
% Passing	
3/4"	100.0%
#4	100.0%
#10	99.9%
#20	99.1%
#40	95.1%
#60	88.3%
#100	65.0%
#200	55.1%
Oversize Fraction	
Bulk Gravity	
% Moisture	
% Oversize	
MDD	
Opt. MC

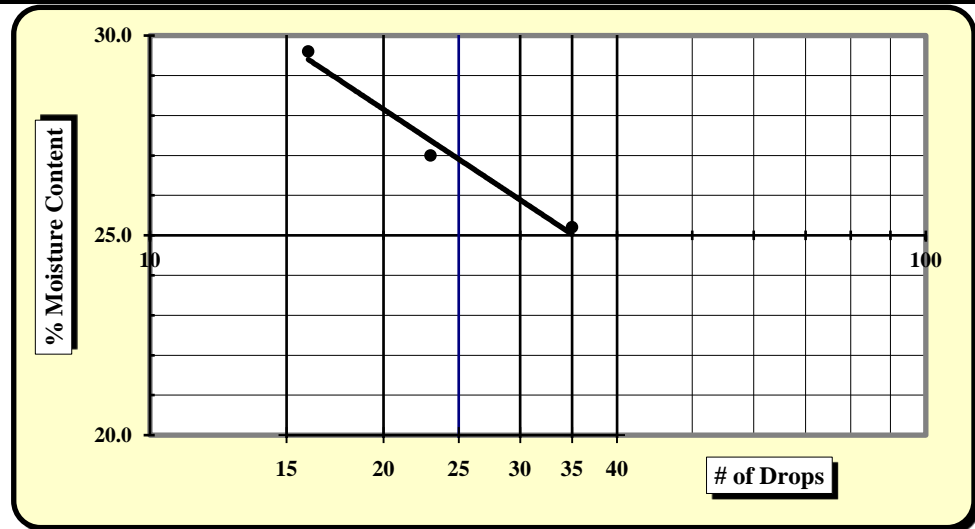
Pan #	Tare #:	Liquid Limit					Plastic Limit			
		1	2	3	4	5	6	7	8	9
A	Tare Weight	22.82	22.16	20.86				20.74	22.01	
B	Wet Soil Weight + A	45.71	44.96	48.74				29.48	30.43	
C	Dry Soil Weight + A	40.85	39.75	43.13				28.25	29.28	
D	Water Weight (B-C)	4.86	5.21	5.61				1.23	1.15	
E	Dry Soil Weight (C-A)	18.03	17.59	22.27				7.51	7.27	
F	% Moisture (D/E)*100	27.0%	29.6%	25.2%				16.4%	15.8%	
N	# OF DROPS	23	16	35						
LL	LL = F * FACTOR									
Ave.	Average									16.1%

One Point Liquid Limit			
N	Factor	N	Factor
20	0.974	26	1.005
21	0.979	27	1.009
22	0.985	28	1.014
23	0.99	29	1.018
24	0.995	30	1.022
25	1.000

NP, Non-Plastic	<input type="checkbox"/>
Liquid Limit	27
Plastic Limit	16
Plastic Index	11
Group Symbol	CL
Multipoint Method	<input checked="" type="checkbox"/>
One-point Method	<input type="checkbox"/>

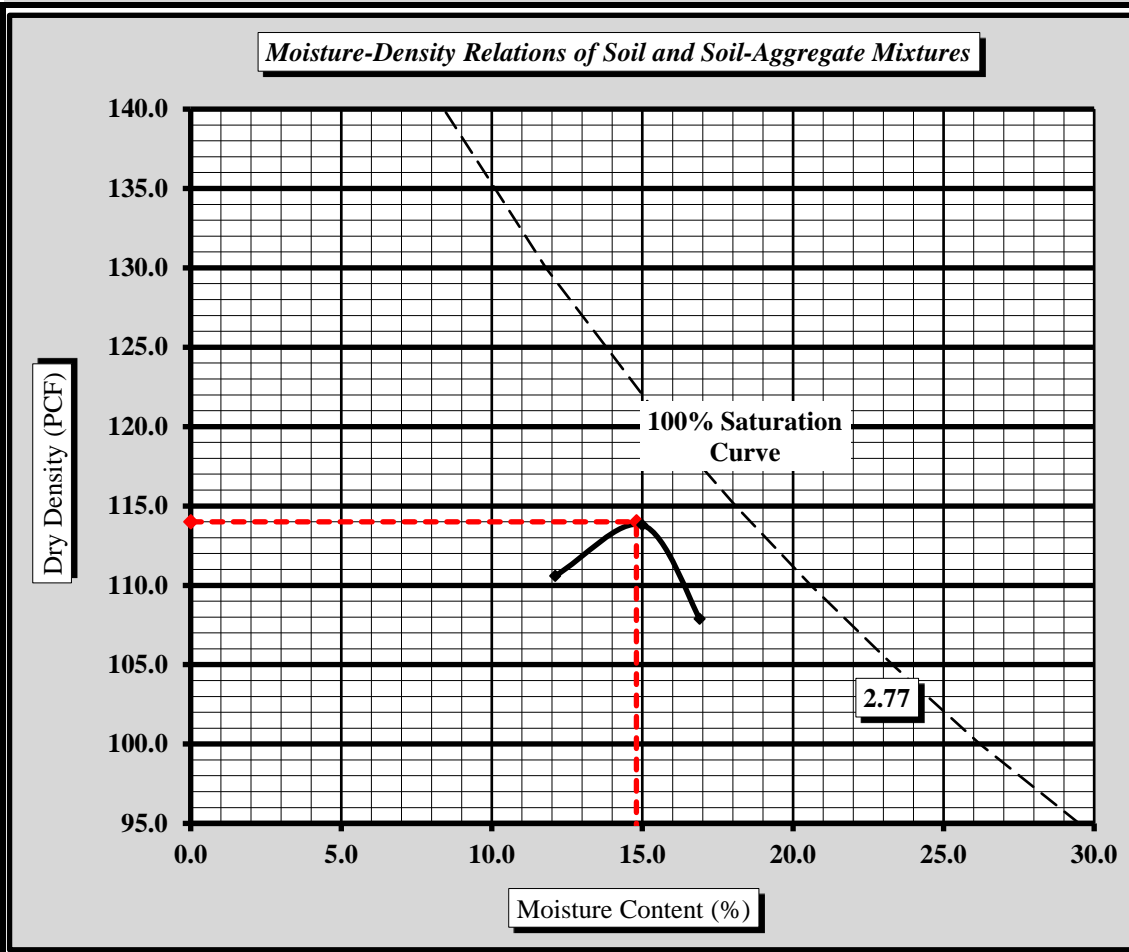
Soil Properties	
Natural Moisture Content	<b>9.6%</b>
Specific Gravity of Soil	
Liquid Limit	<b>NP</b>
Plastic Limit	<b>NP</b>
Plastic Index	<b>NP</b>
% Passing	
3/4"	100.0%
#4	99.7%
#10	99.5%
#20	98.8%
#40	90.8%
#60	70.3%
#100	23.4%
#200	15.5%
Oversize Fraction	
Bulk Gravity	
% Moisture	
% Oversize	
MDD	
Opt. MC

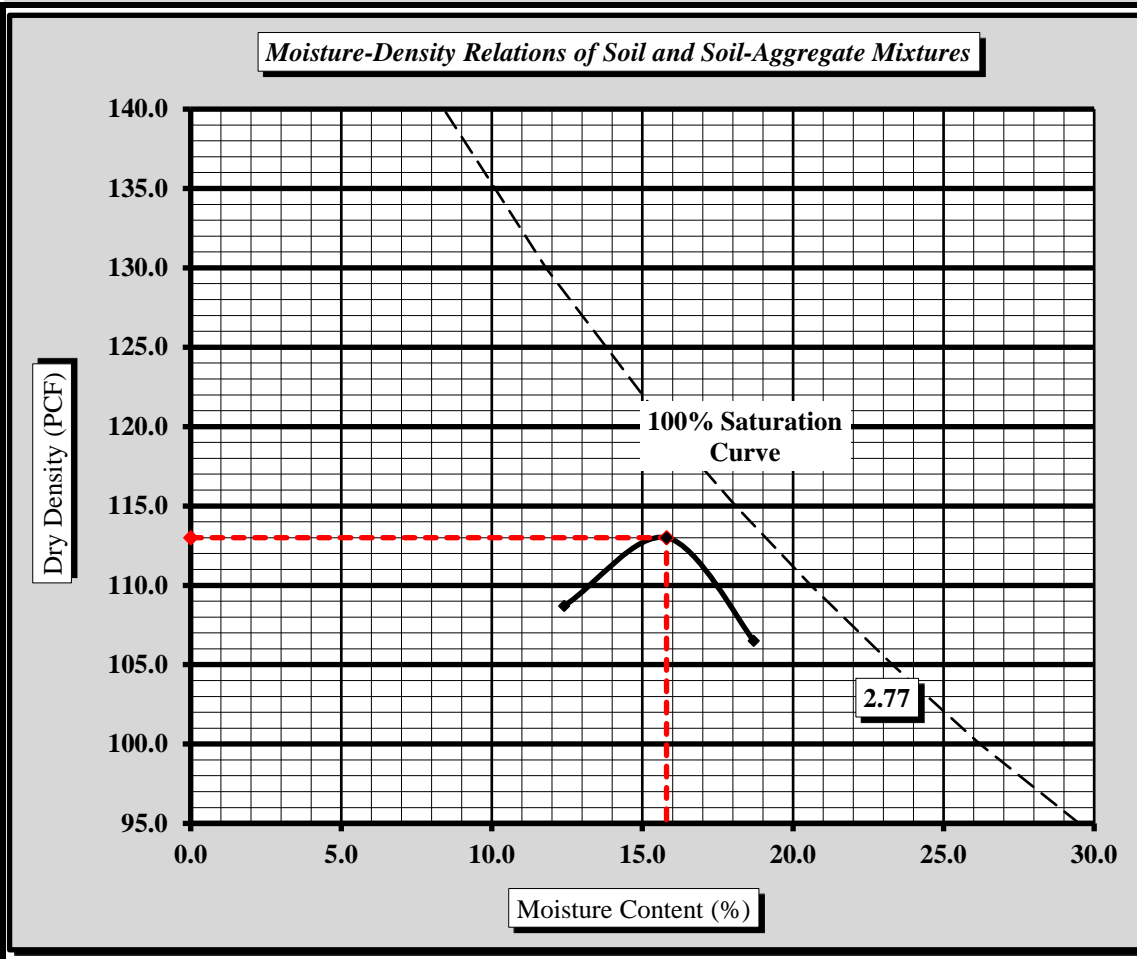
Soil Properties	
Natural Moisture Content	<b>18.8%</b>
Specific Gravity of Soil	
Liquid Limit	<b>27</b>
Plastic Limit	<b>15</b>
Plastic Index	<b>12</b>
% Passing	
3/4"	100.0%
#4	98.7%
#10	98.6%
#20	98.3%
#40	94.3%
#60	80.0%
#100	36.9%
#200	30.7%
Oversize Fraction	
Bulk Gravity	
% Moisture	
% Oversize	
MDD	
Opt. MC

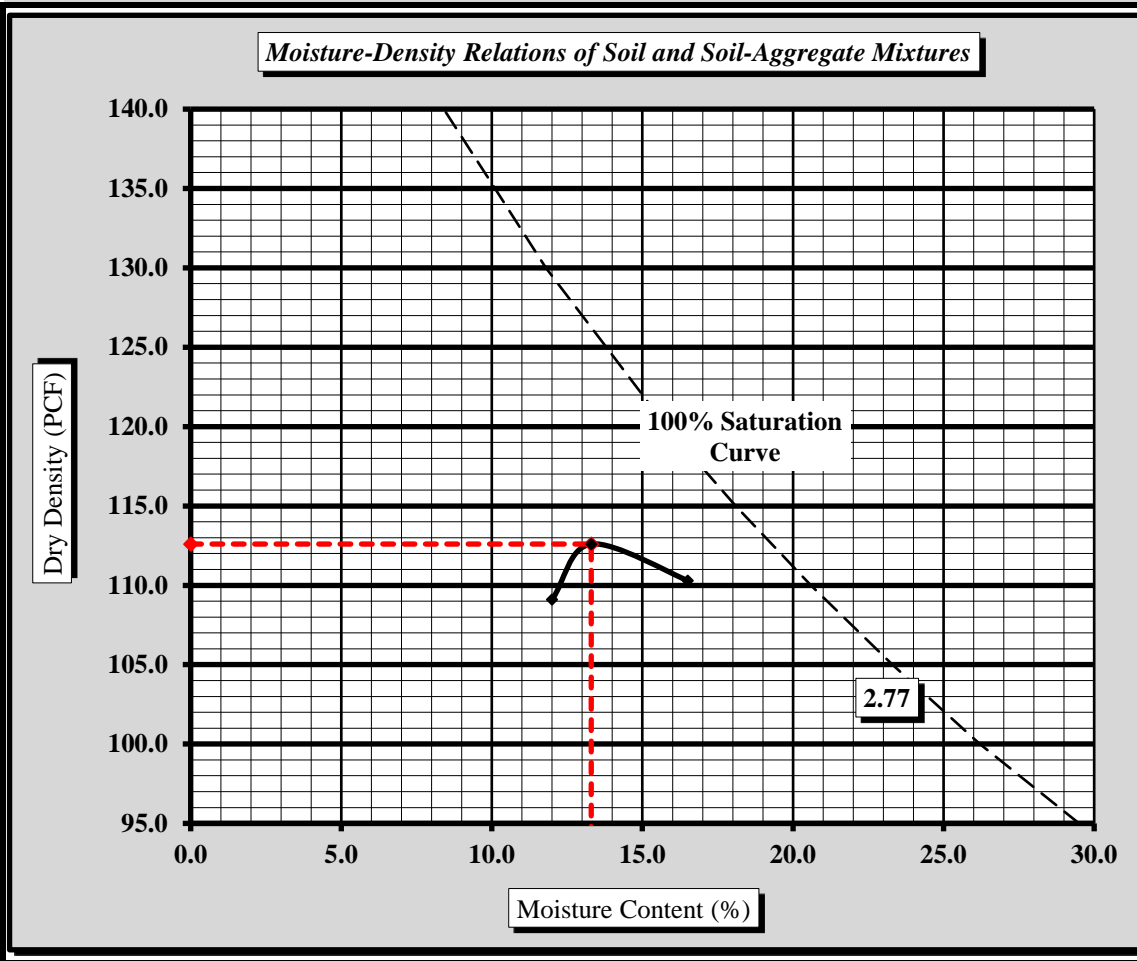
Soil Properties	
Natural Moisture Content	<b>16.3%</b>
Specific Gravity of Soil	
Liquid Limit	<b>31</b>
Plastic Limit	<b>13</b>
Plastic Index	<b>18</b>
% Passing	
3/4"	100.0%
#4	100.0%
#10	99.7%
#20	98.2%
#40	95.9%
#60	93.1%
#100	80.1%
#200	71.8%
Oversize Fraction	
Bulk Gravity	
% Moisture	
% Oversize	
MDD	
Opt. MC

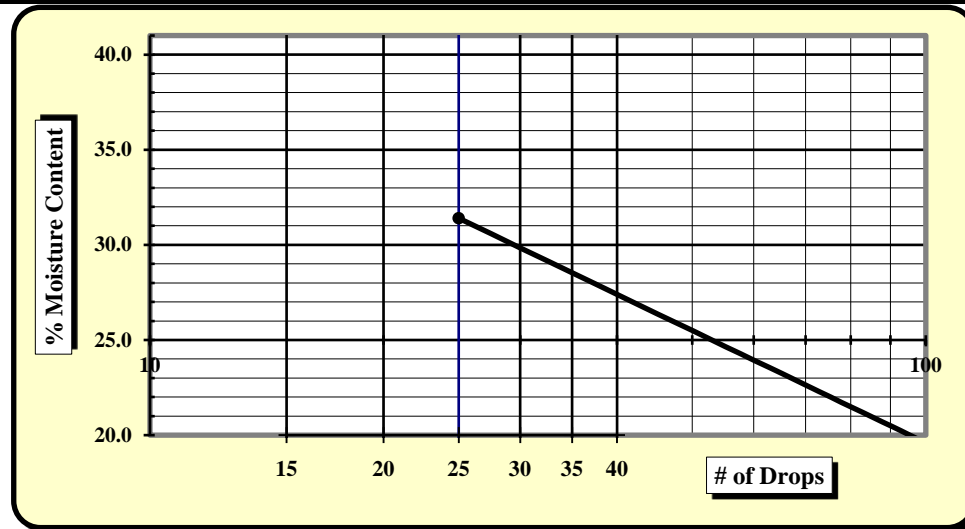
Pan #	Tare #:	Liquid Limit					Plastic Limit			
		1	2	3	4	5	6	7	8	9
A	Tare Weight	22.50						<b>20.81</b>	21.22	
B	Wet Soil Weight + A	48.29						27.16	27.17	
C	Dry Soil Weight + A	42.12						26.35	26.46	
D	Water Weight (B-C)	6.17						0.81	0.71	
E	Dry Soil Weight (C-A)	19.62						5.54	5.24	
F	% Moisture (D/E)*100	31.4%						14.6%	13.5%	
N	# OF DROPS	25								
LL	LL = F * FACTOR									
Ave.	Average									<b>14.1%</b>

One Point Liquid Limit			
N	Factor	N	Factor
20	0.974	26	1.005
21	0.979	27	1.009
22	0.985	28	1.014
23	0.99	29	1.018
24	0.995	30	1.022
25	1.000

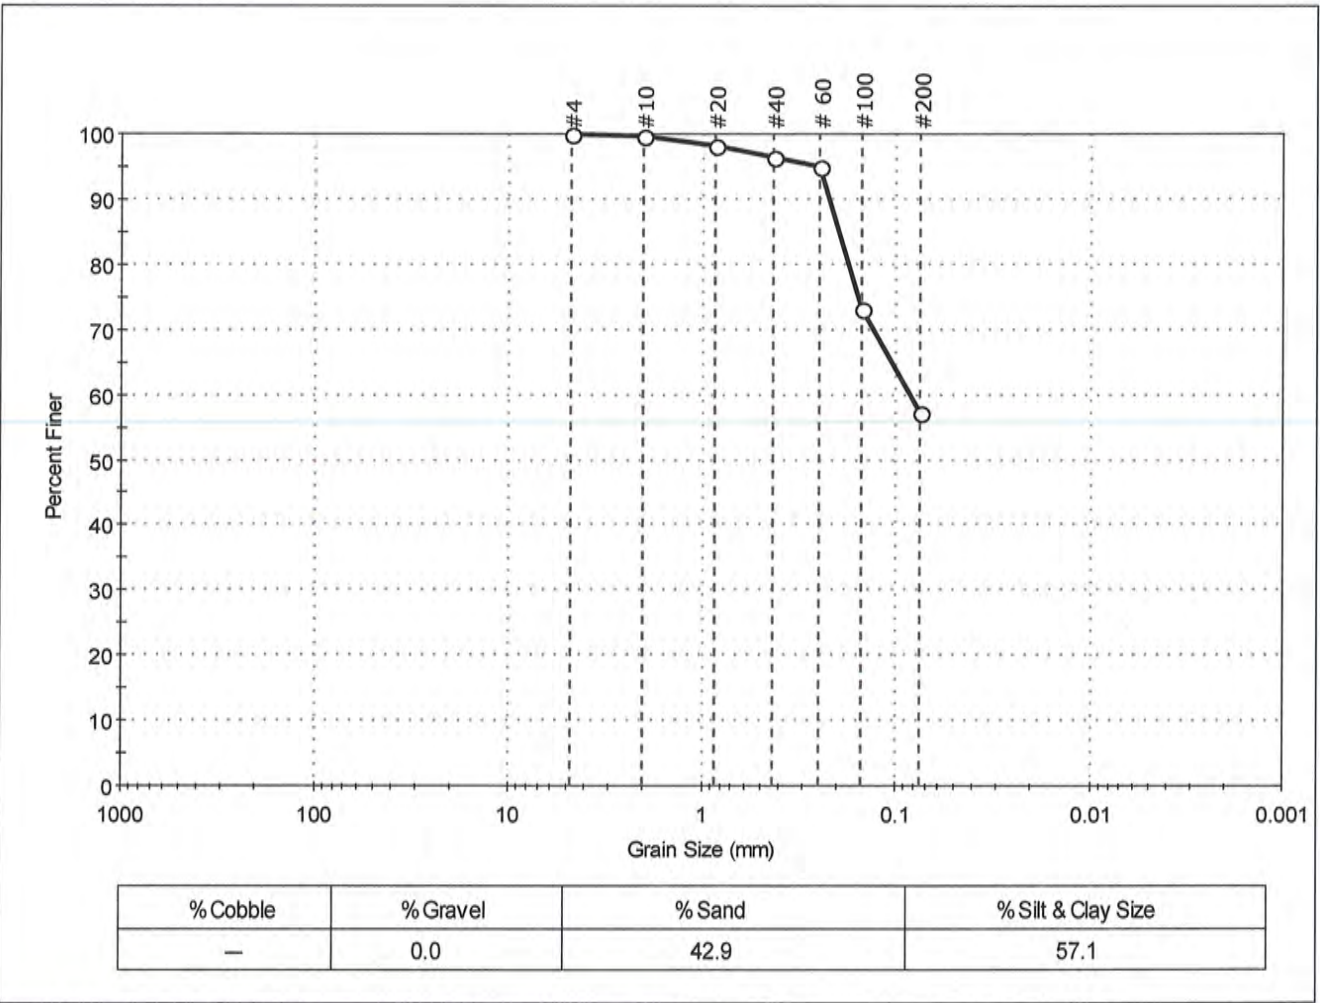
Sieve Name	Sieve Size, mm	Percent Finer	Spec. Percent	Complies
#4	4.75	100		
#10	2.00	100		
#20	0.85	98		
#40	0.42	96		
#60	0.25	95		
#100	0.15	73		
#200	0.075	57
