## **US 301 Bridge**

Petrographic Examination of Concrete Cores

Orangeburg County, South Carolina

### **FINAL REPORT**

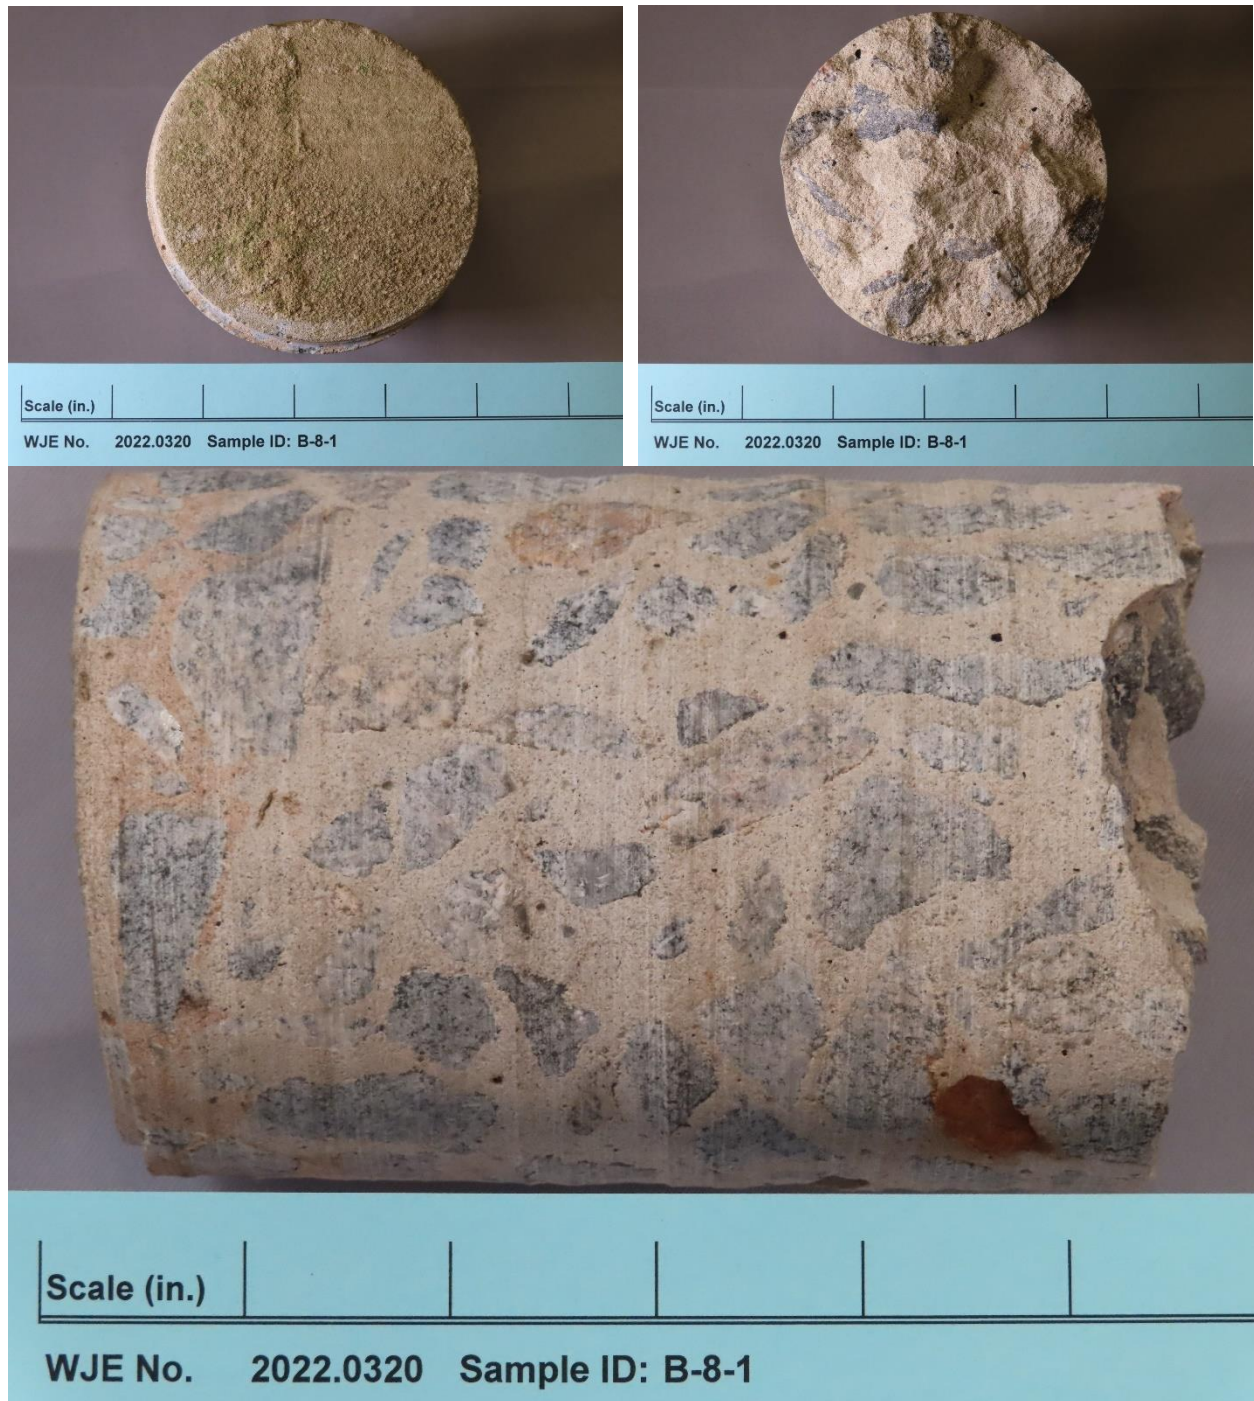
No distress was observed on the surface or within the body of Core B-8-1.

The material on the surface of Core B-8-1 represents an air-entrained, cement mortar. The benefits of air entrainment and the use of air-entraining admixtures started in the 1930s. Given this timeframe, and the coarse gradation of the residual portland cement particles, it is possible that this material represents a repair that was installed recently after original construction or during the bridge widening. No evidence of previous repairs was observed in the other three examined cores.

No distress was observed in the core sample extracted from above the waterline.

Figure A3. As-received appearance of exterior (upper left), interior (upper right), and side (lower) of Core B-8-1.
